**OLD SCHOONER CHANNEL  
PROPOSED DREDGING AREA**

**MARINE ARCHAEOLOGICAL SURVEY**

**CHRISTIANSTED HARBOR**

**FINAL REPORT**

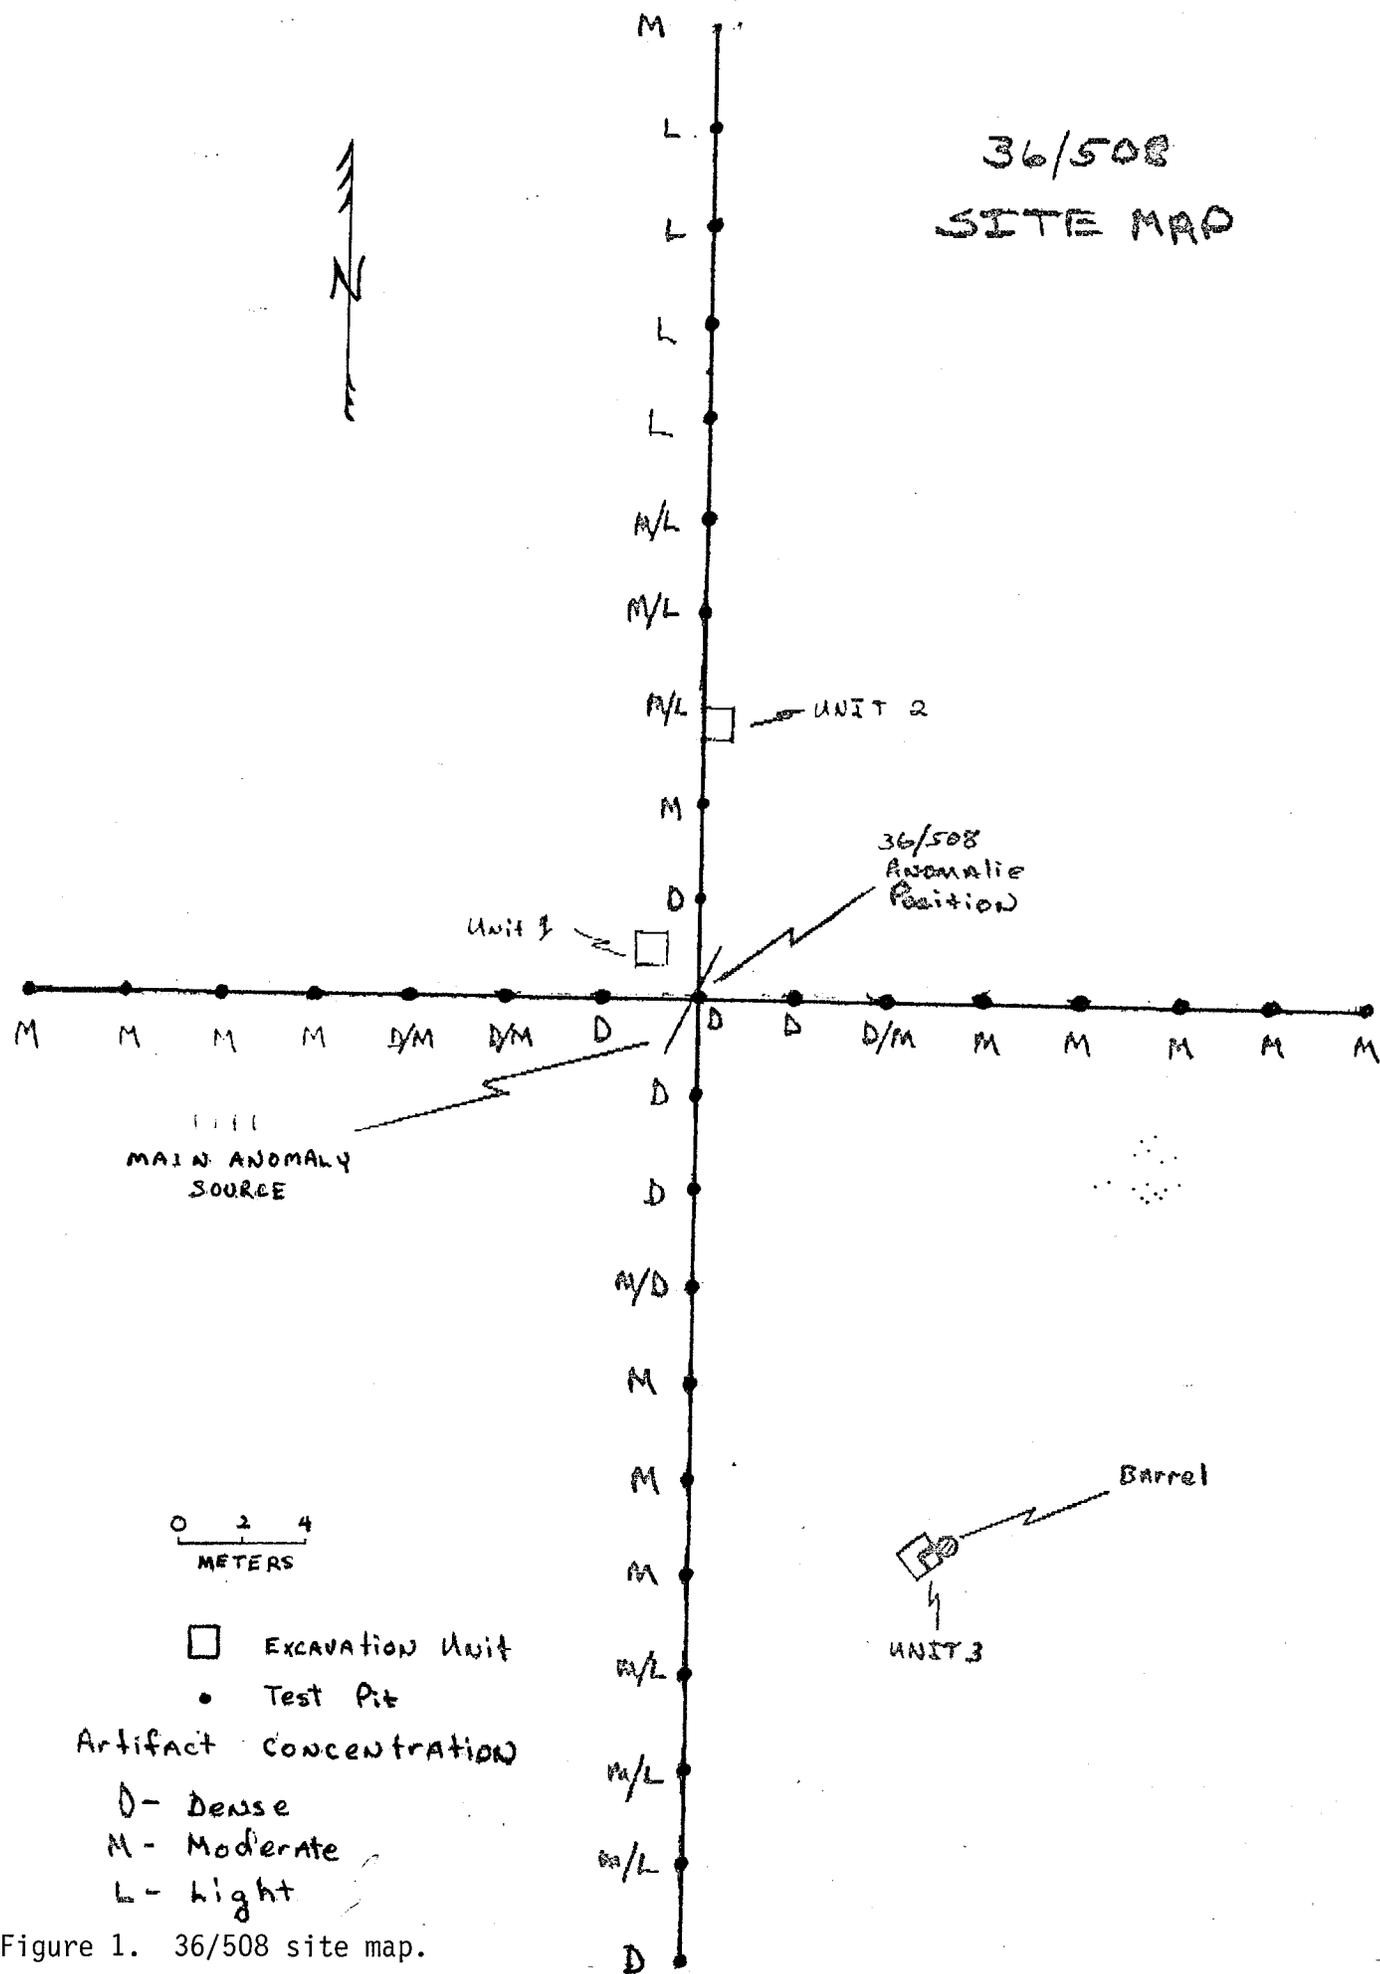
# 36/508 SITE MAP

In addition to the three airlifted test units, a series of hand fanned tests were placed at three meter intervals along the grid lines in order to assist in determining the spatial and compositional aspects of the site. The density of artifacts was the main characteristic recorded for these tests. Density, defined as dense (D), moderate (M), and light (L) was a comparative reference to the dense concentration of artifacts located at the center of the site. A hand fanned test with an artifact concentration dense as that noted at the anomaly center received a "D," a test that revealed a concentration of approximately half of that realized at the site center received an "M," and those tests that revealed few if any artifacts received the label "L" (Figure 1 [36/508 Site Map]).

By the employment of this method it is apparent that the dense, central concentration covers an area approximately 12 meters north and south by 9 meters east and west. To the north the artifact density becomes extremely light while to the east and west a moderate amount of artifact density is encountered. The area to the south is marked by a moderate artifact density. However, 30 meters to the south is located another artifact concentration similar in density to that of the main concentration. In addition to the determination of the sites horizontal composition, plastic was found in association with red roof tile at 40 cm BD in a test pit 22 meters north of Unit 2. This evidence further argues that the cultural deposit is disturbed.

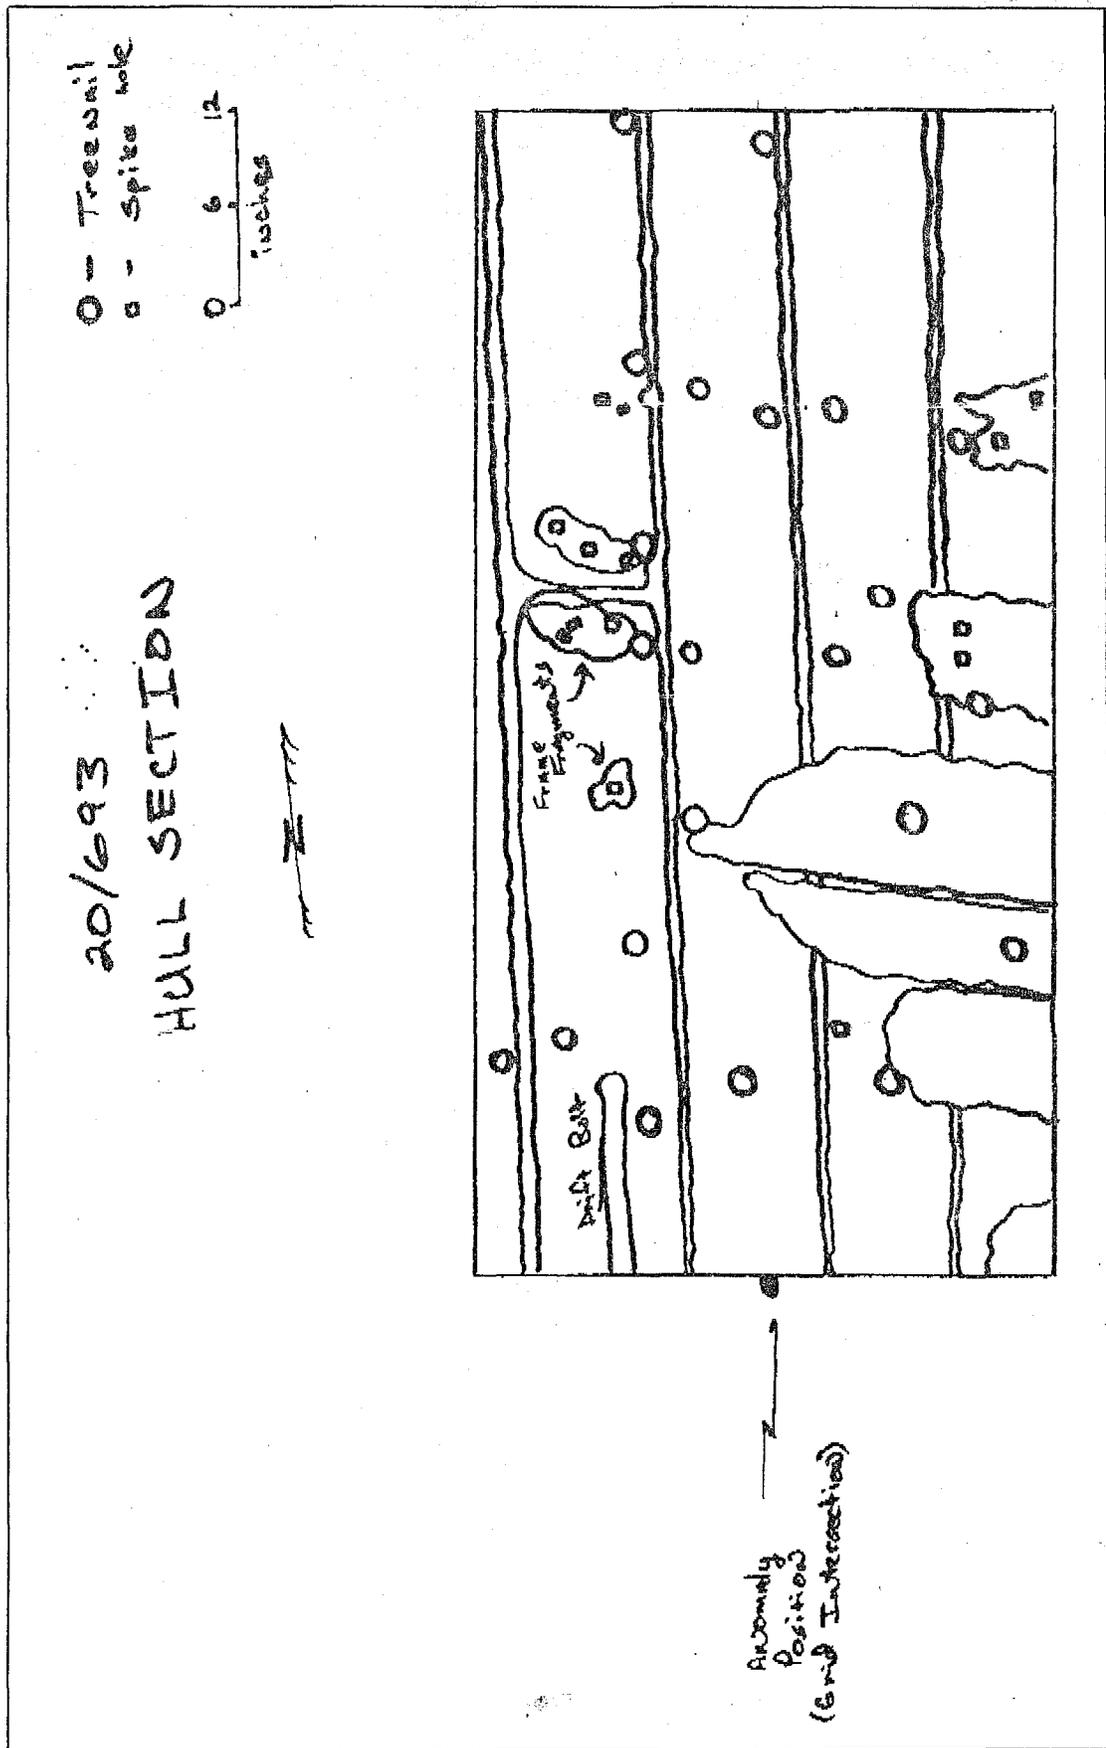
Figure 4. Hull section.

The excavation of the units exposed a run of outer-hull planking composed of 5 hull planks and the remains of 6 frames (Figure 4 [Hull Section]). The planks range from 7-to-9 inches in width and are 2.5 inches thick. They are worm eaten, spongy and easily damaged, but are in relatively good condition when compared to the frames. A total of 7 frames are present. The frames are

most intact along the east wall of the units. However, they are all badly deteriorated, especially as one goes from their base against the hull planks upwards. Their extremely deteriorated condition made an accurate determination of moulding and siding difficult at best. A possible scenario for the contrasting conditions of planks and frames may have seen the planking, which lay directly on the sea floor, being buried first while the frames, projecting into the non-protective water column, being subsequently covered at a later date during which time their deterioration progressed past that of the planks.

The remaining sided dimensions of the frames range from 5-to-8 inches, but the original dimension of two of the frames may have been as much as 10 or 11 inches. This projection is based on fastener locations. The largest remaining moulded dimension is 10 inches. The frames cross the planks at a slight angle and appear to have little or no longitudinal curve. The deteriorated condition of the frames and the small portion of hull section does not readily allow for a determination of the frame type and space, or the section's location on the vessel. It does appear that the frames are fairly large and their slight cant may be an indication of the hull section originating from the bow or stern. They appear to be predominately fastened with treenails as opposed to iron spikes and drift bolts. Though speculative, the intact 2 foot drift that is present at the extreme southern end of the hull section may be indicative of a deck shelf, knee, or internal stringer. A glimpse of the outer side of the planks in this area revealed no evidence of sheathing or hull covering.

As mentioned, the fasteners are predominately 1-inch diameter treenails although several 1/2-inch square iron spikes are present. No apparent pattern was noticed except at the butted ends of two planks. These have each been fastened to a single frame with 3 square iron spikes and 1 treenail (Figure 4 [Hull Section drawing]). Remains of the frame are only present at this location because of concretions caused by the spikes. The fasteners allow for a projection of frames across the planks and it appears that all cross the planks. No frame-to-frame drifts were noted in situ. However, a drift bolt was present lying atop the planks in the Southwest corner. Its positioned angle, perpendicular to the frames, would be correct for an edge fastener. This is only tentative speculation as frames in this area were completely eroded.
