Report of Archaeological Reconnaissance at Fish Bay, St. John, U.S.V.I.

**Dave Davis, Ph.D.
Associate Dean, Tulane College
Tulane University
New Orleans, LA 70118
ddavis113@cox.net**

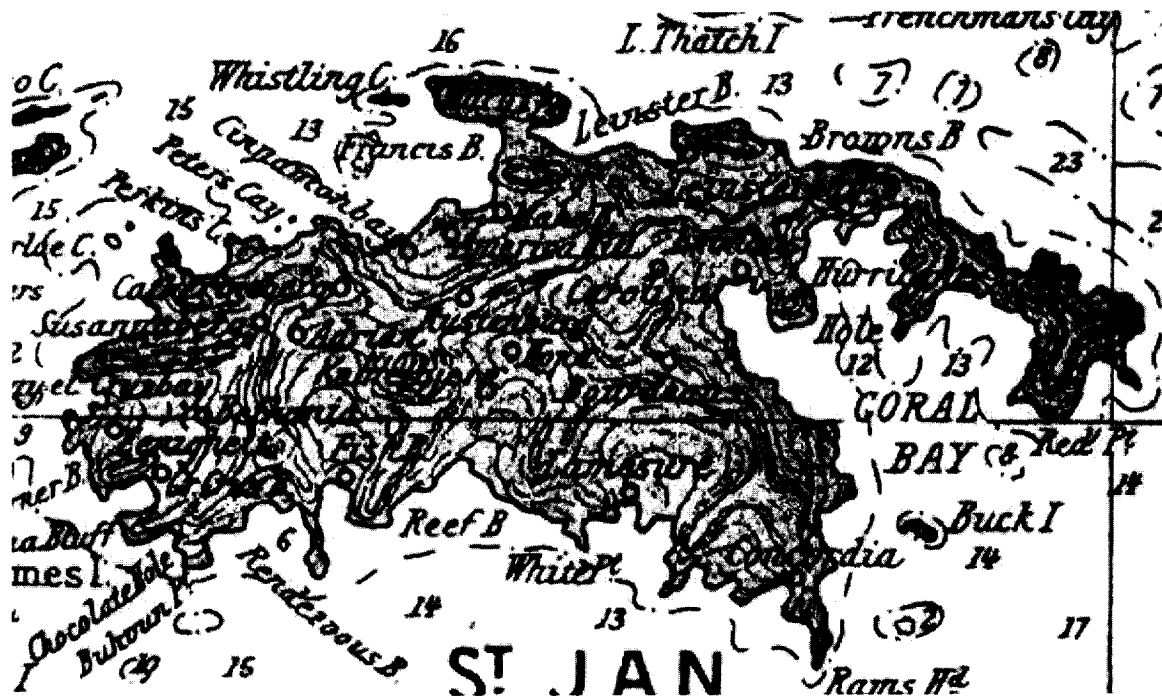
Fig. 1. Danish Plantations on St. John in the Eighteenth Century
 (Source: <http://www.rootsweb.com/~usvi/thomas1.jpg>)

century. Indeed, a map in the Danish archives of the locations of eighteenth century plantations on St. John (Fig. 1) shows a plantation at this location, near the northeastern shore of Fish Bay.

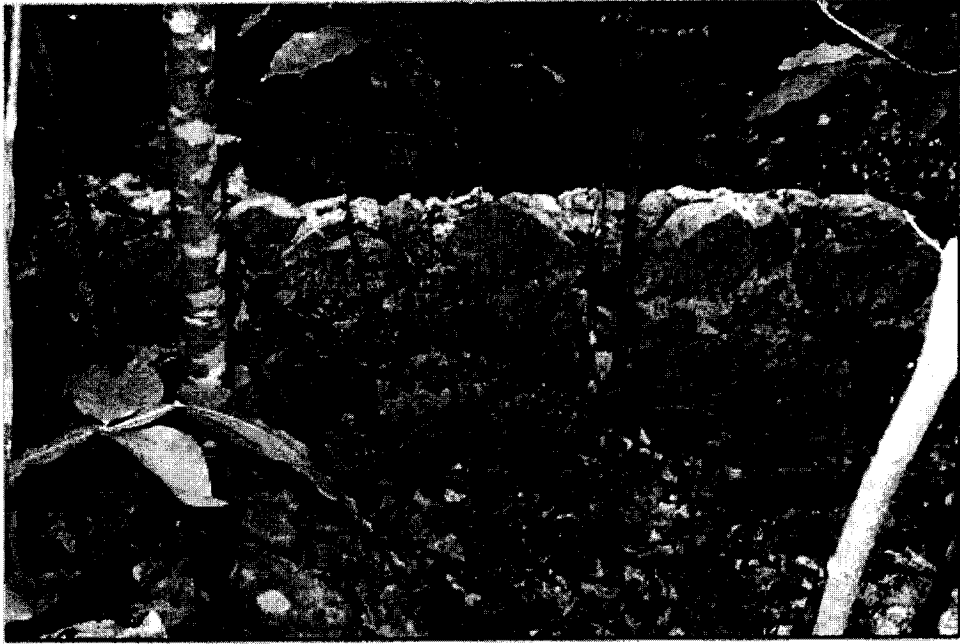
Fig. 2. Fish Bay Structure 1, East Wall

Structure 1. Structure 1, the largest of the three, consists of the lower walls of a rectangular building that encloses an area of 87.4 square meters (Figs. 2 and 3). The remaining height of the stone masonry structure is uniformly 75-80 centimeters. This uniformity suggests that the structure actually represents foundation walls, and that the remainder of the building, which rested atop the foundation walls, was made of impermanent materials. Openings that are approximately centered in the eastern and western walls probably represent doors. The eastern opening measured 1.33 m., while the western opening was 1.30 m. wide. The door doorways are nearly but not perfectly aligned: the western doorway (northern edge) is 189.5° east of north as measured from the center of the eastern doorway. A GPS reading on the center of the eastern door opening showed it to be located at W $64^{\circ}45.023'$ and N $18^{\circ}19.547'$. The interior of the structure consists of a compressed unpaved earth floor. Shallow trowel tests in the interior failed to yield any artifacts.

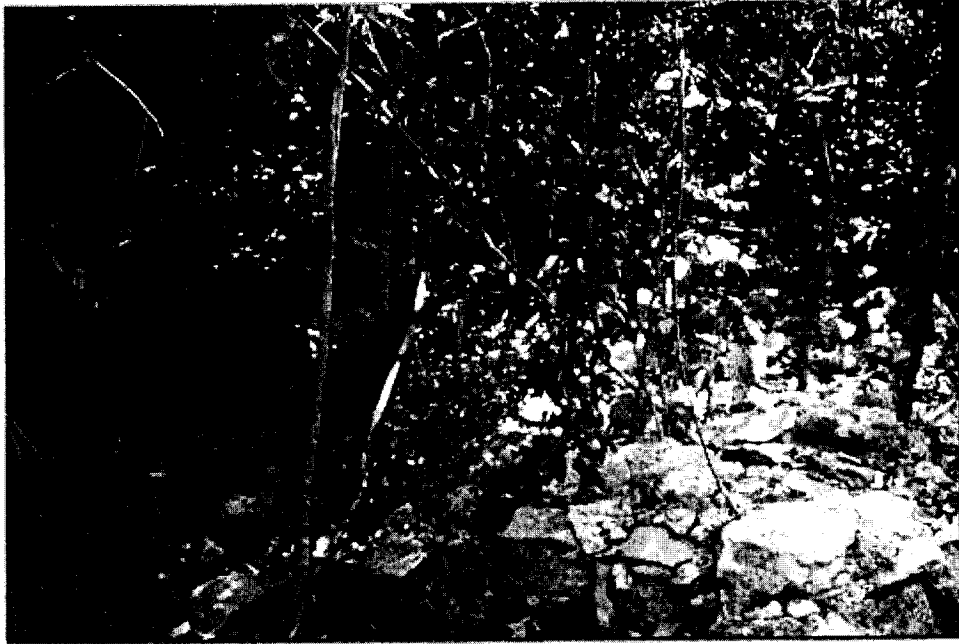
Fig. 4. Fish Bay Structure 2

Structure 2. This structure (Fig. 4) consists of the largely collapsed remains of a mortared stone building. Its southwest corner is located at W 64°45.824' and N 18°19.562'. The building's components are so scattered that it was impossible to accurately measure its original dimensions; we estimated it to have been in the range of 5-7 meters square. The northern wall has two segments whose lower courses are partially intact; these are oriented 106° east of north, and measure 3.51 and 2.0 meters in length. The remaining portion of the southern wall has a length of 4.32 meters. There is no evidence of interior walls.

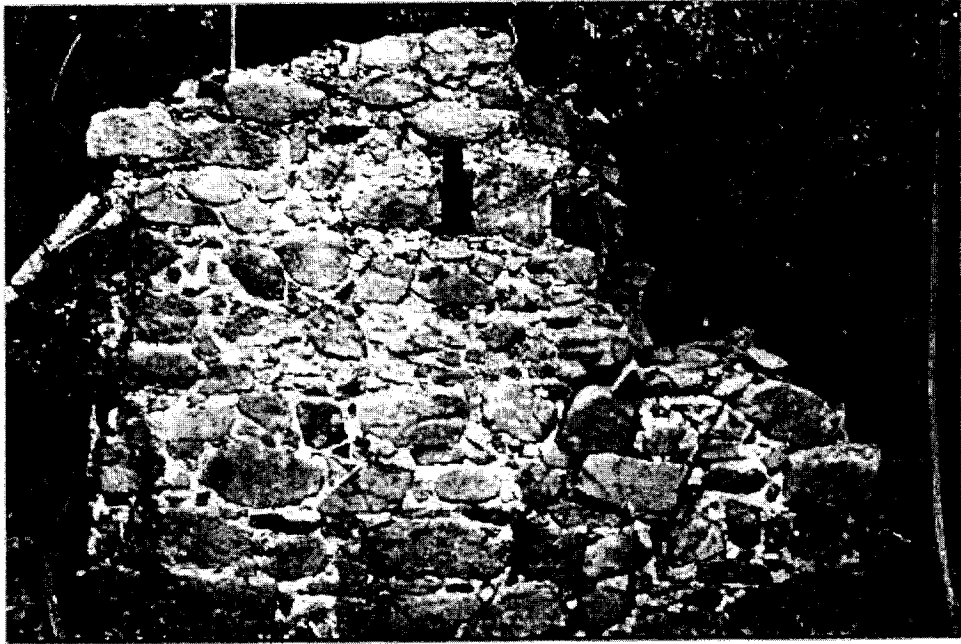
Fig. 5. Fish Bay Structure 3

Structure 3. Structure 3 (Fig. 5) is a portion of a mortared stone wall that is 2.55 meters in length and 2.0 meters high. Its orientation is roughly east-west, and its southern end is located at W 64°45.828' and N 18°19.546'. The wall contains a window opening whose sill is located at a height of 1.83 meters. The opening is 30 centimeters high, 12 centimeters wide at the bottom and 7 centimeters wide at the top. A brick ledge, 11 centimeters in width, runs the length of the interior of the wall 18 centimeters below the window sill.
