ENVIRONMENTAL IMPACT OF DEPOSITING DREDGE SPOILS IN AN AREA
NORTHEAST OF HANSONS BAY, ST. JOHN'S, ANTIGUA

September 12, 1987

Prepared for Ivor L. Jackson Associates, St. John's, Antigua

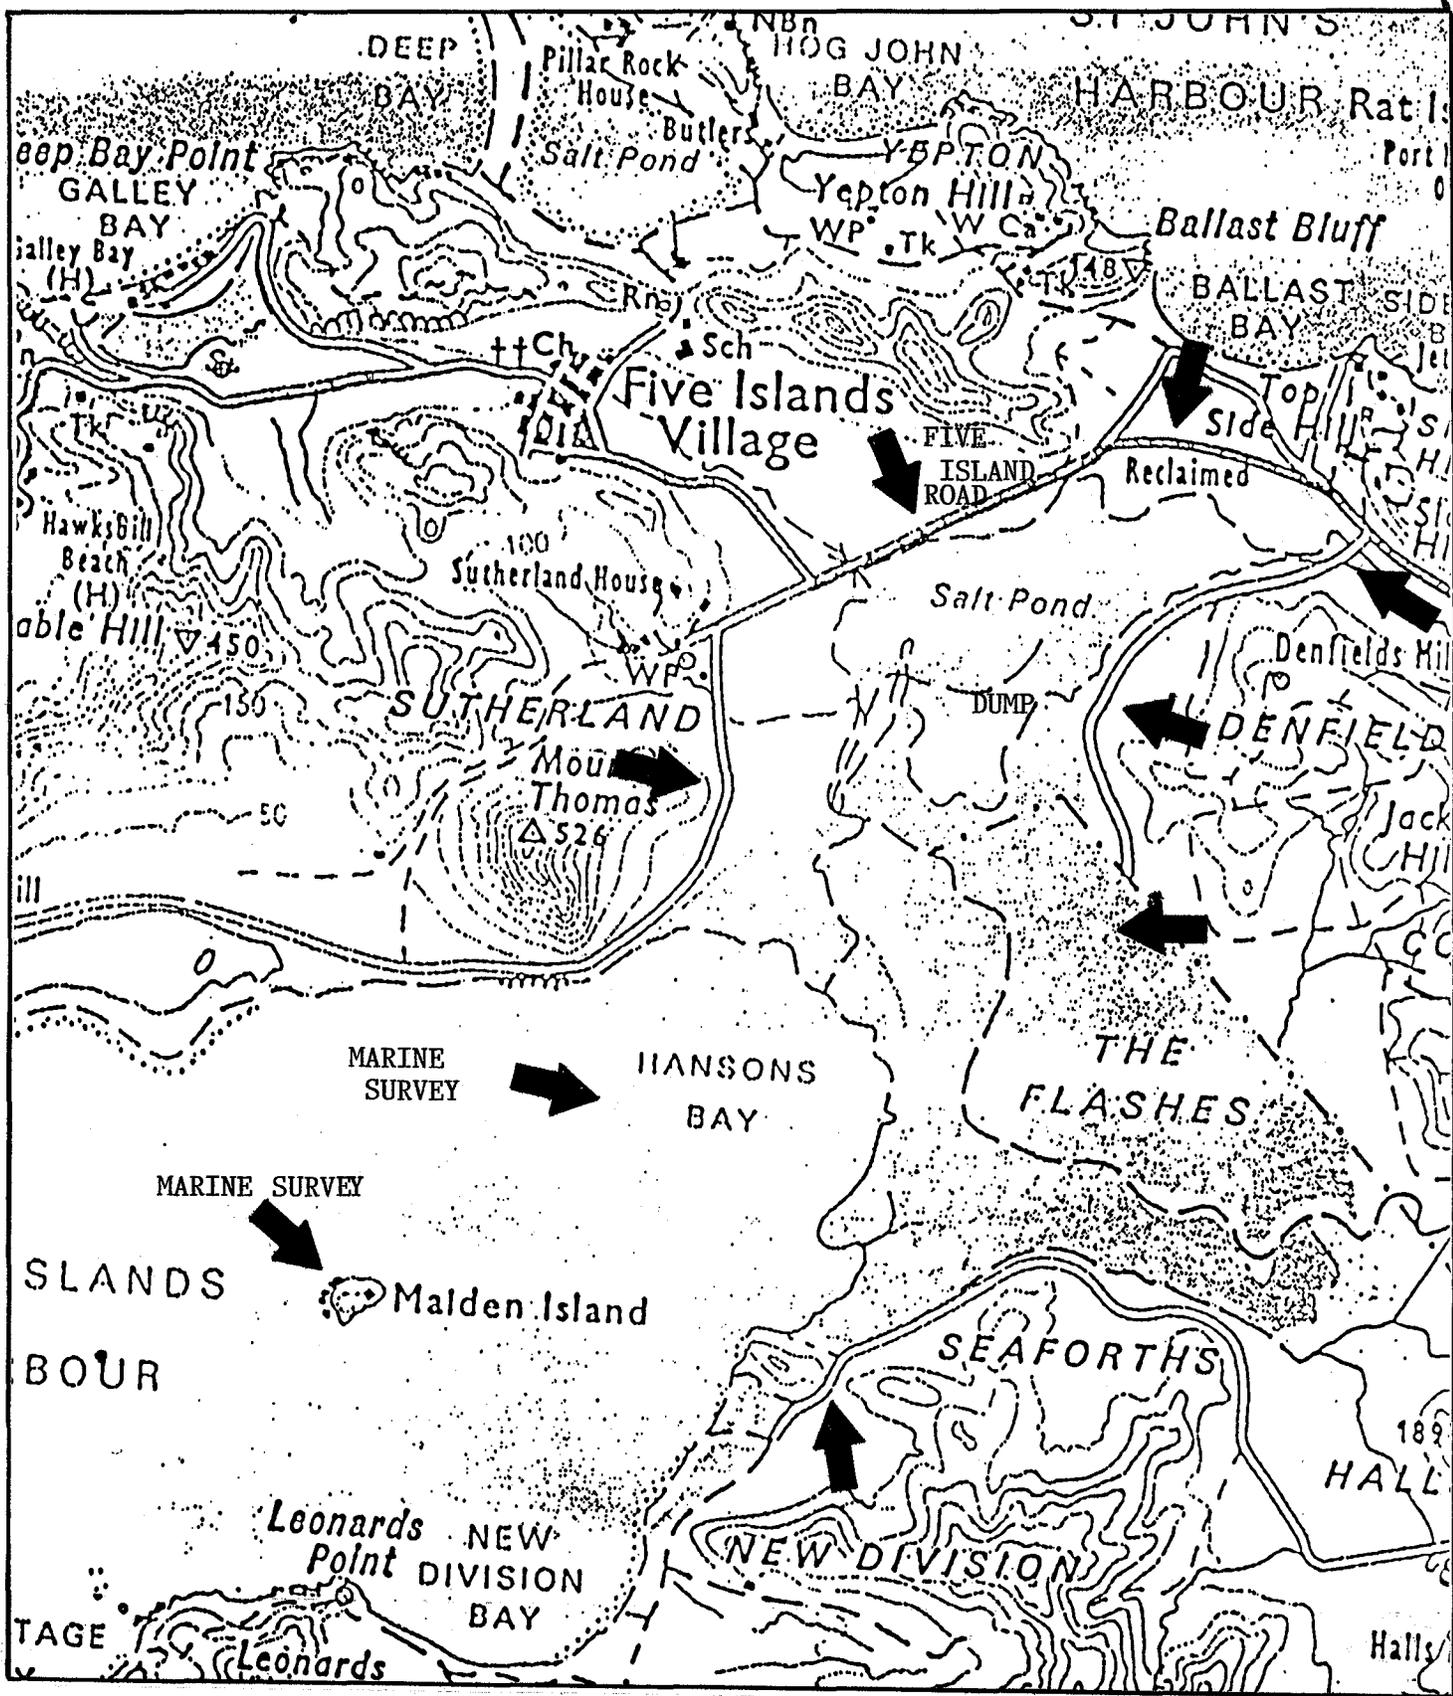
Figure 1. The area between Five Island Road, the roadway to the municipal dump, The Flashes and Hanson Bay was surveyed for evaluation of the impact of depositing dredge spoils from St. John's Harbour. The marine environment of Hanson's Bay was also surveyed.

On September 4 & 5, 1987, an assessment was undertaken to evaluate the impact of depositing dredge spoils, taken from St. John's deep water harbour, in the area of reclaimed land and salt pond northeast of Hansons Bay (Figure 1). Potentially impacted terrestrial and marine environments were surveyed to assess the impact on fauna, flora, nearby residents, the garbage dump and the impact of diverting the flow of natural run-off. The survey also included fact finding necessary for recommending the location of the containment dike and the outflow of supernatant from the settling ponds.

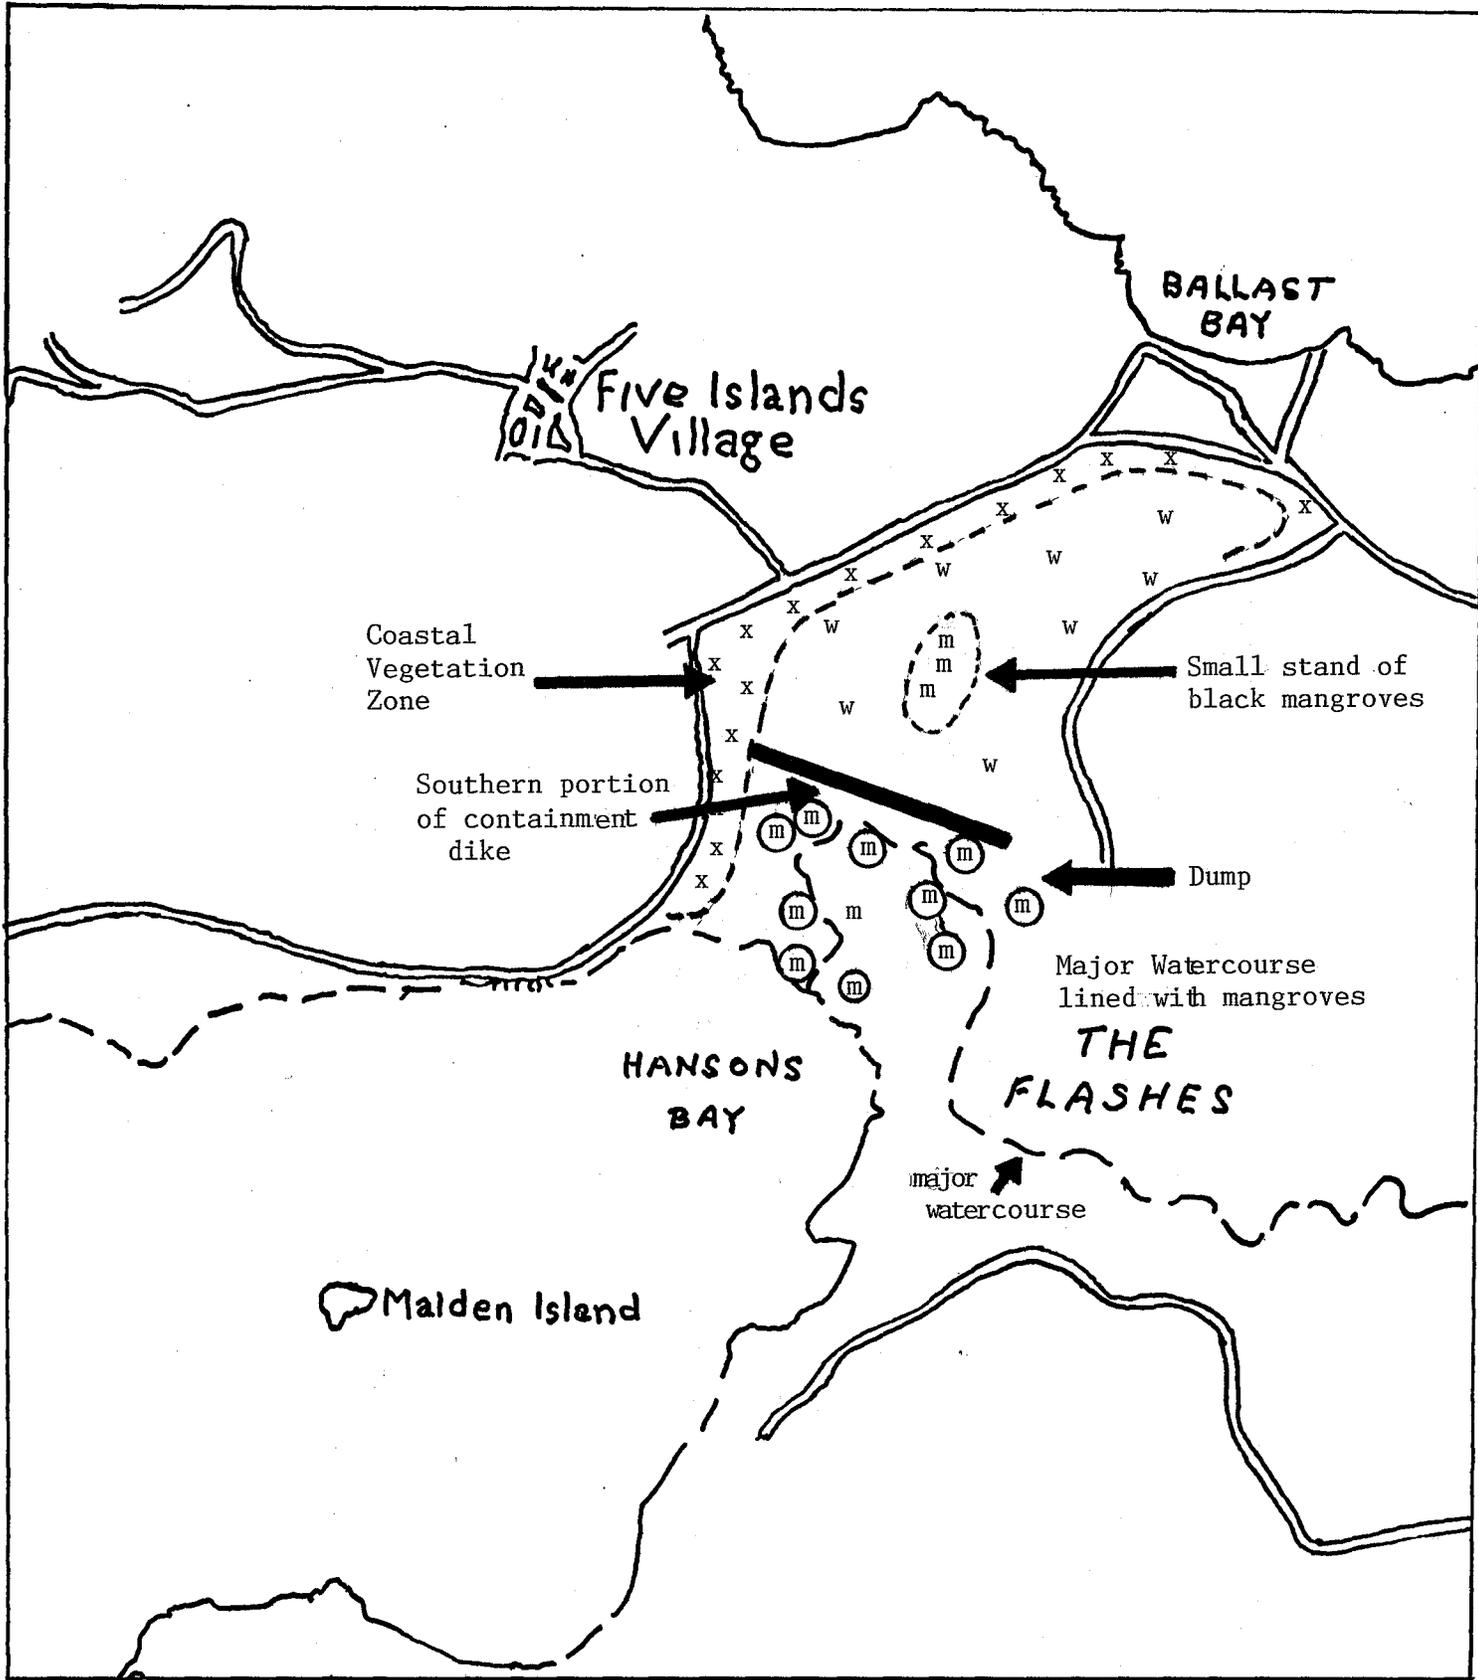
Figure 2. The three major terrestrial vegetation zones: wasteland (w), coastal vegetation (x) and mangrove (m). Also shown is the major mangrove surrounded watercourse, the southern limit of the containment dike and the municipal dump area.

Most of the area is wasteland consisting of exposed soil with very little vegetation cover. A vegetation map is provided (Figure 2). Figure 3 is a photograph looking northward towards St. John showing the wasteland area. The soil is primarily dredge spoils from the previous dredging of the St. John's harbour. Ground cover, which is sparsely distributed, consists of salt adapted grasses (Spartina patens and Sporobolus virginicus) and creeping succulents (Euphorbia buxifolia, Sesuvium portulacastrum, Batis maritima and Salicornia bigelovii). There are patches of small black mangrove plants (Avicennia germinans) throughout the area found along minor watercourses. There is one patch of tall black mangrove of about twenty trees located in the middle of the proposed spoils storage area (Figure 4). This will have to be sacrificed.

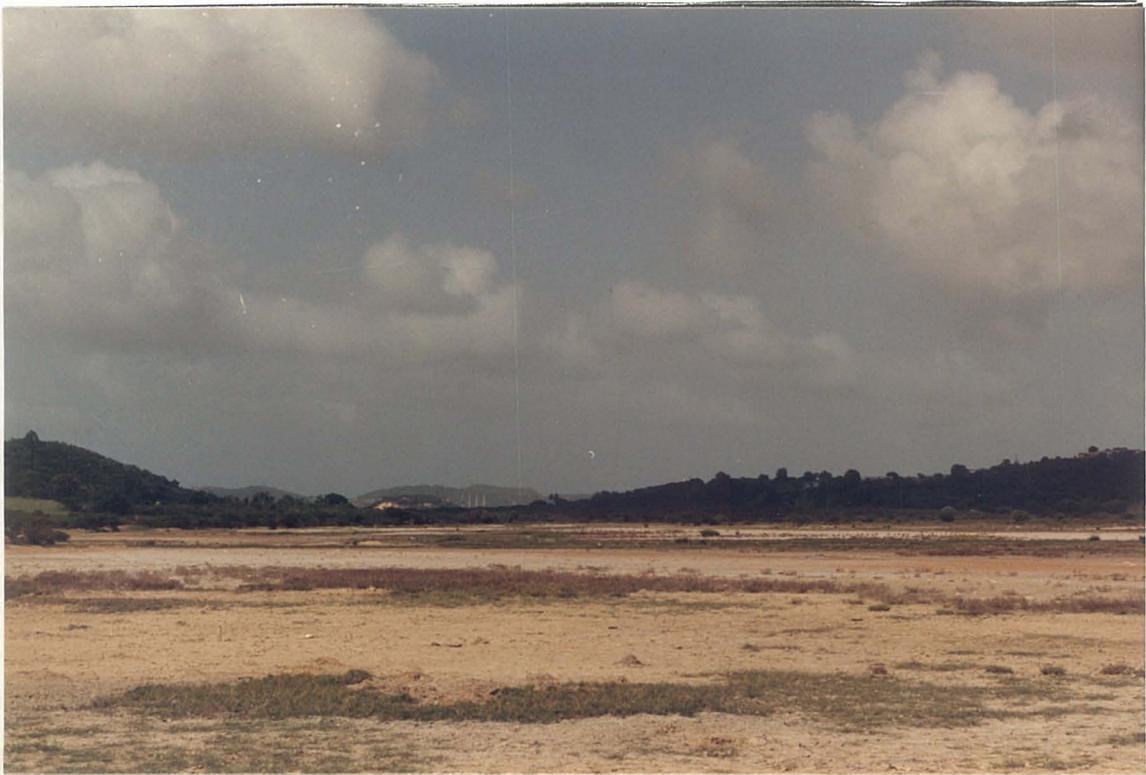
Figure 3. Wasteland. Looking northward towards St. John's the proposed fill area is shown.

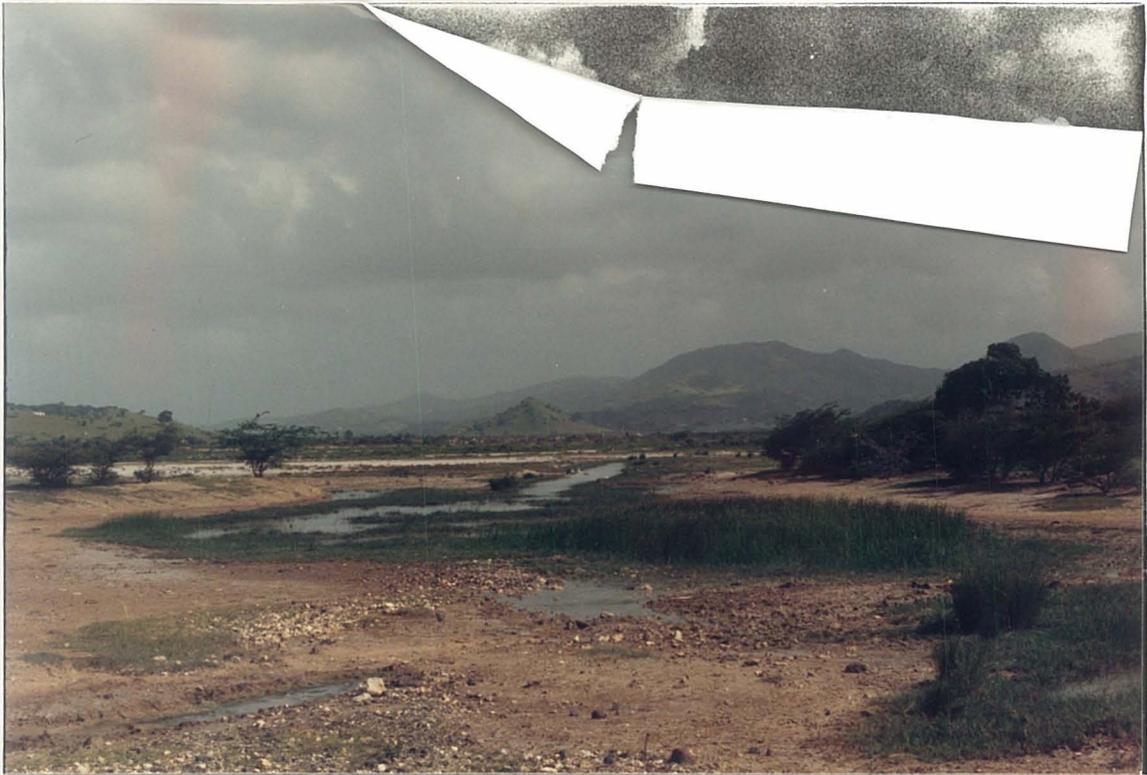
Figure 5. In the center is a freshwater pond with a minor watercourse running east to west across the proposed fill area. On either side is typical coastal vegetation.

A zone of coastal type vegetation runs along the roadsides and down to the waters edge of Hansons Bay on the eastern side. This vegetation is found growing at an elevation from two to six feet above that of the mud flat. Figure 5 is a photograph taken in the proposed fill area showing coastal vegetation on either side of a minor watercourse. The coastal type vegetation along the road is dominated by thorny acacias (Acacia nilotica and A. tortuosa) and logwood (Haematoxylum campechianum) with the occasional loblolly (Pisonia fragrans), bread-and-cheese (Pithecellobium unguis-cati) and tamarind (Tamarindus indica). A large number of blackbirds (Quiscalus lugubris) were found throughout the coastal vegetation area. Closer to Hansons Bay, manchineels (Hippomane mancinella) become dominant with scattered acacia and divi-divi (Caesalpinia coriaria). Trees of this area support large populations of bromeliads (Tillandsia utriculata).

Figure 5 also shows one of the minor vegetation zones present in the area: freshwater ponds and associated vegetation. There are numerous small freshwater ponds scattered throughout in the area with minor watercourses

The coastal vegetation that occurs along the roadways (Five Islands Road) should be preserved and the containment dike built behind this thin band of vegetation. The vegetation will provide stability to the soils outside of the dike during times when heavy rains can cause excessive run-off from the hills. The vegetation will also provide an aesthetically pleasing facade to the somewhat dismal look of the dike walls.

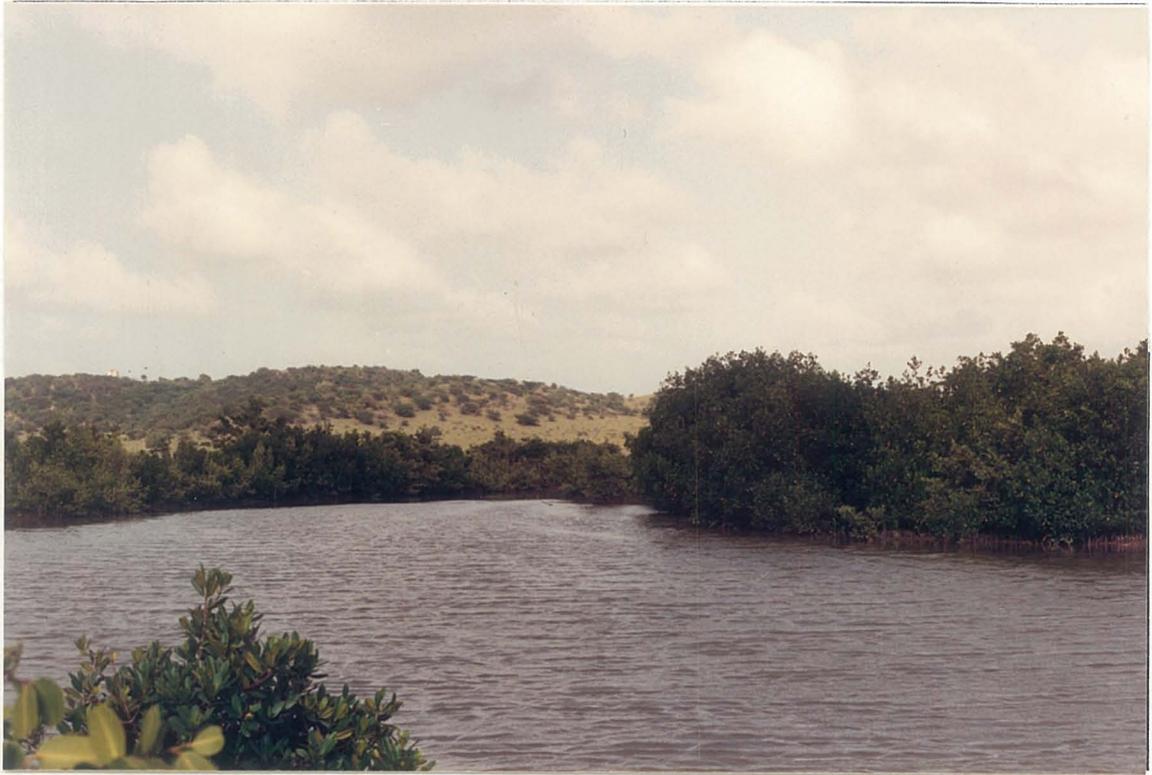
In the southeast portion of the area there is a major watercourse running west to east and turning south and emptying into Hansons Bay (Figures 6 through 9). The waterway is lined with red, black and white mangrove (Rhizophora mangle, Avicennia germinans and Laguncularia racemosa) along with scattered buttonwood (Conocarpus erectus). This mangrove and the waterway provide habitats for a great deal of wildlife. Dredge spoils **MUST NOT** be put in this area. The southernmost portion of the containment dike should remain in wasteland area and not encroach on the mangrove community.

Figure 6. Major mangrove lined watercourse at its northeast turn. Approximate location of where run-off from the settling ponds would enter the waterway. Figure 10 shows where this photograph was taken.

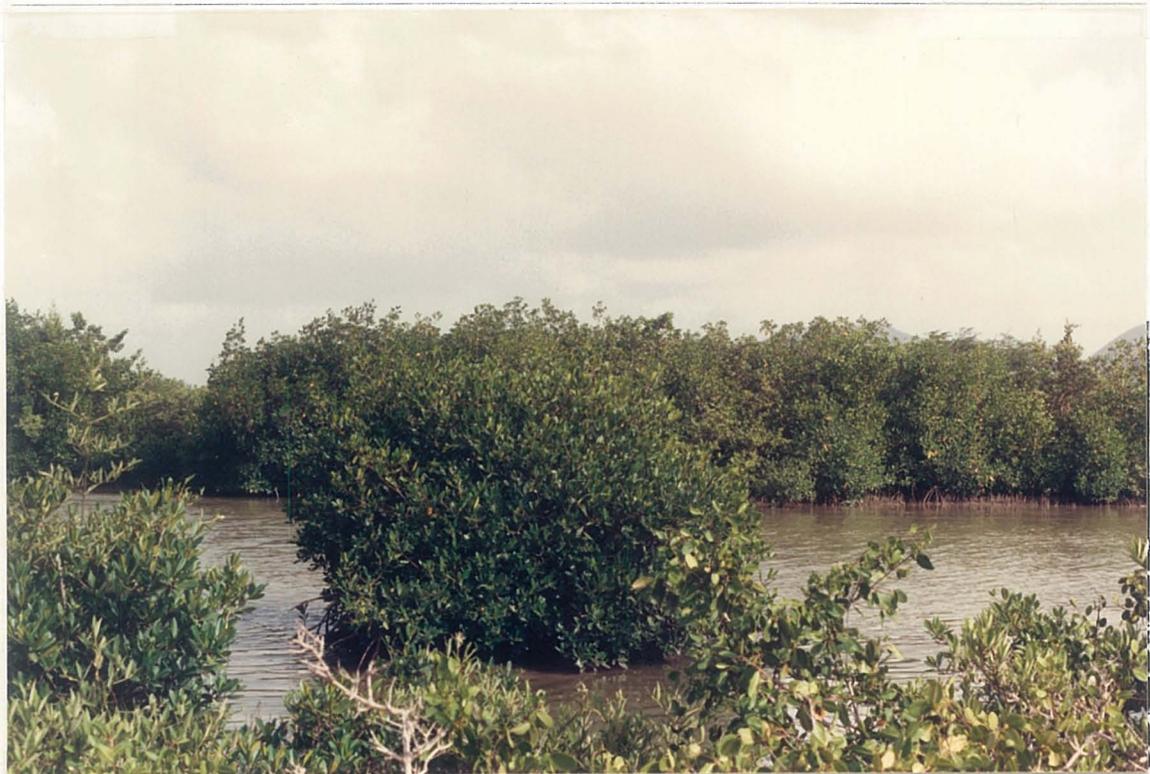
Figure 7. Major mangrove lined watercourse about 500 yards from where it enters Hansons Bay. The area is a bird feeding habitat having abundant supplies of fish and invertebrates.

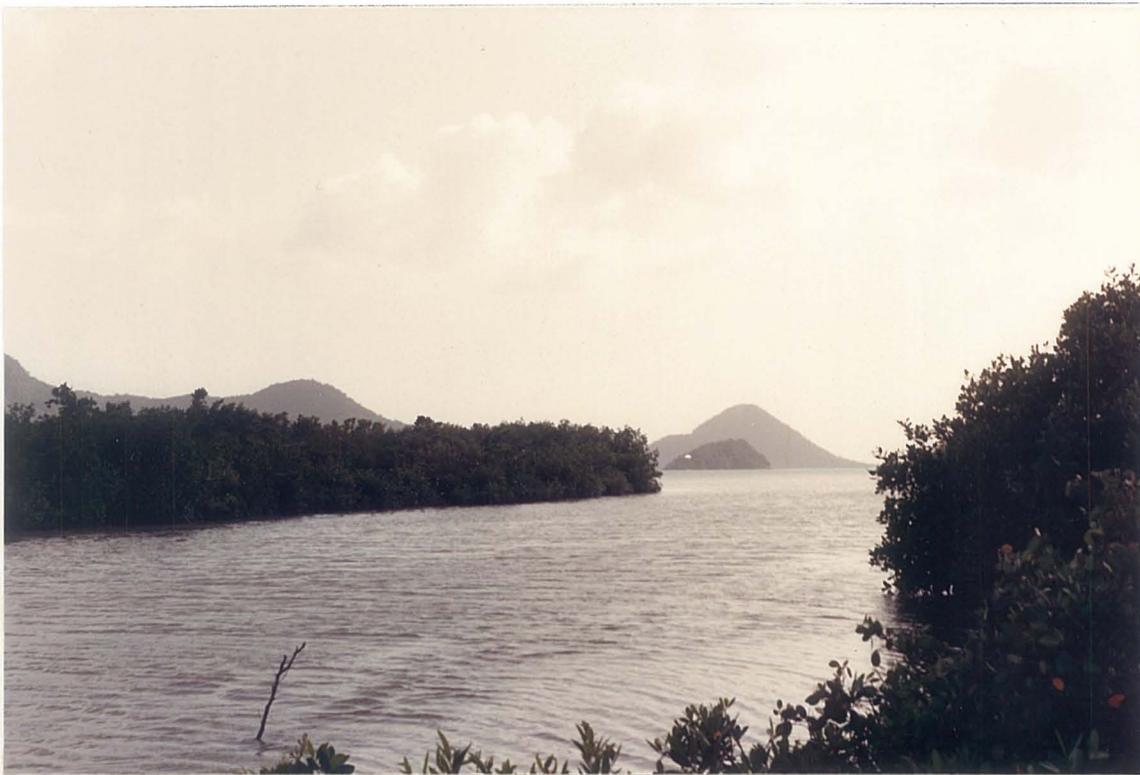
Figure 8. Major mangrove lined watercourse showing the entrance to Hansons Bay. Maiden Island can be seen in the distance.

Marine Survey. A survey was conducted in Hansons Bay to assess the possible impacts of run-off into the Bay from the depositing of dredge spoils on adjacent land. About 100 yard from the mouth of the inlet (see Figures 8 and 9) the bottom was observed using a mask and snorkel. This area of the bay was very shallow, from 1 to 3 feet, with deep soft sediments. The entire area was covered by large patches of thick long shoal grass (Halodule wrightii). Both observers (Coulston and Mussington) agreed it was the thickest and longest grass, of this species, they ever observed. There were the occasional patches of turtle grass (Thalassia testudinum) and very sparse patches of algae (Halimeda incrassata, H. monile, Caulerpa sertularioides, C. mexicana, Acetabularia crenulata, and several Dictyota spp.). Very few fish were observed but there were the occasional juvenile of grey, lane, mutton and yellowtail snappers (Lutjanus griseus, L. synagis L. analis and Ocyurus chrysurus) and juvenile french grunts (Haemulon flavolineatum). Small cockles were found in the mud. Callianassa mounds were abundant, but no other invertebrates were found.

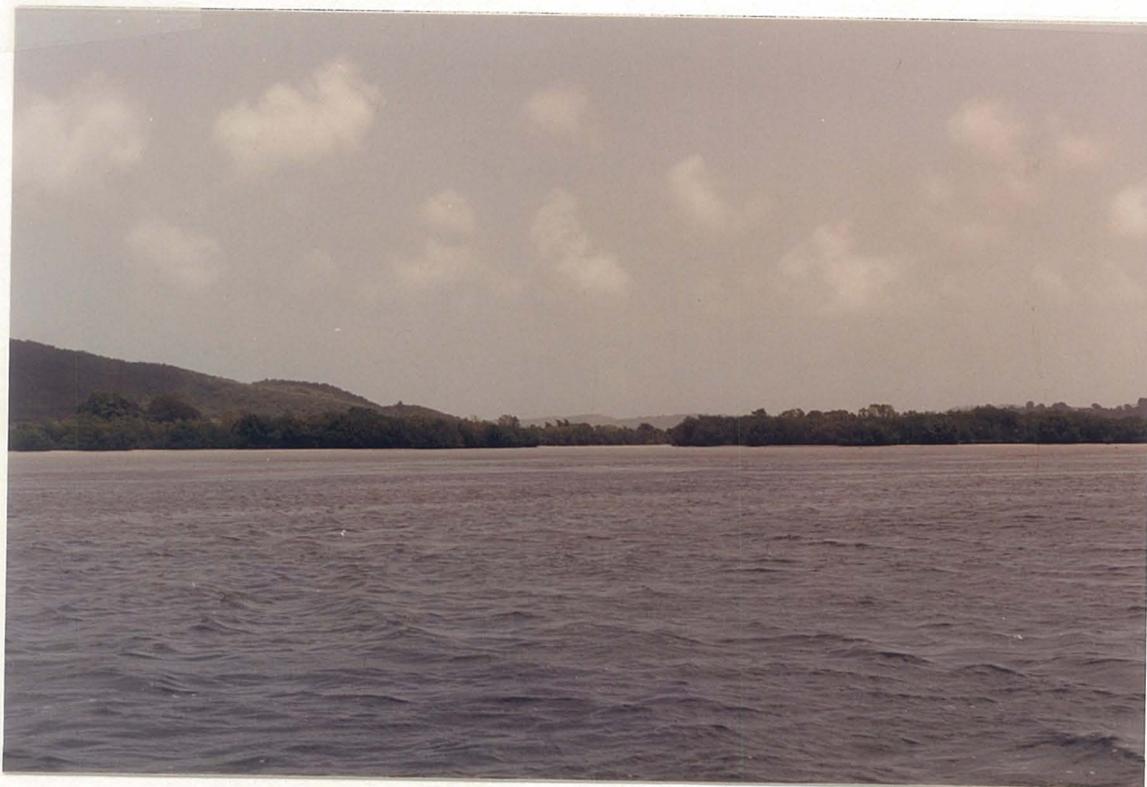
Figure 9. Hansons Bay looking toward the entrance to the run-off channel shown in Figure 8. The benthic marine survey was conducted in this area.

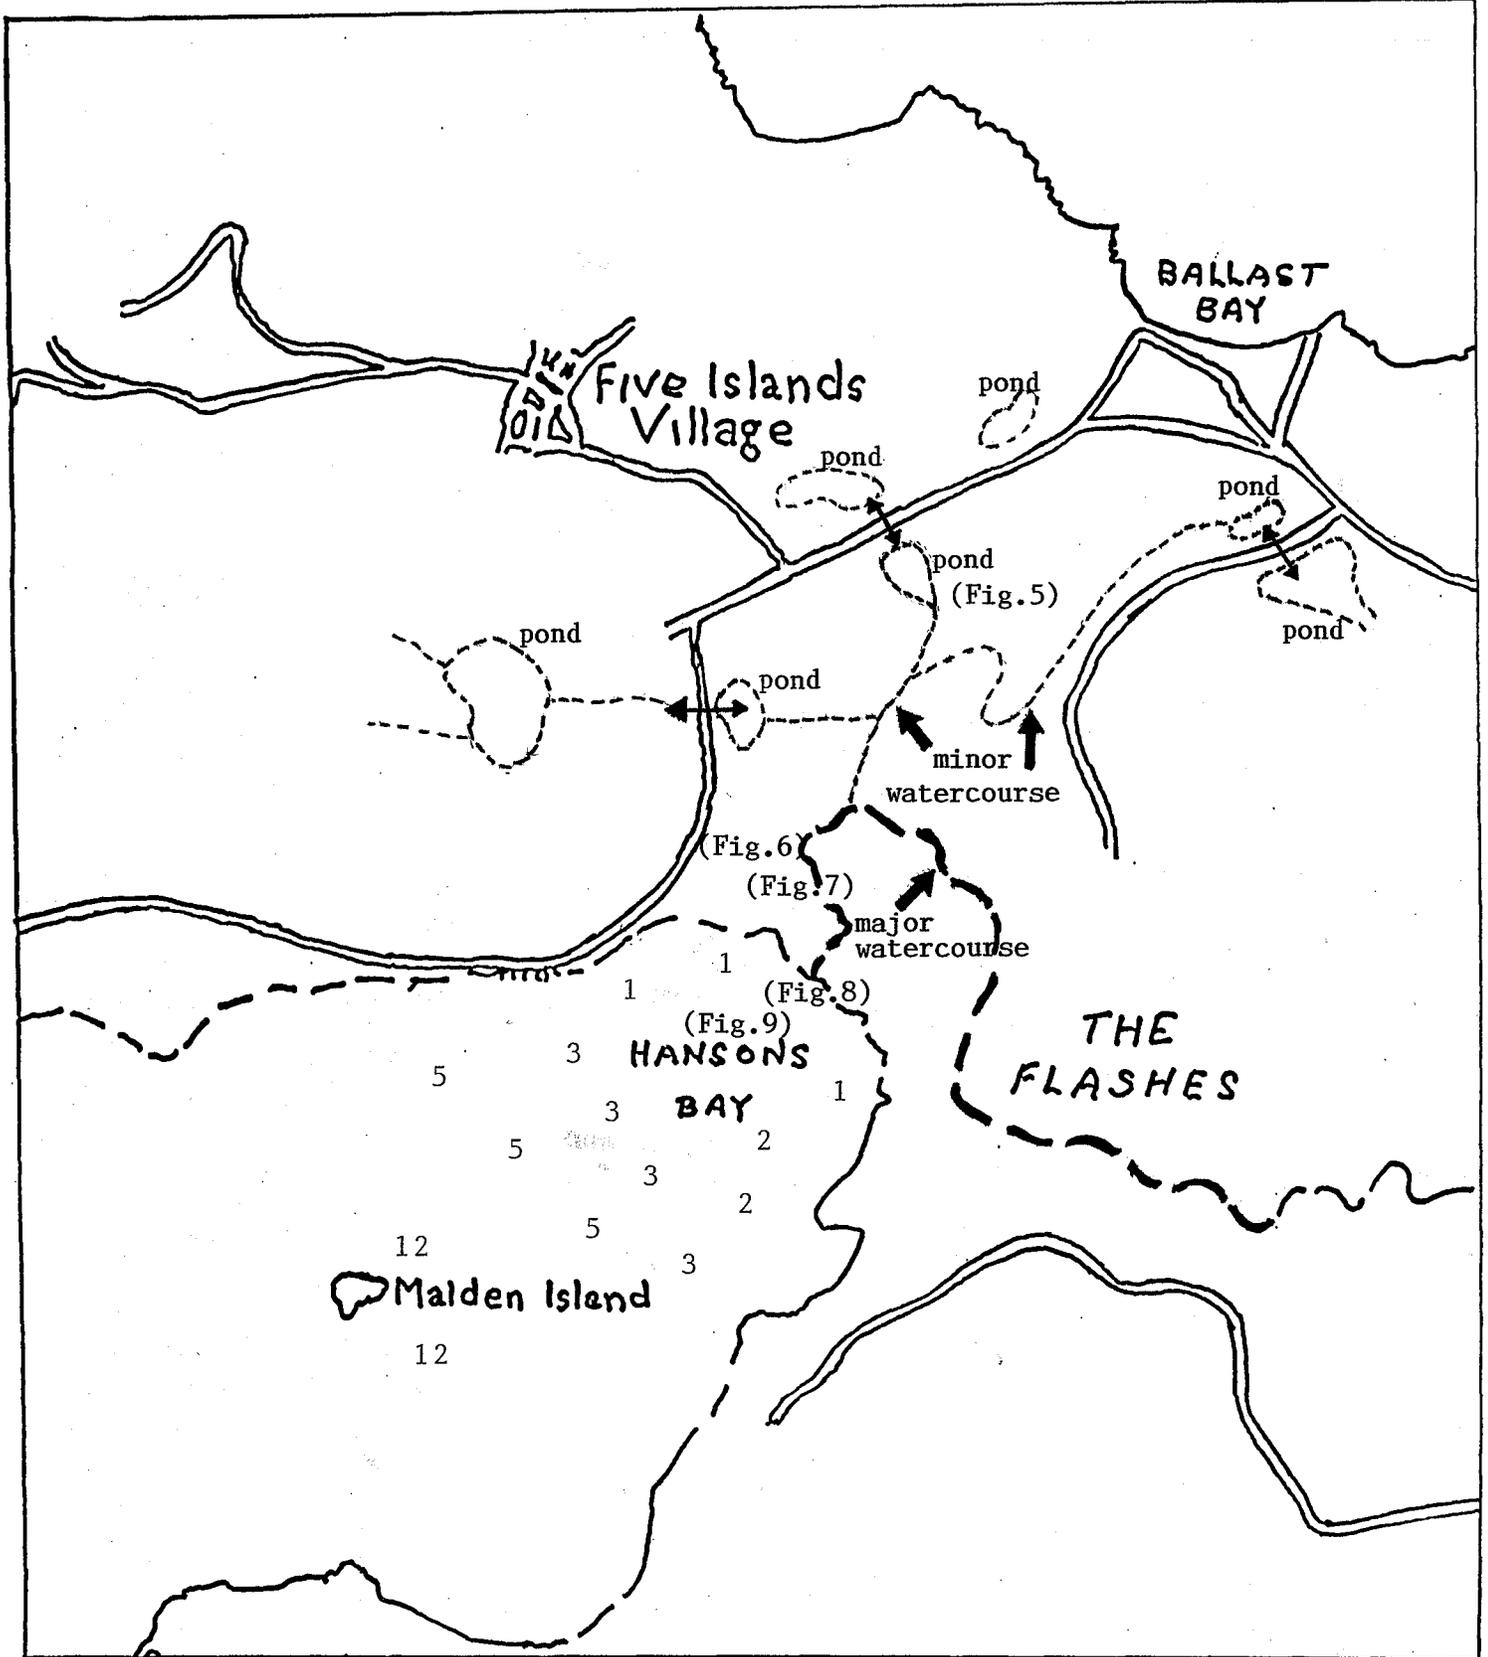
leading to the major mangrove surrounded watercourse and out into Hansons Bay (Figure 10). The damp mud around the pond supports grasses and sedges including the sedge (Cyperus alopecuroides). Several ponds are outside the proposed dike area. Figure 10 shows several of the water collecting areas outside of the containment dike which might overflow and erode the dike. These areas need drainage guts to channel water along the dike and into the flats.

Figure 10. Shown are the ponds in the area. Some of these ponds are outside the proposed containment dikes. They will need to be diverted by constructing culverts so that they run outside of the dikes and intersect with natural watercourses. Depth contours within the bay are also shown.

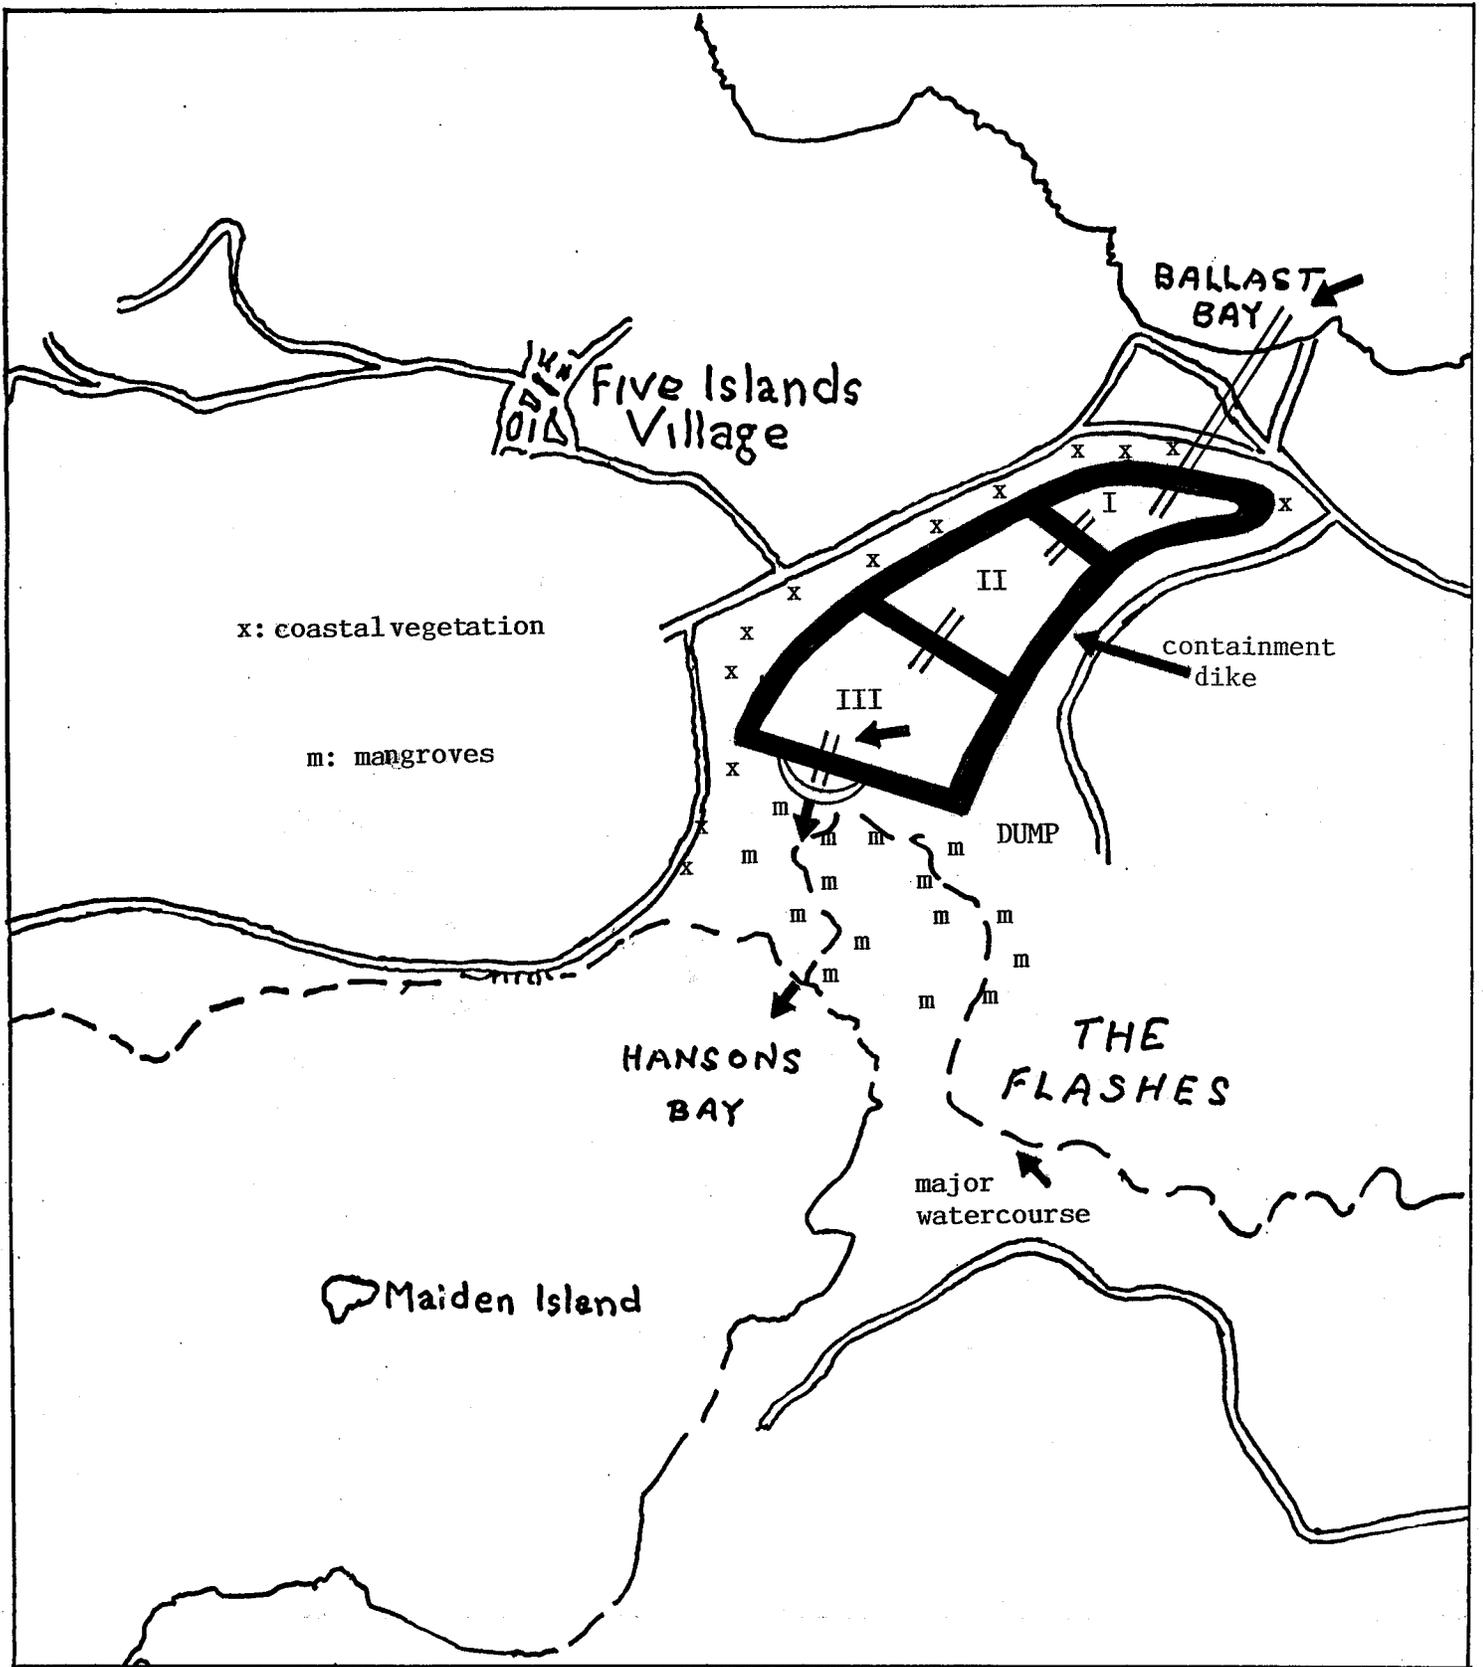
Figure 11. Proposed location of the containment dikes with a receiving pond (I) and primary (II) and secondary (III) settling ponds. The outfall is located at the southernmost wall. A vegetation barrier is recommended to be left between the roadways and the dike walls.

The proposed approximate location of the containment dike is indicated in Figure 11. This recommendation is based on an evaluation of the least impact from a biological standpoint. The outfall should be located in the southernmost wall about two thirds down the wall from the dump and about one third from the east side. The outfall can be placed in close proximity to the mangroves allowing the mangrove plants to be one of the final filters.

The proposal recommends three settling ponds. The final run-off (supernatant) from settling pond III will filter through the mangrove, into the watercourse and out into Hansons Bay. The seagrasses of the bay will also act as a filter as it does for the natural land run-off.

The containment dike should be constructed to leave a vegetation barrier zone between the roads and the dike for both run-off control and aesthetic purposes.

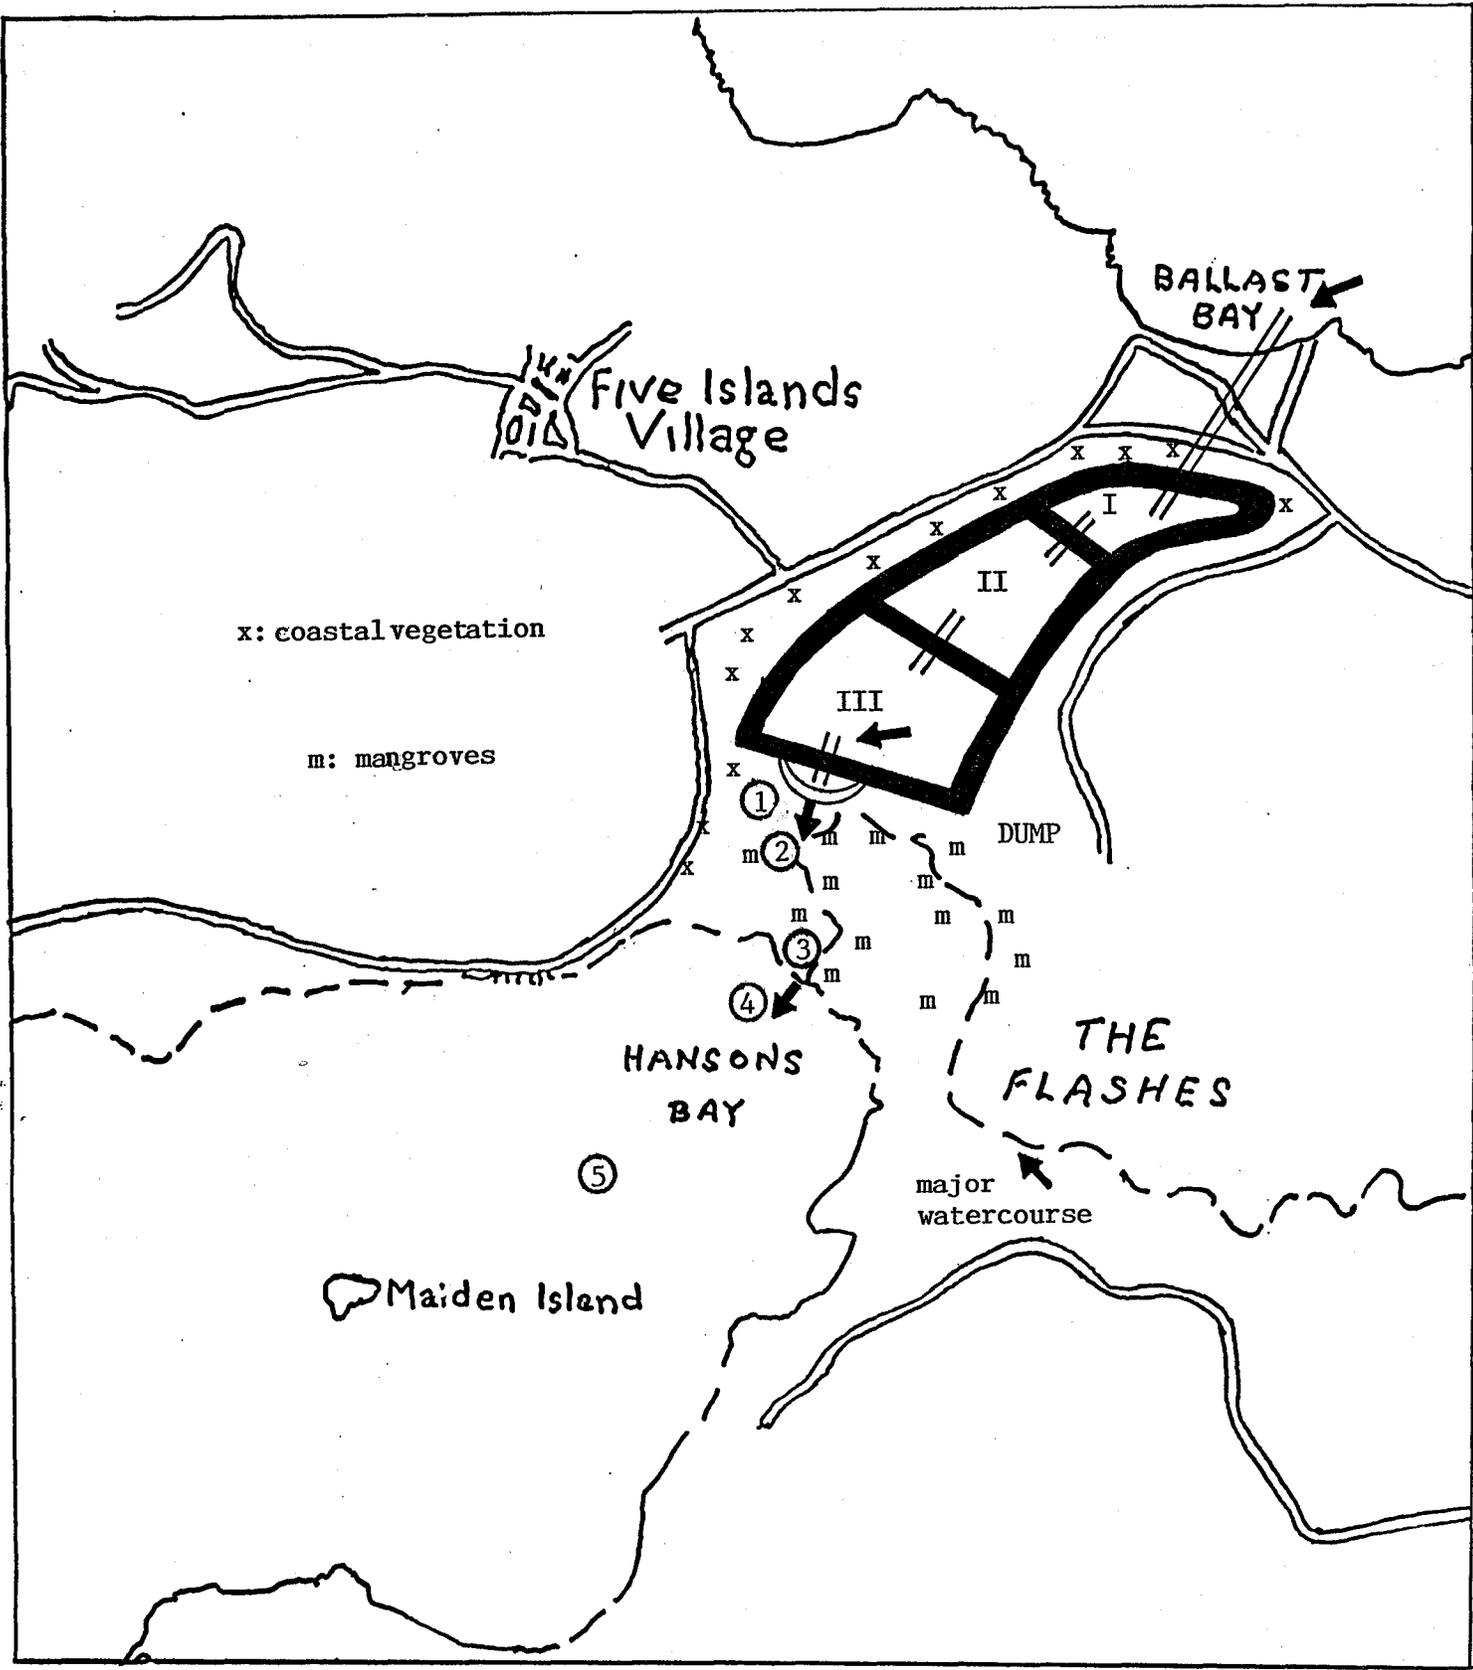
Figure 12. The five water quality monitoring stations recommended are indicated by the circled numbers: (1) sample of supernatant as it leaves the settling pond, (2) sample taken in the waterway at the closest point to where the outfall water enters the watercourse, (3) sample taken near the entrance where the channel enters Hanson's Bay, (4) sample taken just off-shore and (5) sample taken mid-way between the shore and Maiden Island.

The following tests should be done on the water samples: suspended solids, pH, turbidity, dissolved oxygen, nitrates, phosphates, salinity. Each measured water quality variable is a valuable indicator as to the quality of the water and the environmental effects that will occur as a result of the dredged material supernatant passing through the area. Five water quality monitoring stations should be set up (see Figure 12): (1) sample of supernatant taken at the outflow, (2) sample taken in the waterway at the closest point to where the outfall water enters the watercourse, (3) sample taken near the entrance where the channel enters Hansons Bay, (4) sample taken just off-shore and (5) sample taken mid-way between the shore and Maiden Island.
