REPORT OF A STAGE 1A MARINE ARCHAEOLOGICAL SURVEY OF THE
VIRGIN ISLANDS PORT AUTHORITY DREDGE AND FILL PROJECT AT
LIMETREE BAY, SOUTHSORE ST. CROIX

Prepared by
ISLAND RESOURCES FOUNDATION

Submitted to the
Virgin Islands Port Authority

Date of Report: 30 March, 1987

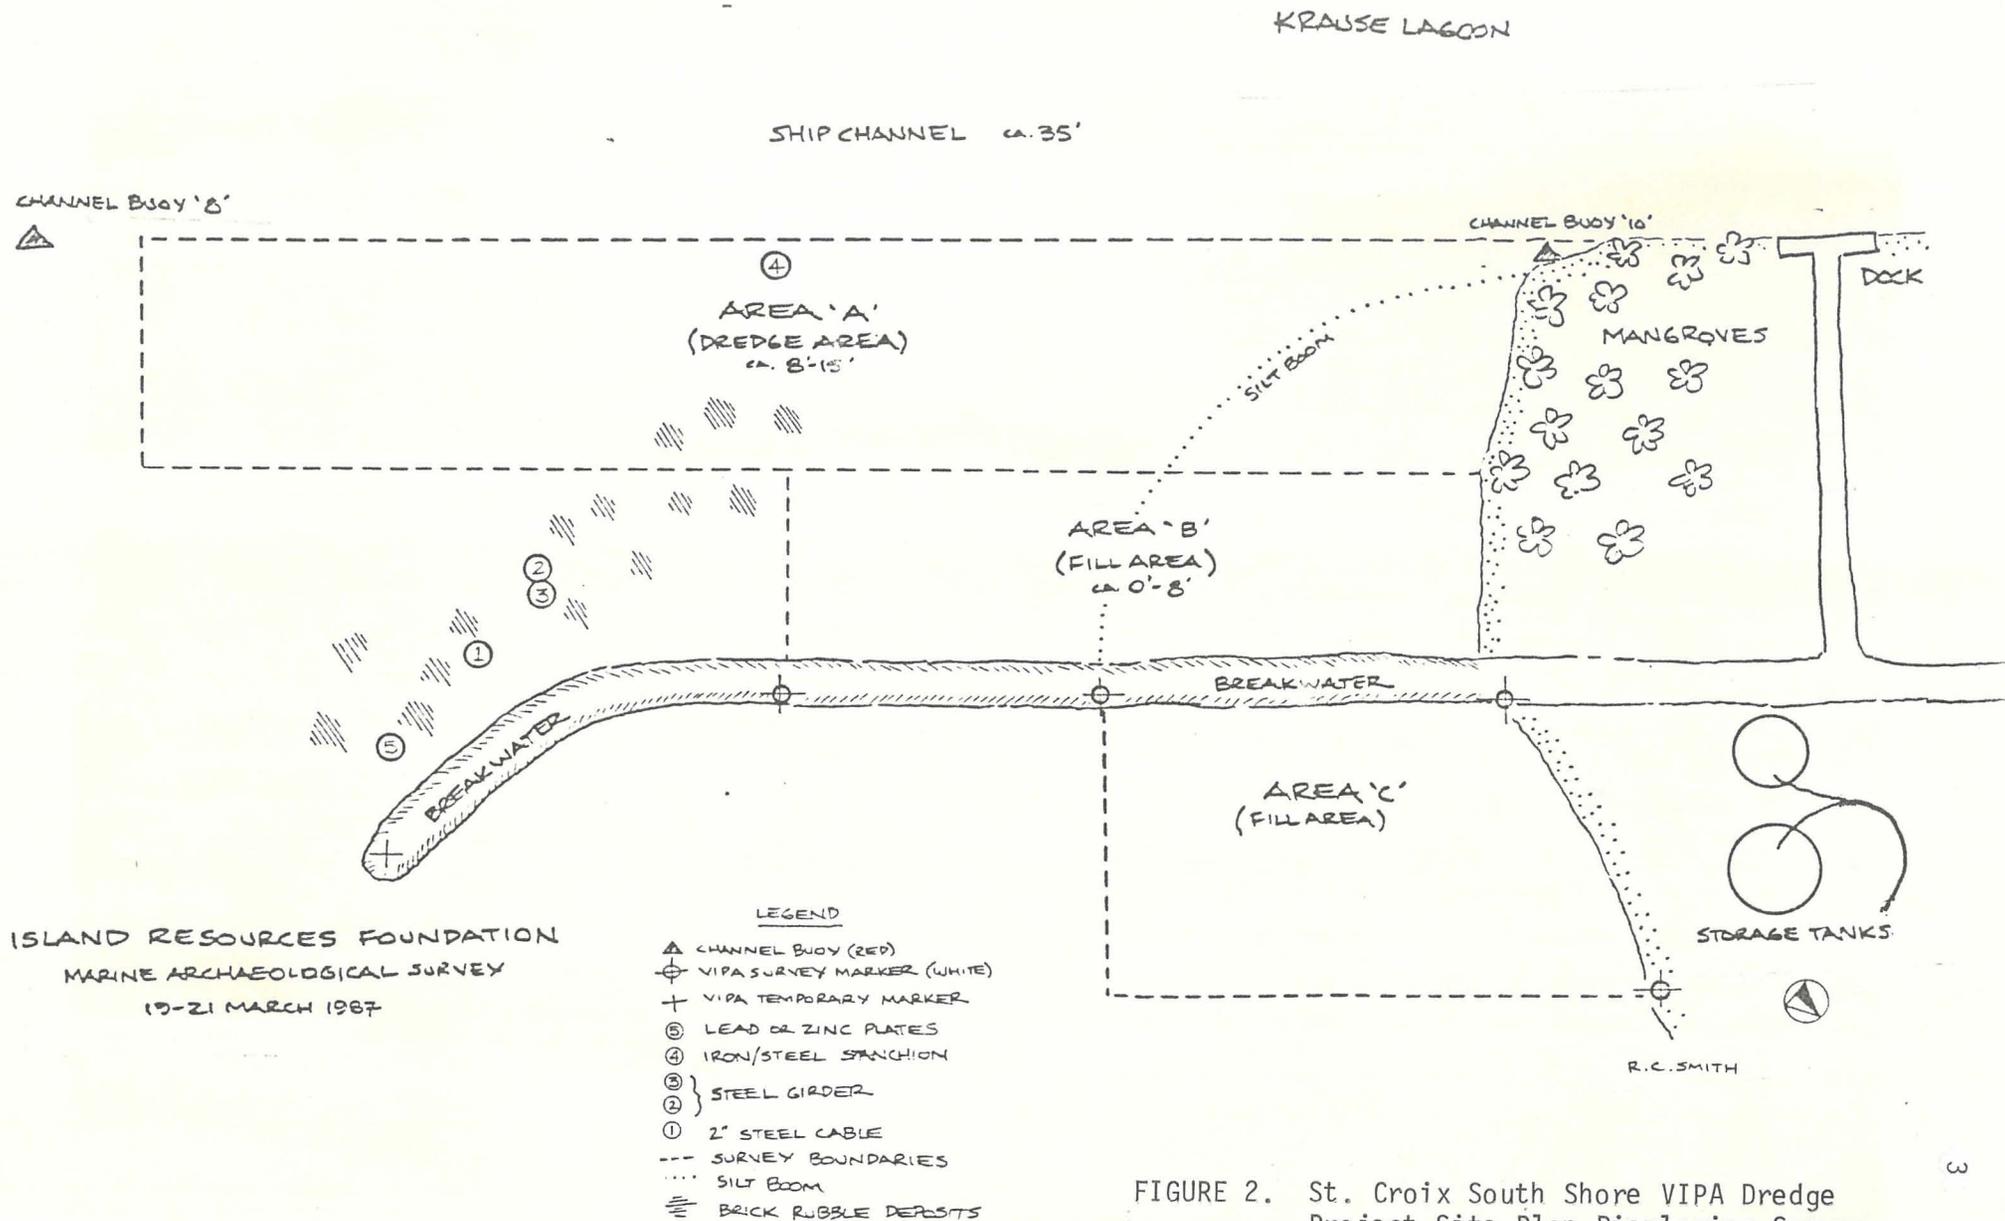
FIGURE 2. St. Croix South Shore VIPA Dredge Project Site Plan Displaying Survey Areas, Boundaries and Debris Locations.

As shown by Figure 2, the proposed project involves dredging a rectangular strip of seabed, 1450 feet by 250 feet (hereafter termed Area A), and using the dredge spoil to fill two smaller rectangular areas (hereafter termed Area B and Area C) on either side of an existing breakwater. The filled area on the western side of the breakwater (Area B) is to be used as a dock for ships offloading bulk molasses.

A breakwater, approximately 50 feet wide and extending approximately 1300 feet southward from the shoreline, bisects the Study Area. Apart from the breakwater, the seabed of the Study Area is more or less undisturbed except for modern debris as noted in the report and displayed in Figure 2.

Survey findings are shown in Figure 2. The portions of Area A and B outside the silt boom were completely surveyed on March 19th by a team consisting of Smith, Tyson and Tonnemacher. Smith and Tyson, spaced 10 feet apart, were slowly towed by an inflatable boat driven by Tonnemacher in a systematic grid pattern consisting of a series of overlapping, north-south sweeps. The survey started along the Harvey Channel cut and moved progressively eastward towards the breakwater.

shown by Figure 2, these concentrations are part of a distribution pattern that extends eastward outside of the Study Area.

After inspection and analysis of cultural deposits and recording of their location, the majority of the buoys were removed. However, five buoys (shown on Figure 2) which marked objects potentially hazardous to dredging activities, were left in place to designate their precise location on the seabed for the benefit of the Port Authority (see Appendix I and Figure 4).

Because some of the submerged cultural materials located by this survey constitute hazards for dredging operations, we suggest that the Port Authority take every precaution to ensure that its dredge stays strictly within the confines of the proposed dredge area, unless it removes the items in question.

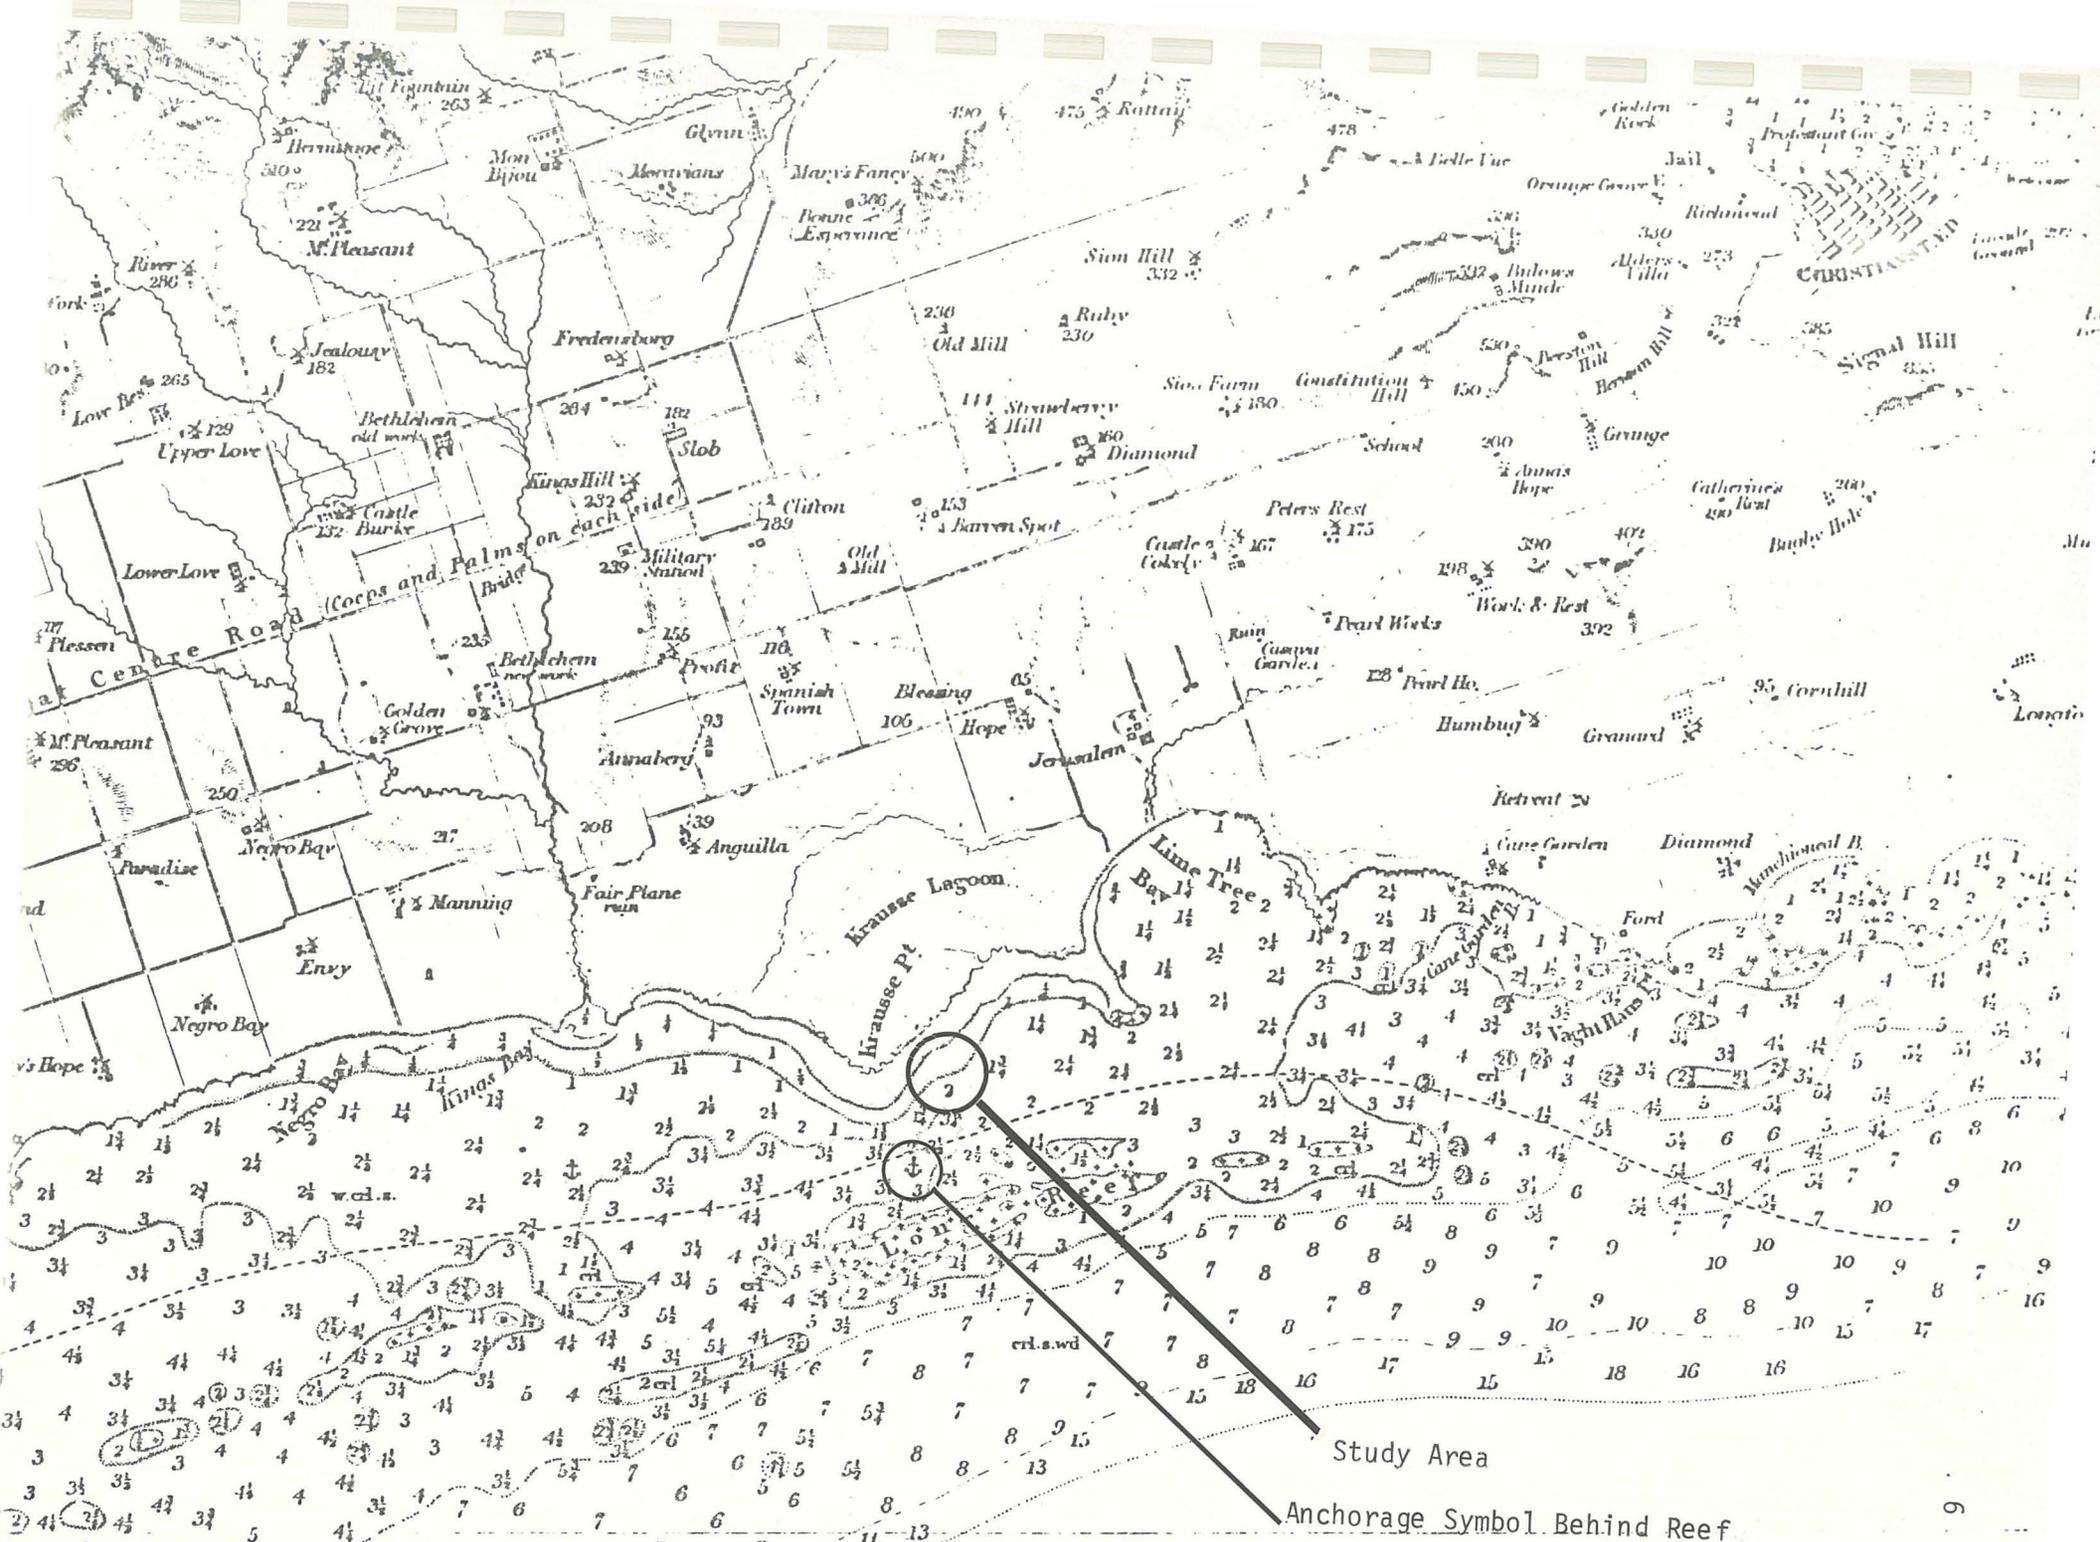
FIGURE 3. Admiralty Chart by Parsons (1856)

While the Admiralty chart prepared by Parsons in 1856 (Figure 3) shows an anchorage immediately southwest of the Study Area, most coastal shipping would have stayed well south of Long Reef. And shipwrecks of large oceanic vessels would most likely have occurred on the offshore reefs. However, shipwrecks cannot be ruled out, since small island sloops and droghers certainly penetrated the reefs on a regular basis in order to take on produce from southside sugar plantations.

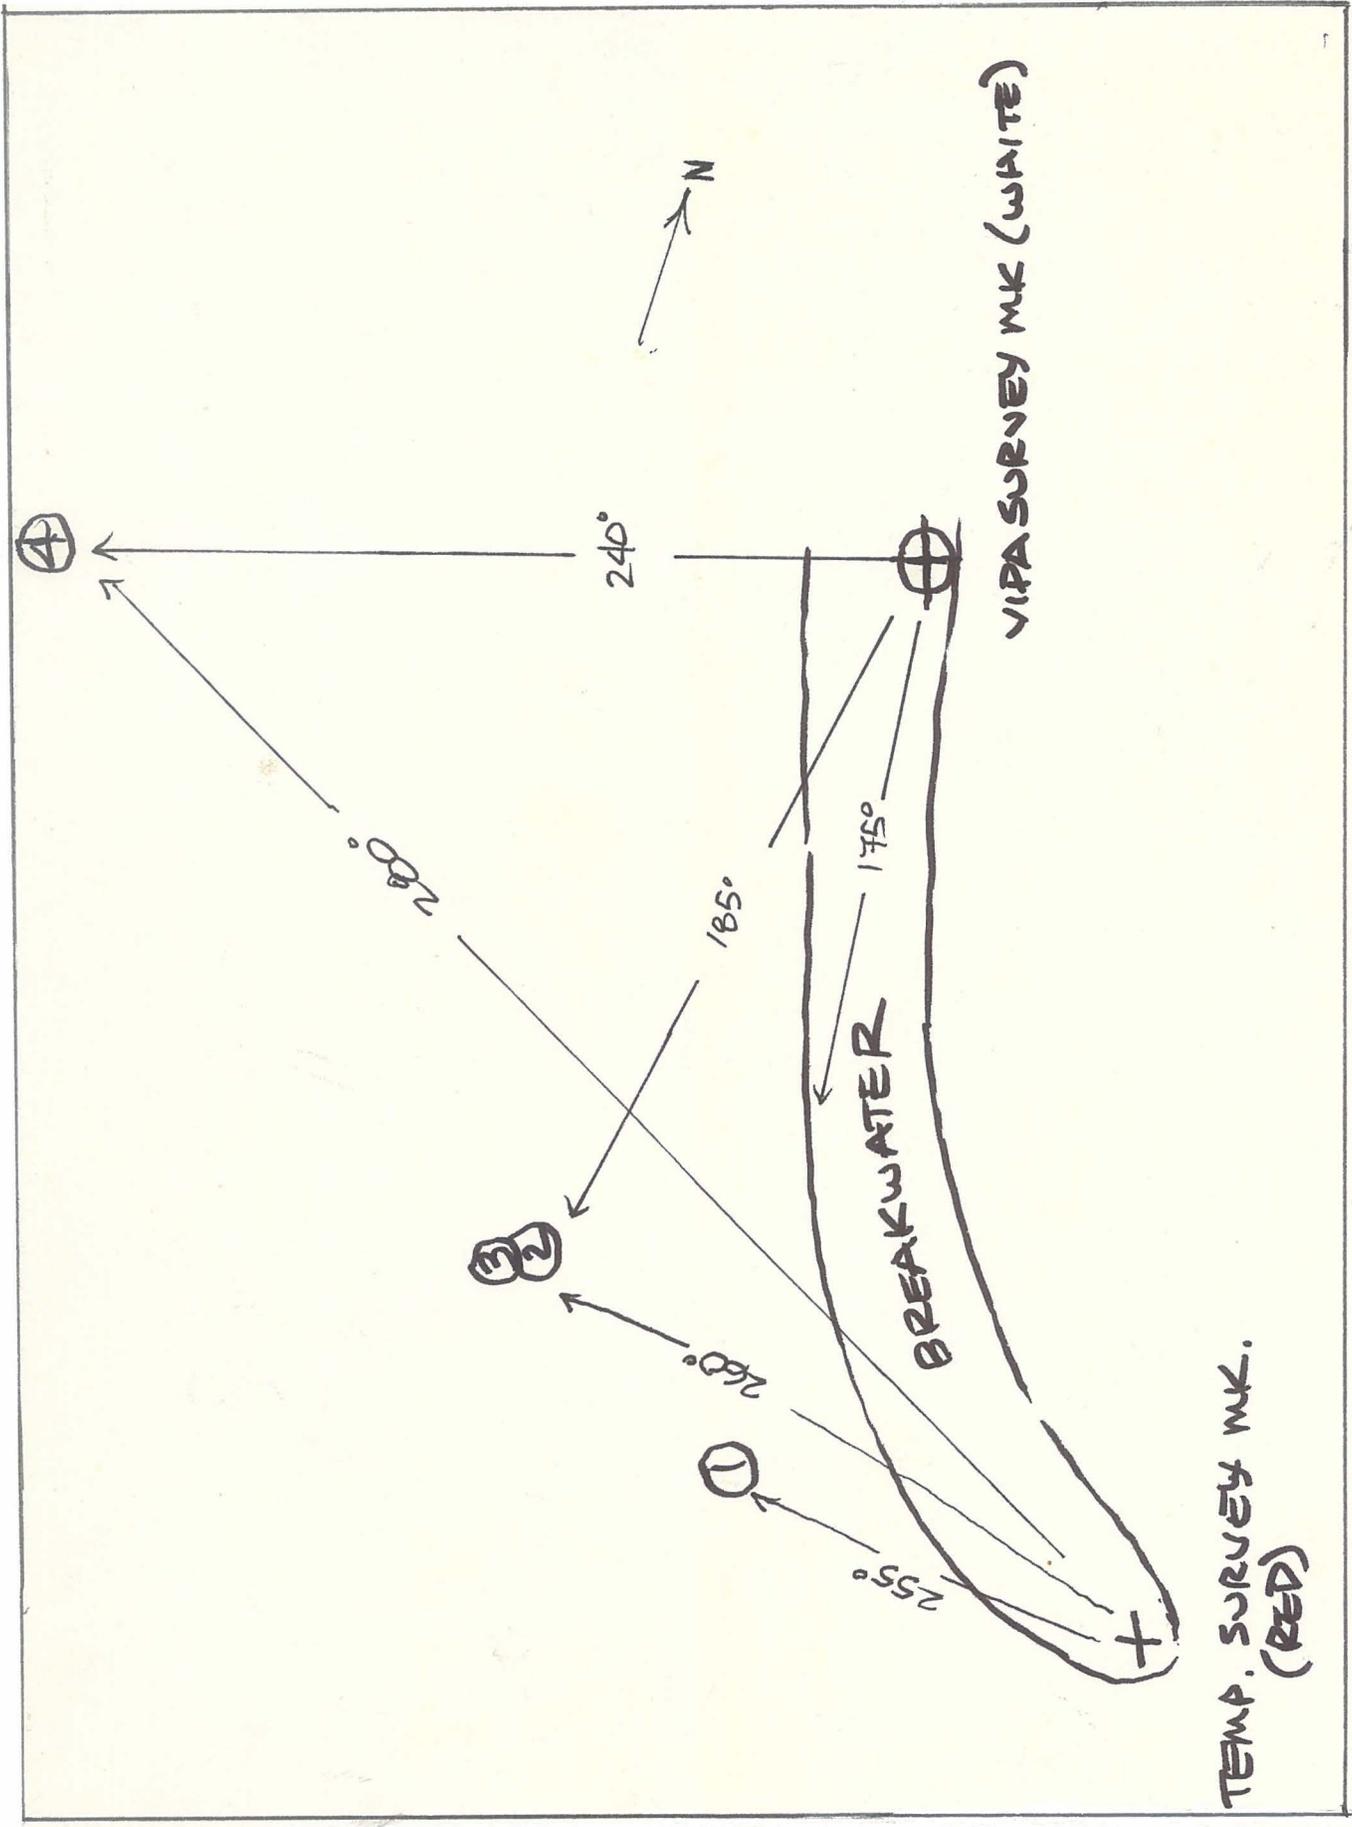
FIGURE 4. Magnetic Compass Bearings of Debris Sites.

DESCRIPTION AND BEARINGS OF BUOYS MARKING POTENTIAL NAVIGATIONAL HAZARDS IN SURVEY AREA

Buoy #1. Two-inch steel cable

Buoys #2 and #3. Steel I-beam girder

Buoy #4. Iron/steel stanchion

A. From 3rd (southernmost) white VIPA marker on the breakwater to:

Buoy #1: 175 degrees

Buoy #2 and #3: 185 degrees

Buoy #4: 240 degrees

B. From marker at end of breakwater to:

Buoy #1: 255 degrees

Buoy #2: 260 degrees

Buoy #3: 280 degrees

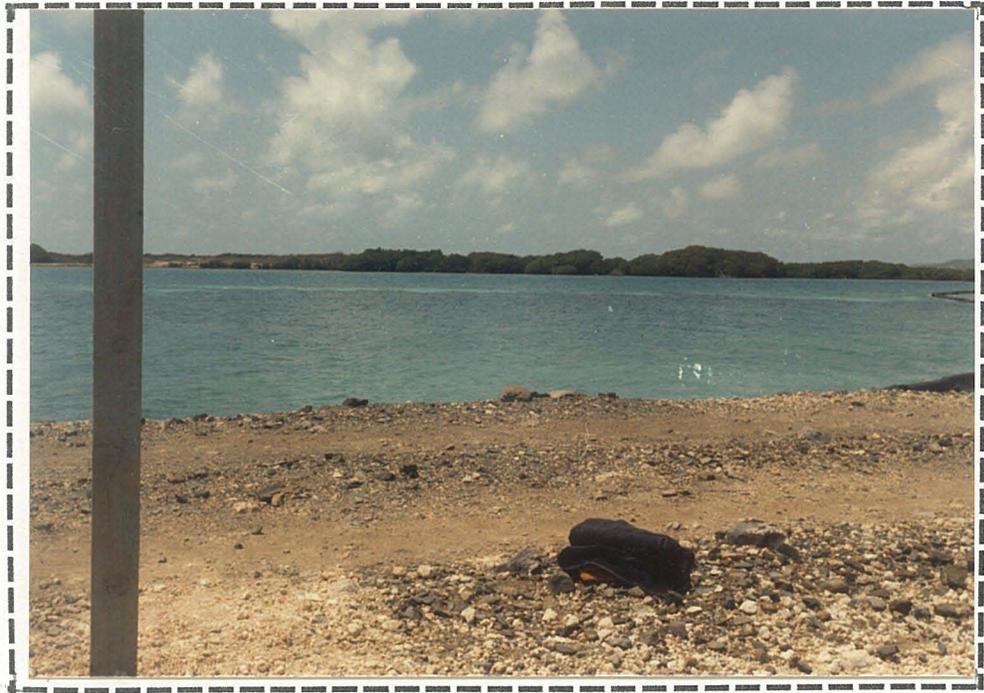
• PHOTOGRAPH #1

Photograph 1, looking west from the breakwater, shows Area A.

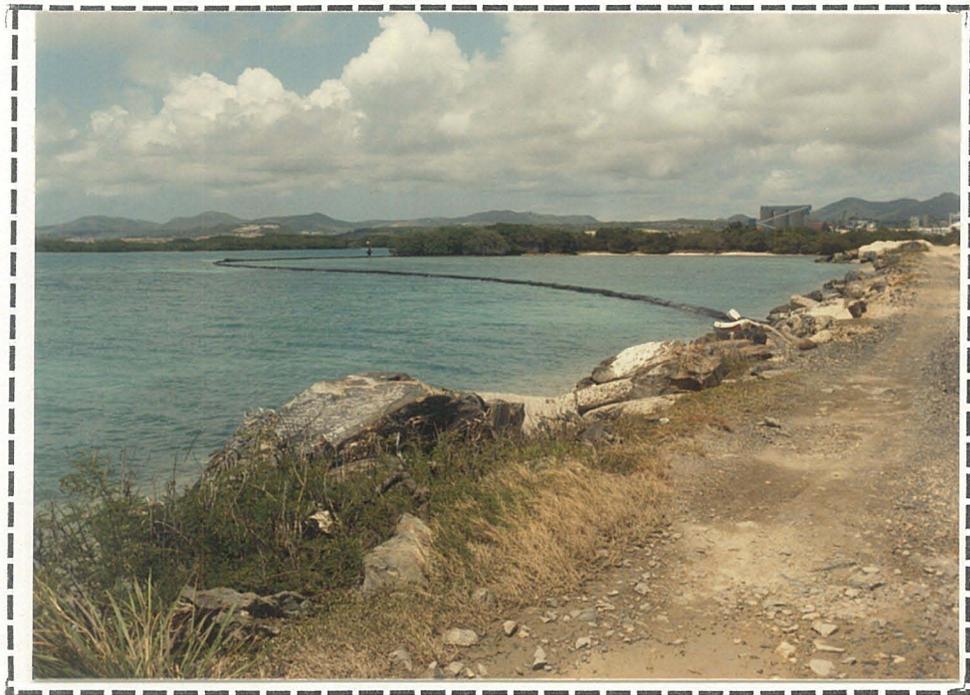
• PHOTOGRAPH #2

Photograph 2, looking northwest from the breakwater, shows Area B.

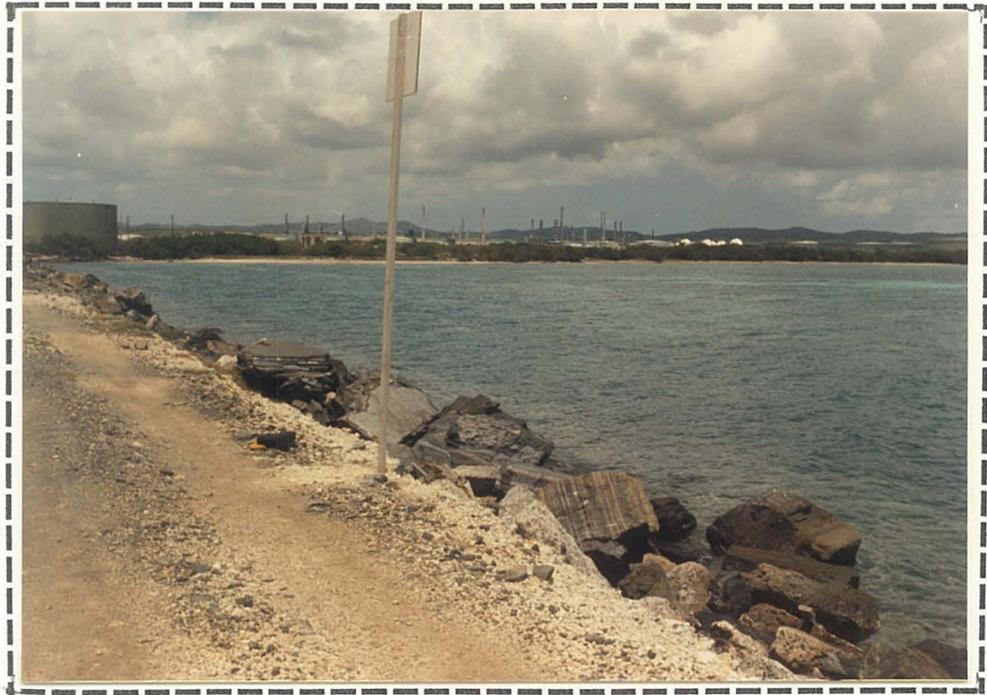
• PHOTOGRAPH #3

Photograph 3, looking northeast from the breakwater, shows Area C.

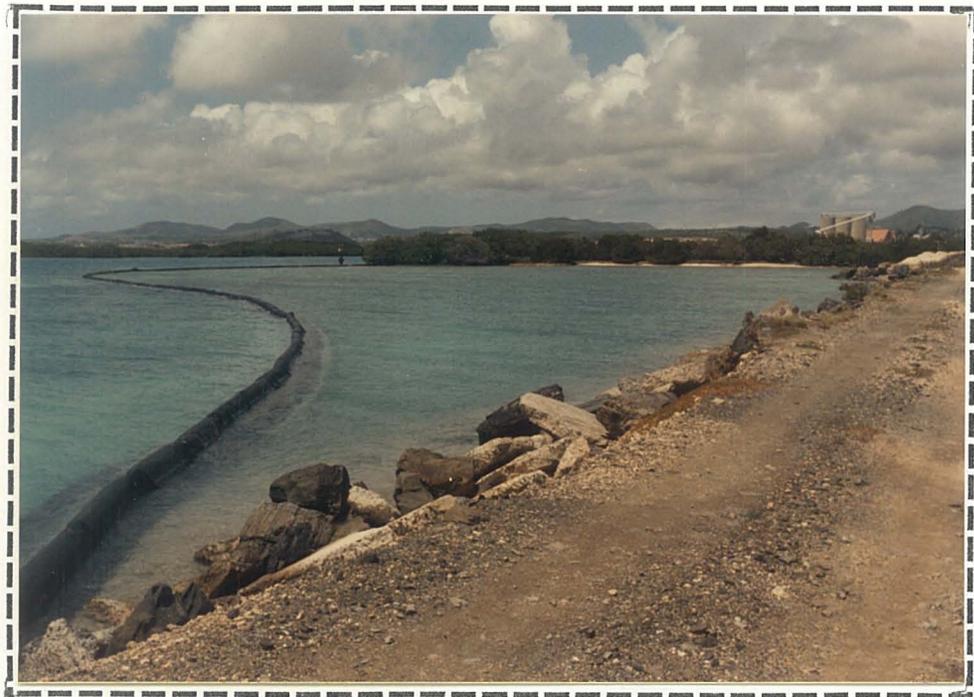
• PHOTOGRAPH #4

The Port Authority has recently put in place a silt boom that arcs in a northwest direction from the middle of the breakwater to a point near where the existing shoreline intersects with the Harvey Channel cut (Photograph 4). At the time of our survey this boom enclosed approximately 50% of Area B and 10% of Area A.

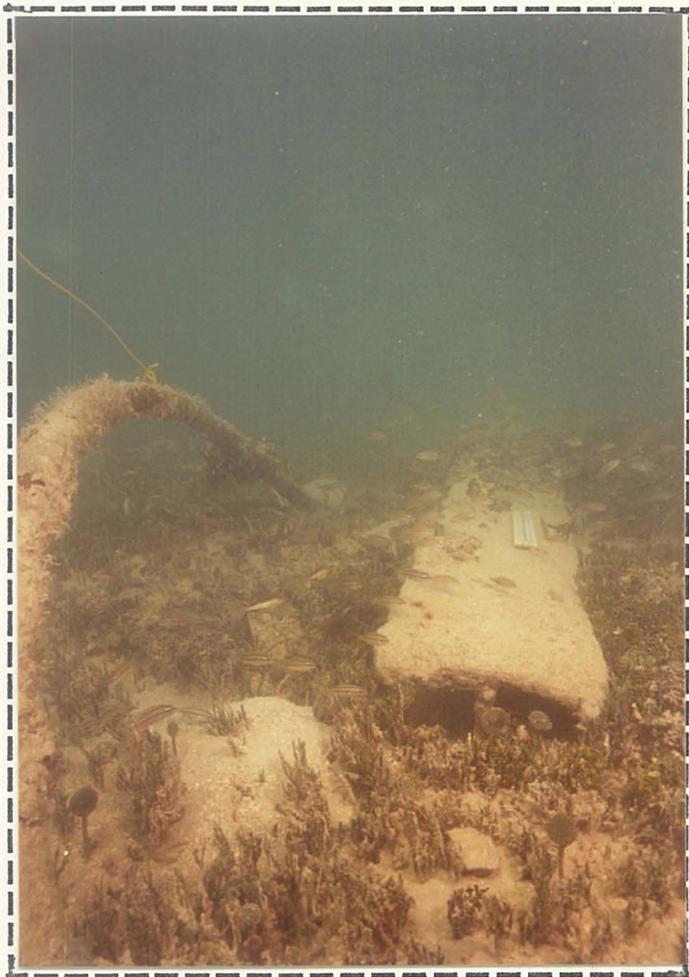
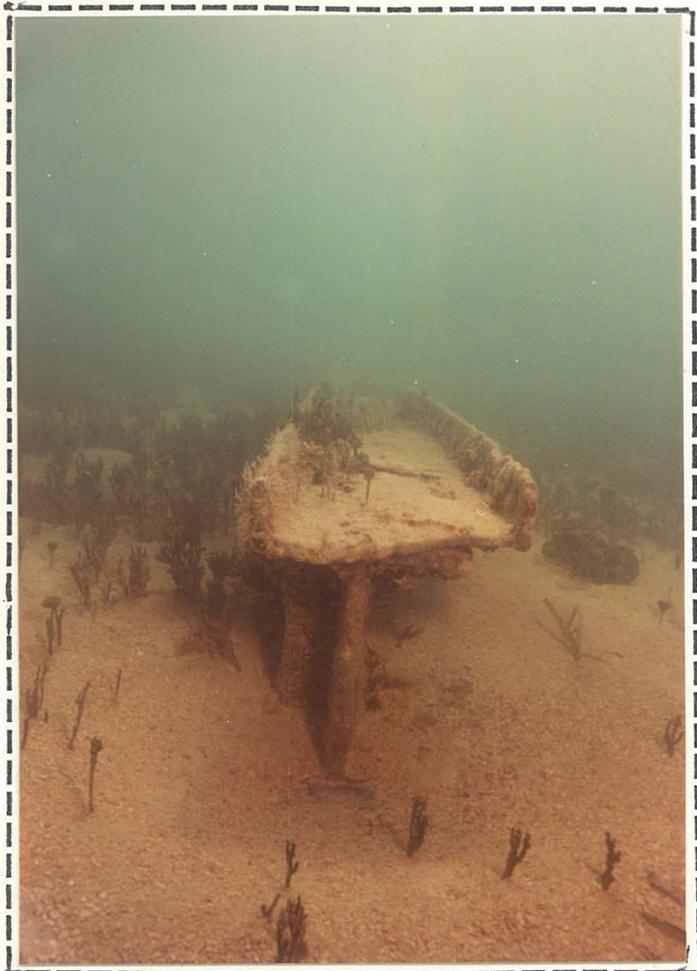
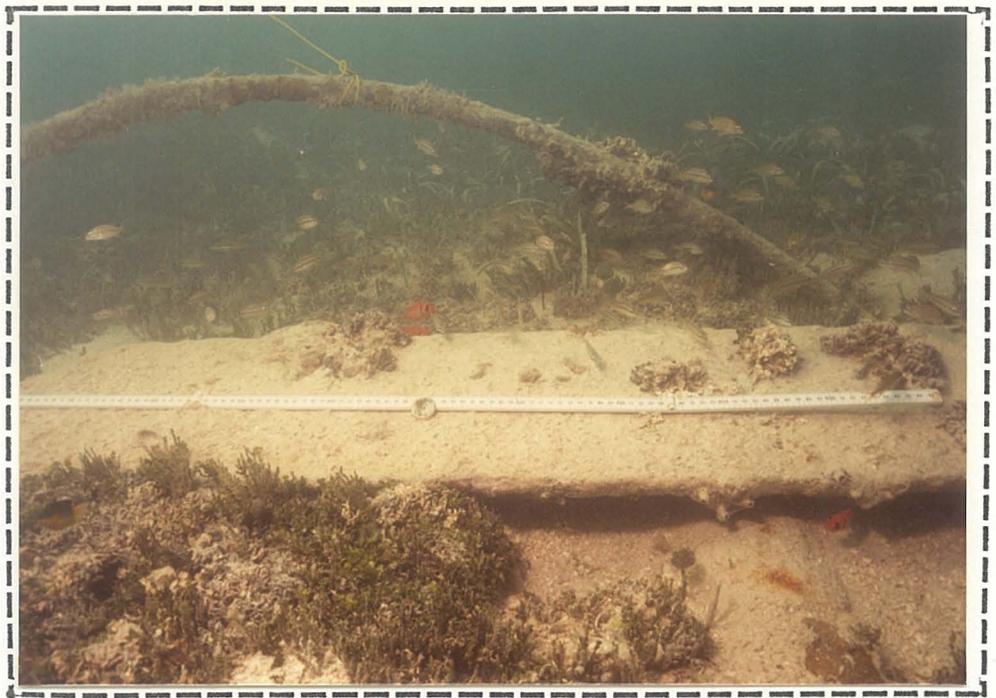
1. A discarded, modern-boat alternator partially buried in the silt at the edge of the Harvey Channel.
2. Miscellaneous modern refuse, such as beer bottles and cans.
3. An iron or steel girder (I beam), 9.7 meters long, with associated metal material at either end (Photographs 5 - 7). This girder, of modern construction, appears to be an isolated feature.
4. A 2-inch metal rod or piece of cable, protruding from the seabed to a height of about 3 feet (Photograph #8). This object also appears to be an isolated feature.
5. The most interesting and widespread cultural remains encountered were several assemblages of modern bricks, in association with stones and concrete aggregate material (Photographs 9 - 15). As

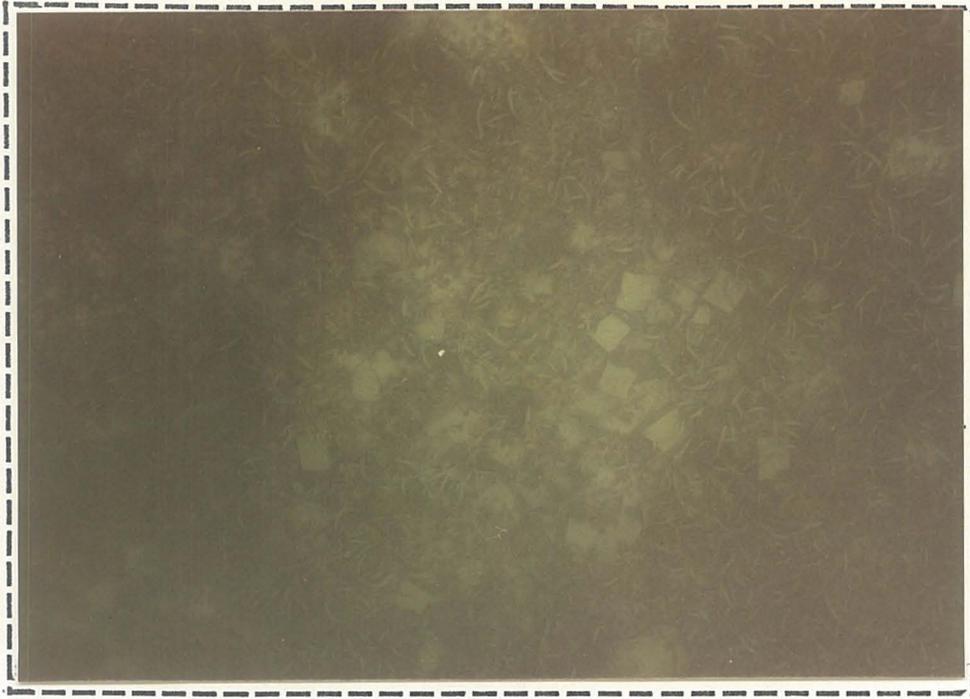
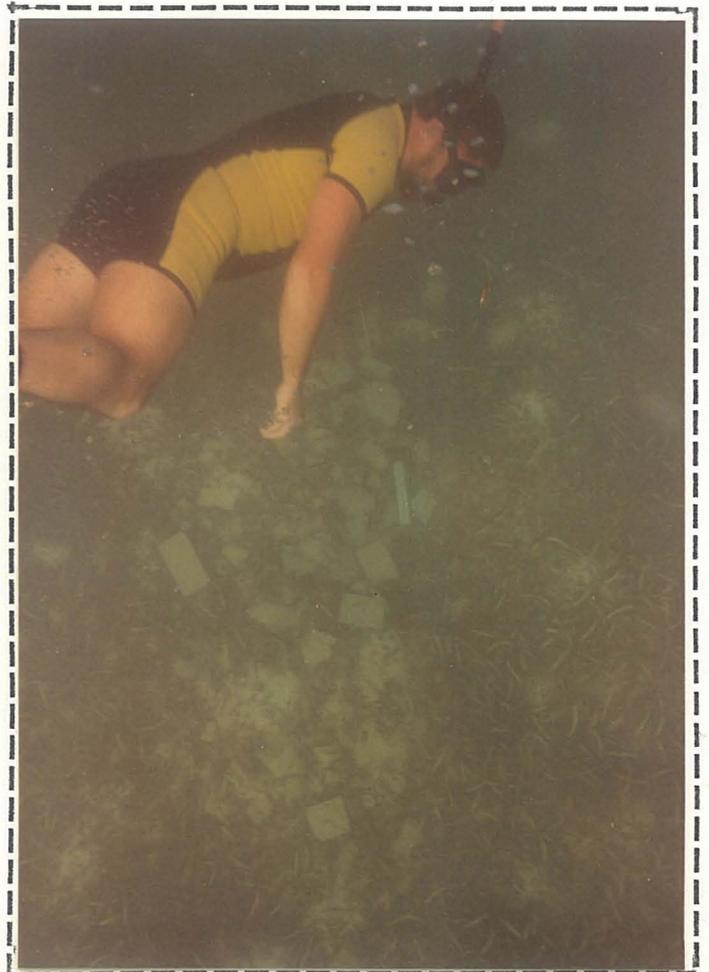
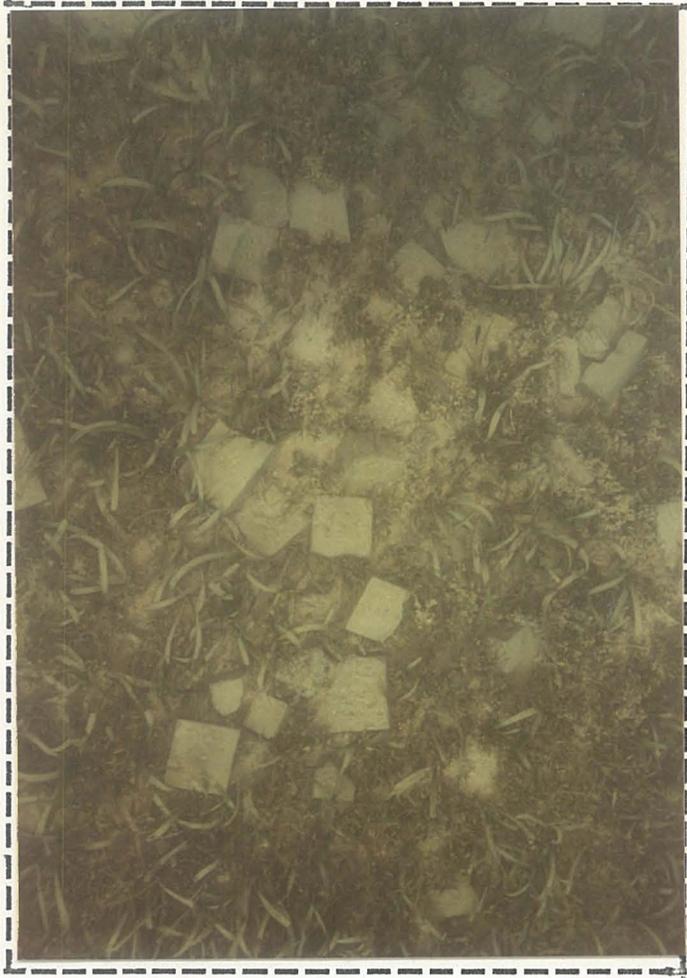
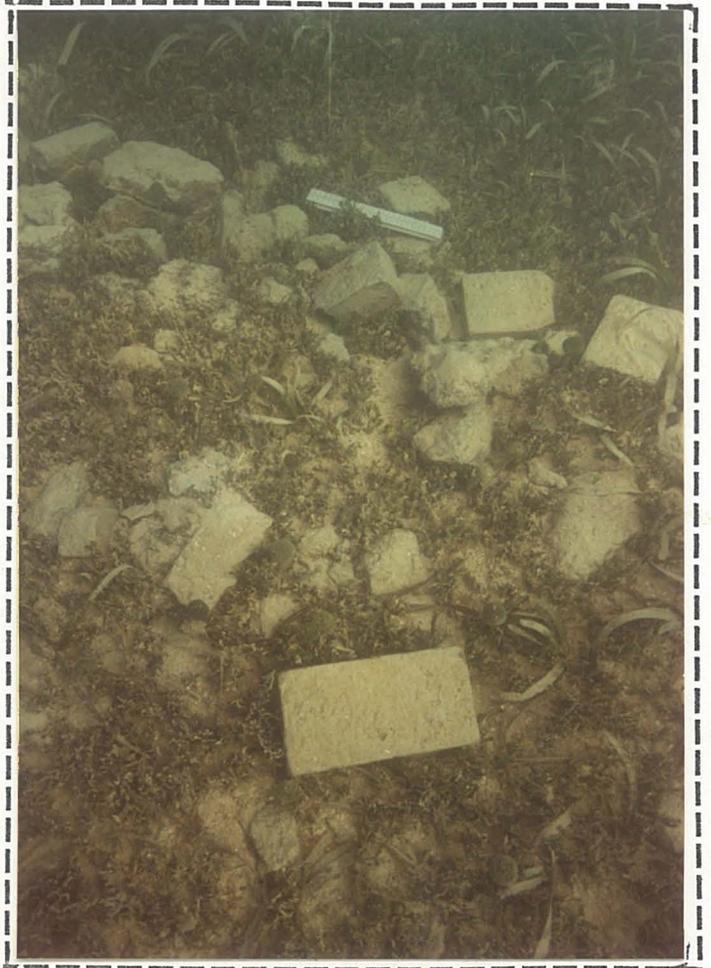
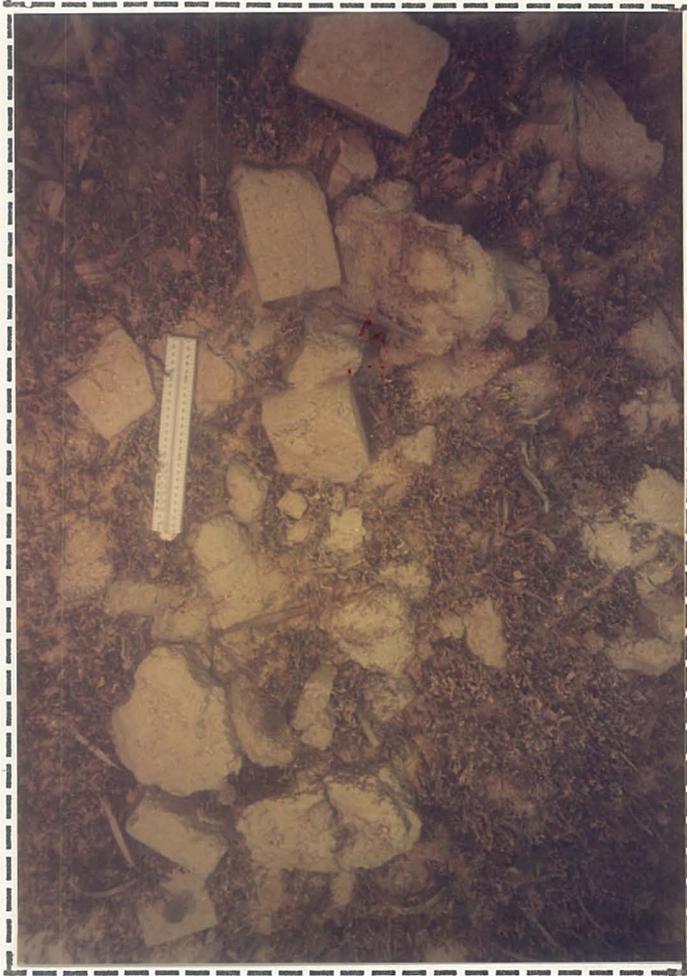
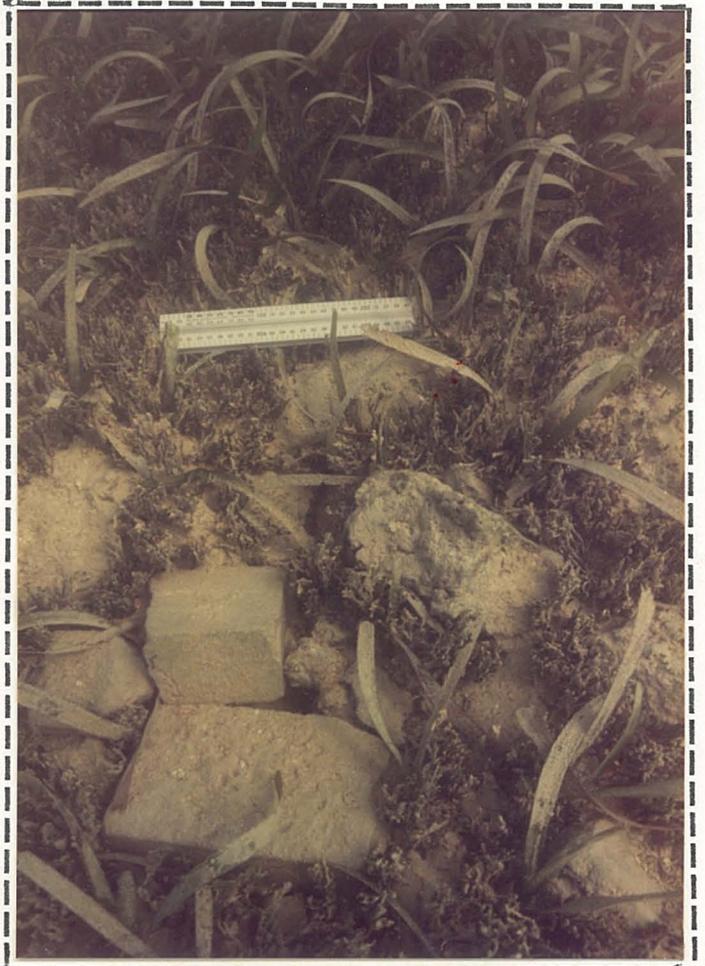
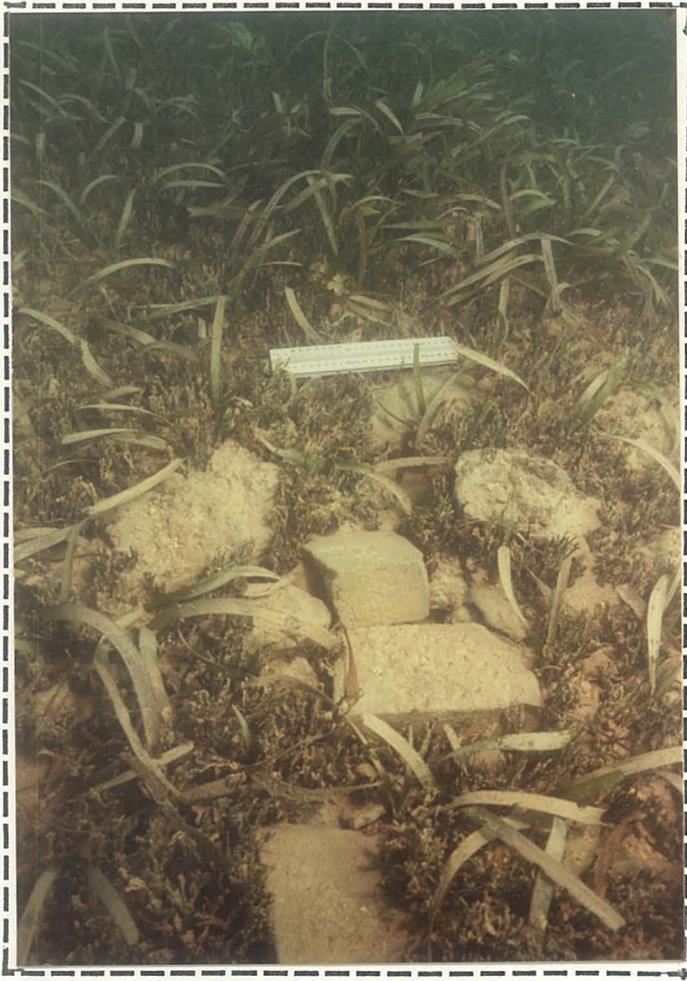
Approximately ninety percent of the bricks encountered were scattered, broken and fragmentary, indicating that they probably were deliberately discarded. All were manufactured with yellowish to buff colored clay, producing an extremely dense, highly fired brick, that exceeds standards for ordinary construction usage. Most likely these are fire bricks intended for some industrial kiln or boiler application, most probably associated with the Harvey Alumina plant, now closed.

The bricks were found in association with a non-uniform, concreted, aggregate material, that may represent some form of mortar or cement. Also found were occasional cobble-sized stones. The origin and purpose of these modern materials cannot be determined at this time.

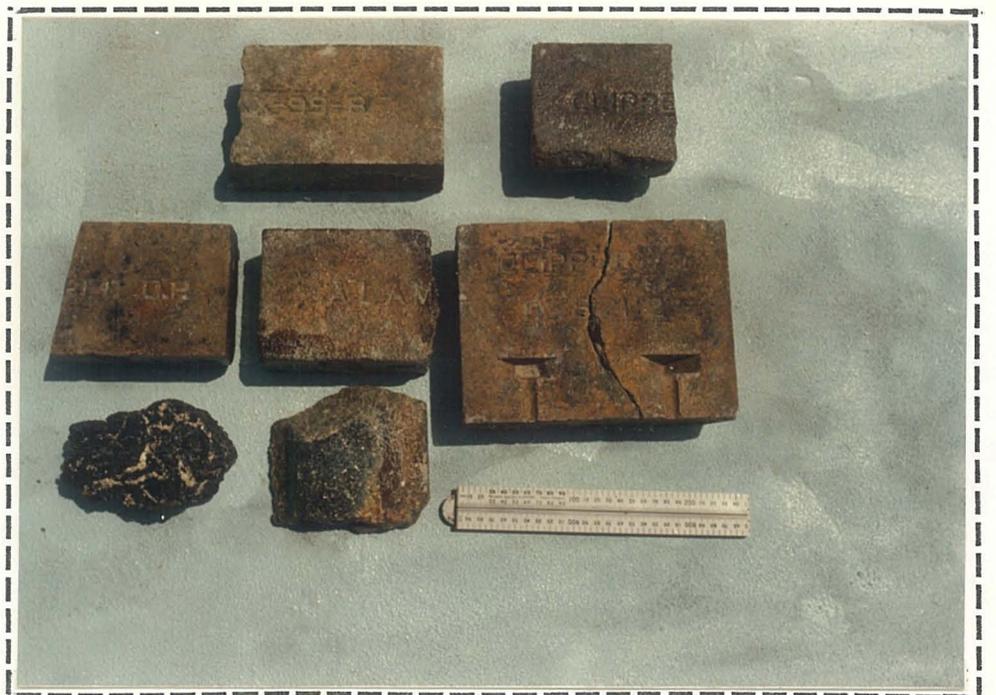
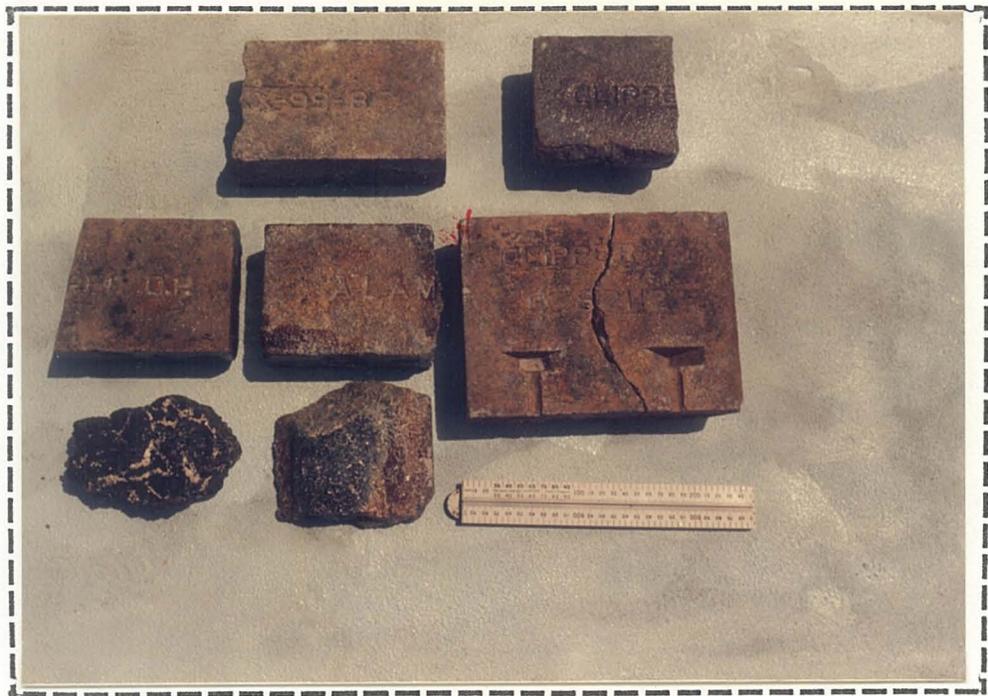
Two types of brick were found in these assemblages (Photographs 16 - 17). The first and most common type is rectangular, measuring 23.3 centimeters long, 11.3 centimeters wide, and 6.4 centimeters thick. Some of these bricks were embossed with the label "ALAMO" on their upper face; others were embossed with the label "CLIPPER D.R.," while a few others were labelled "B 62112."

The second type of brick measures 23.3 centimeters long, 17 centimeters wide and 6.4 centimeters thick. These were embossed with the label "CLIPPER" and below it "B-62112." These bricks have two molded indentations on the outer edges of their upper face, each in the form of an incised concave "T."

These indentations probably are mortices for metal fasteners, such as staples, to hold bricks with corresponding features together.

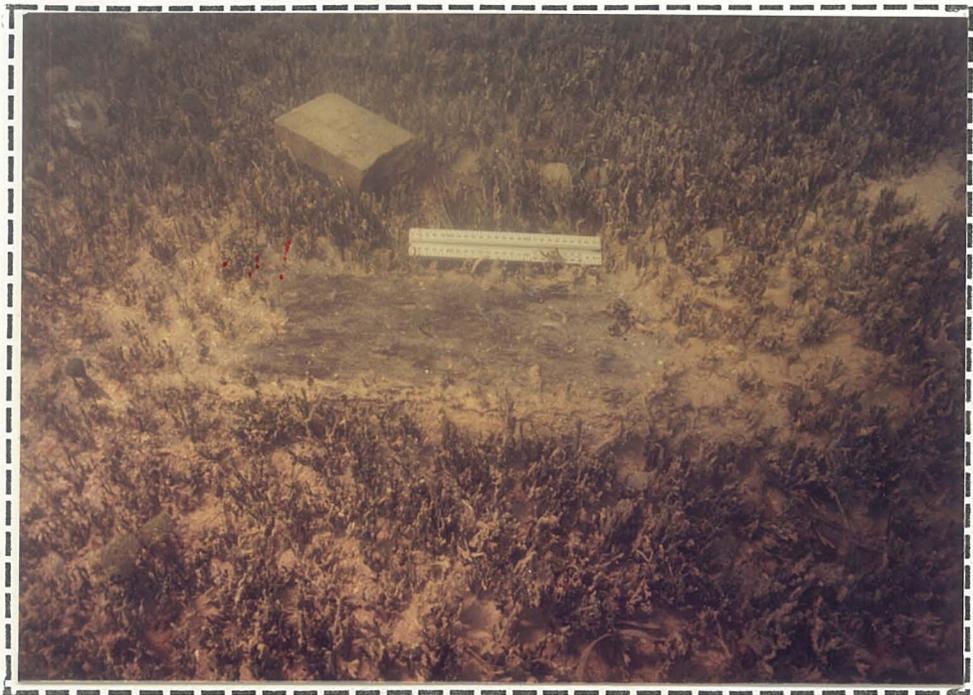
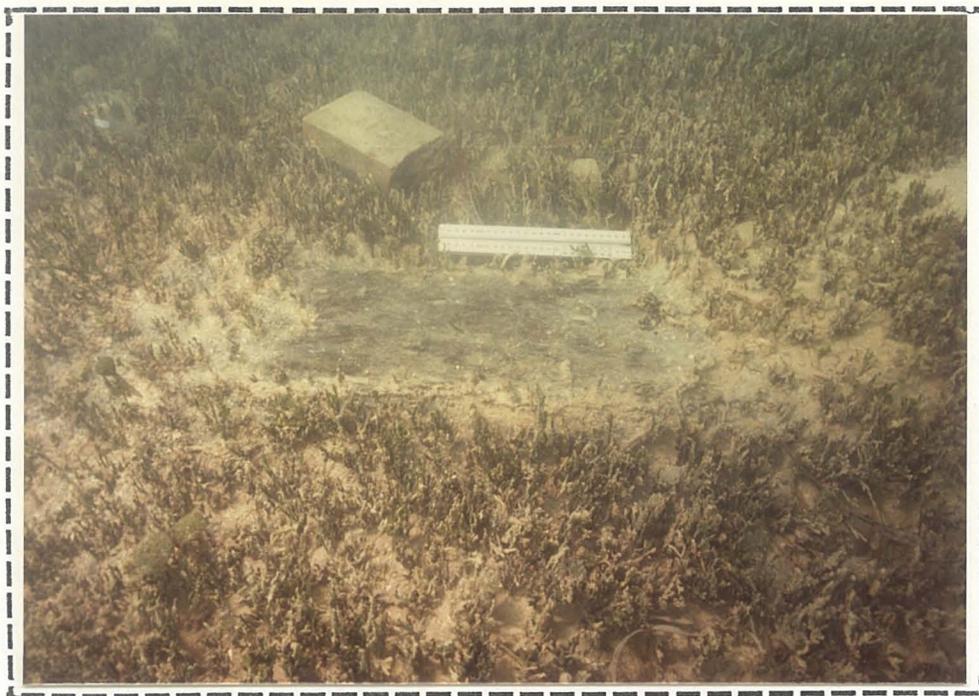
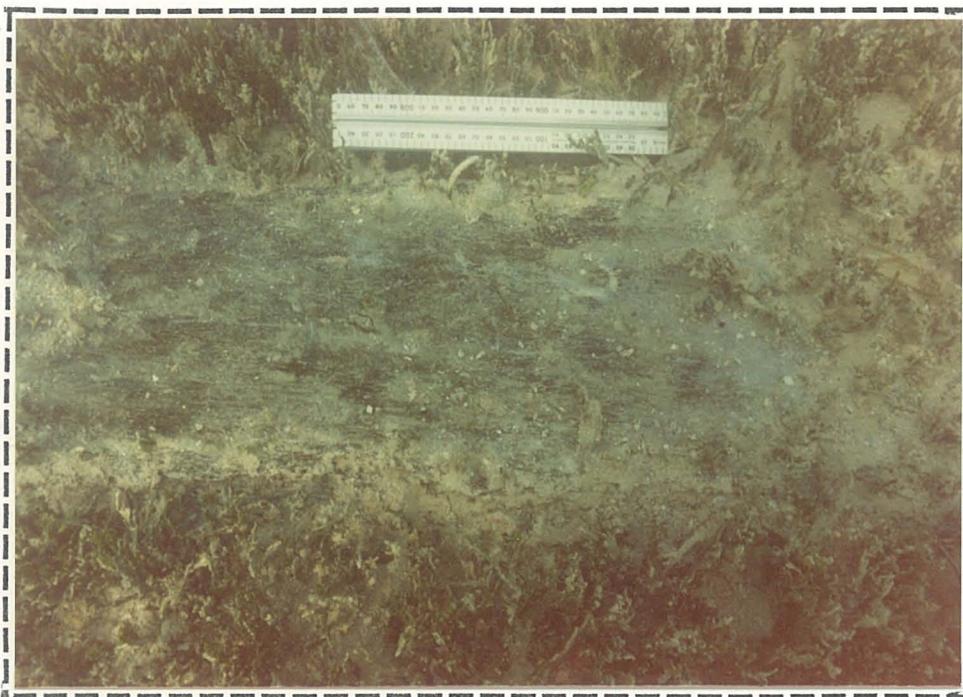
6. A buried wooden timber, 30 centimeters wide and 10 centimeters thick, in association with a concentration of bricks (Photographs 18 - 20). This timber was cleaned of sediments and partially excavated by hand fanning to a depth of 50 centimeters. It appears to be an isolated feature, since no tool marks or associated fasteners for articulated components, such as other connecting timbers, were encountered.

A systematic, sub-bottom exploration of the surrounding seabed by metal detector produced signals running in a westerly direction from the timber. Limited excavation of this anomaly revealed it to be a segment of two-inch steel cable, completely buried to a depth of 20 centimeters, and running for an approximate length of 7 meters.
