REPORT OF A STAGE 1A MARINE ARCHAEOLOGICAL SURVEY OF THE
VIRGIN ISLANDS PORT AUTHORITY DREDGE AND FILL PROJECT AT
LIMETREE BAY, SOUTHSORE ST. CROIX

Prepared by
ISLAND RESOURCES FOUNDATION

Submitted to the
Virgin Islands Port Authority

Date of Report: 30 March, 1987

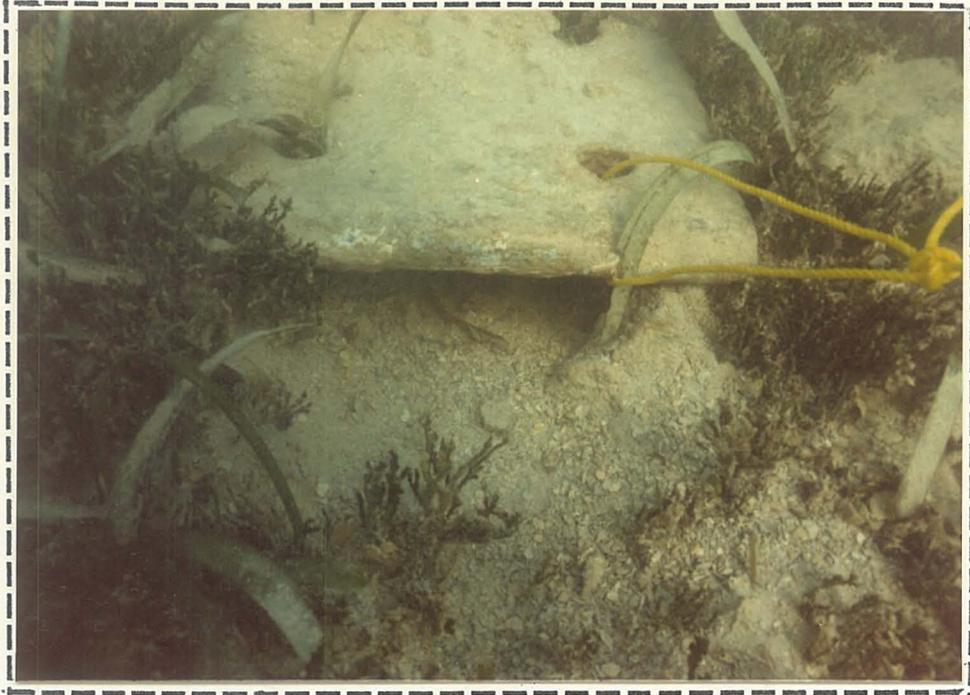
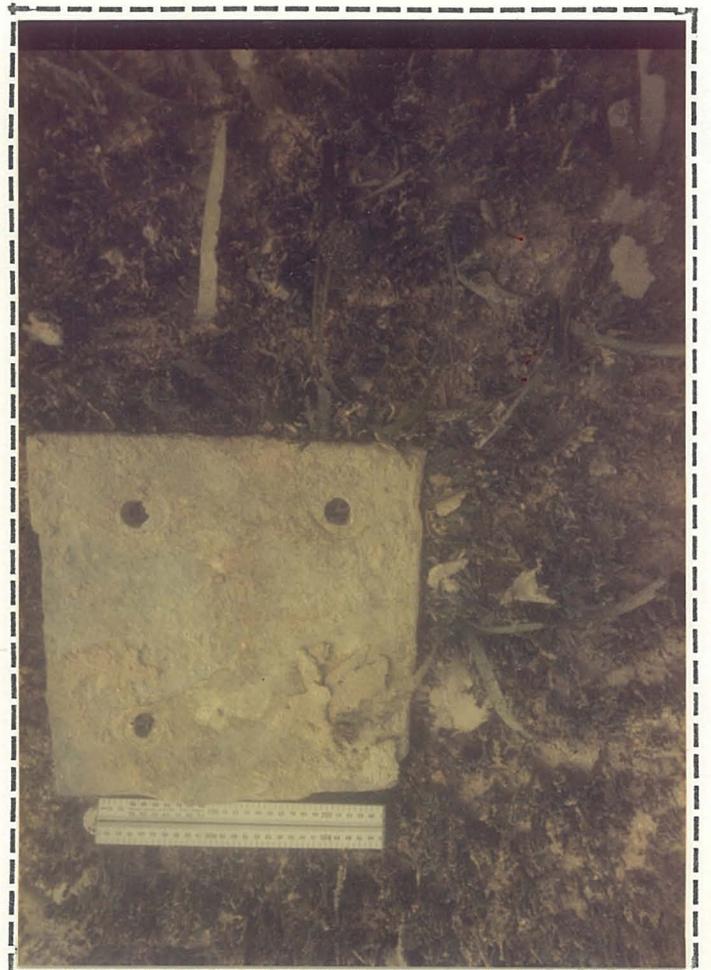
7. Six, square, lead or zinc plates, each measuring 30 centimeters by 30 centimeters and 2 centimeters thick, and each having four corresponding bolt holes, were found in association with another concentration of brick rubble (Photographs 21 - 22). These squares probably had an industrial function, since they appear to have been designed to be bolted to a flat surface.
