Nanny Cay, Tortola British Virgin Islands

A TERRESTRIAL RESOURCE CHARACTERIZATION

island resources
FOUNDATION
Road Town, Tortola
British Virgin Islands

July 2010

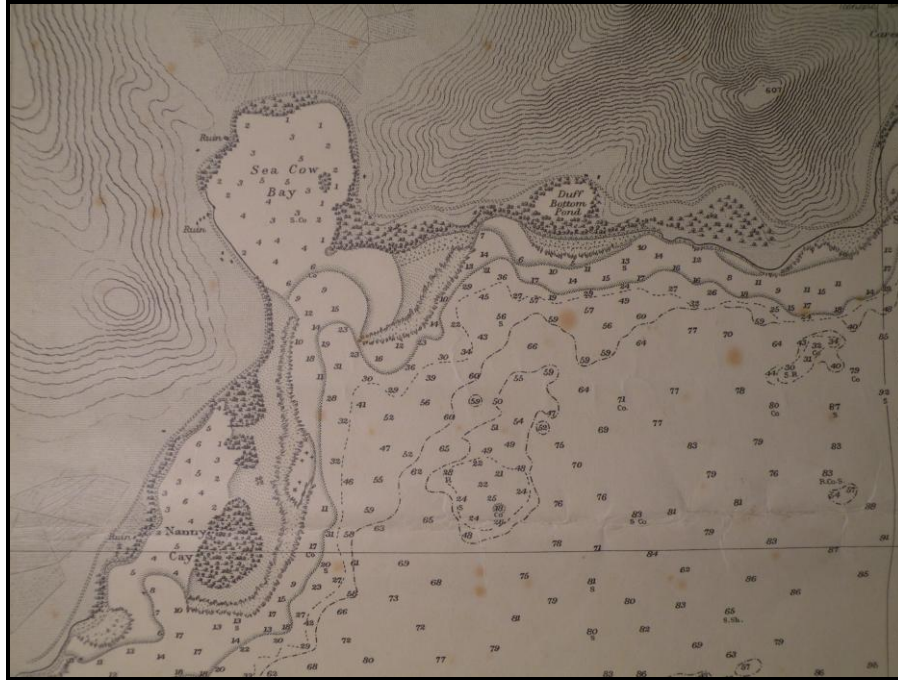
Figure 2. Nautical chart showing Sea Cow's Bay and Nanny Cay
(Source: BVI Admiralty Chart #2019, 1930)

The entire coastline of Nanny Cay has been extensively modified during several decades of construction and fill activities. The original shorelines as inferred through historical photographs and old nautical charts likely consisted of a low coral ledge platform with pockets of coralline sand (Figure 2). Red mangroves formed the core vegetation cover. The Cay was surrounded by a shallow-water lagoon, and a well developed reef system further offshore.

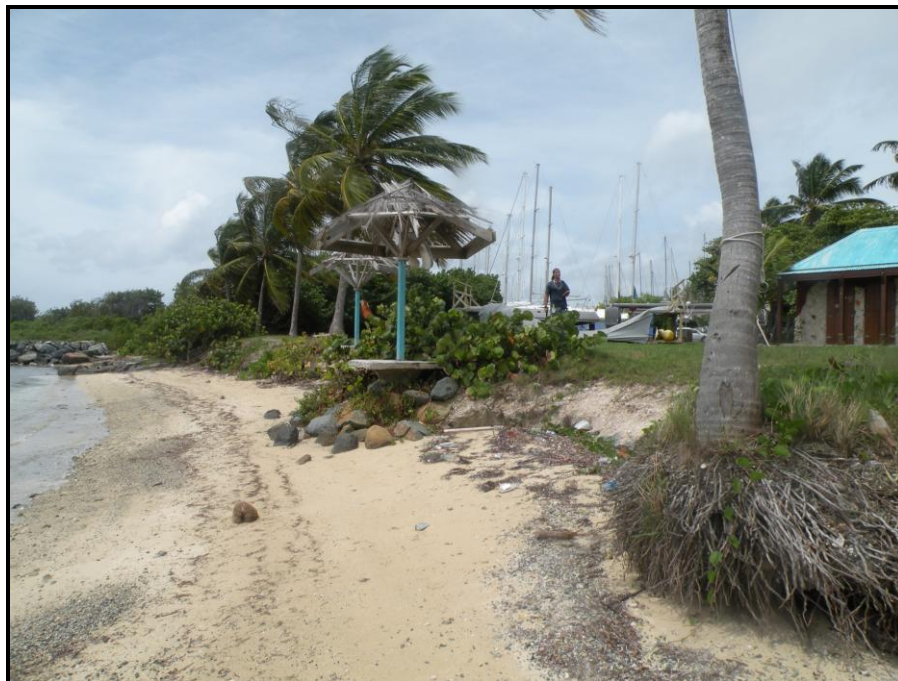
Today, most of the shoreline is characterized as antropogenic (of human origin) as depicted by features such as; the existing marina marking the entire western coastline; a series of groins and narrow pocket beach system along the south and east side of the cay; and a narrow beach along the northeast sector of the cay adjacent to the lagoon (proposed land reclamation area). This coastal section shows severe erosion (Figure 3). Many palm trees show exposed root systems and most tiki huts are undermined by wave activity.

Figure 3. Northeast shoreline showing severe erosion.

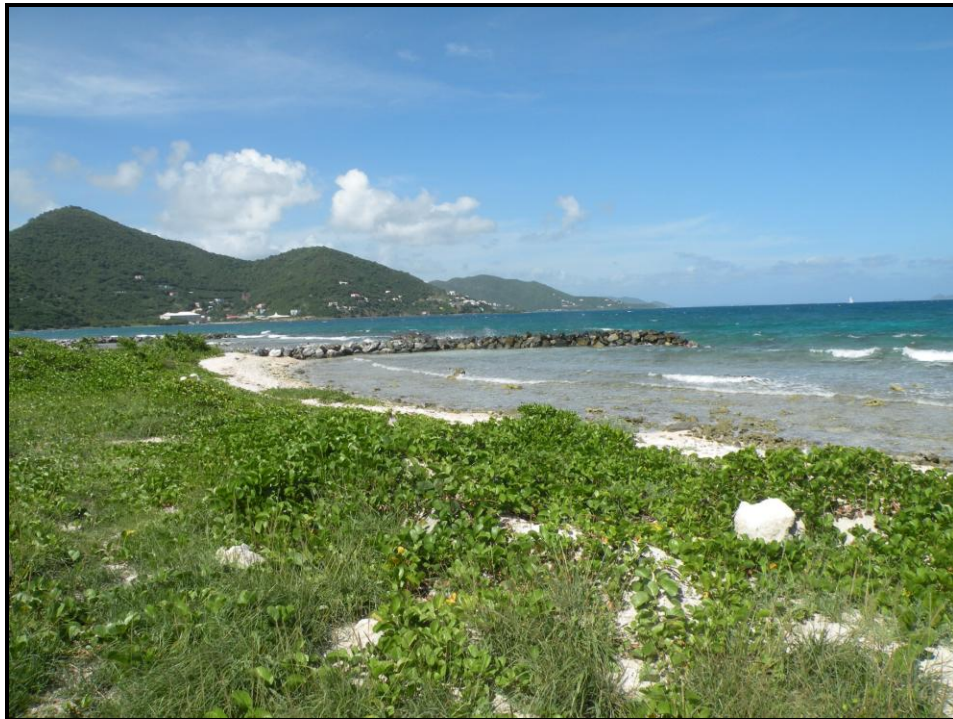
Figure 4. Beach vegetation type along southern shoreline.

This community type occurs along the shoreline beach of sand, gravel, cobbles, and coral rubble. It is primarily found along the south and southeast coast of the cay. The vegetation consists of a low growth of grasses, vines and herbaceous plants (Figure 4). Constant changing beach and shoreline provide unstable growing condition, although some plant species are well adapted like the Bay Bean (*Canavalia rosea*), Morning Glory (*Ipomoea pescaprae*) and Sea Purslane (*Sesuvium portulacastrum*).

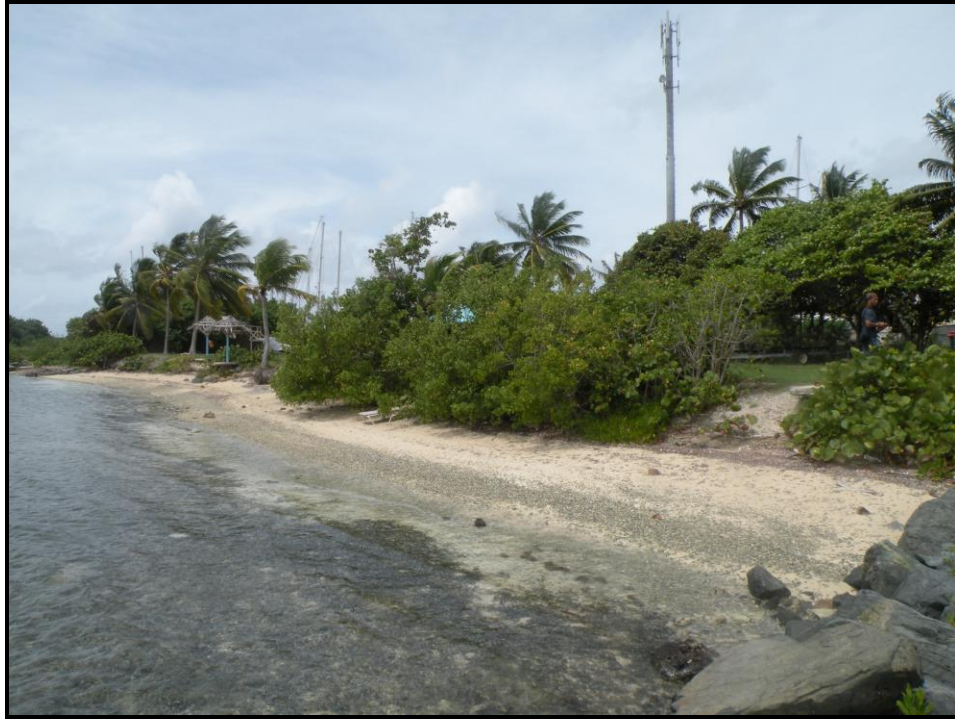
Figure 6. Coastal hedge.

This community is influenced by wind, sun exposure and salt-spray. It is found in small narrow patches on the southern and northeastern coastline of the cay (Figure 6). The vegetation consists of low trees and shrubs, dominated mainly by Seagrape (*Coccoloba uvifera*), and Seaside Mahoe (*Thespesia populnea*).

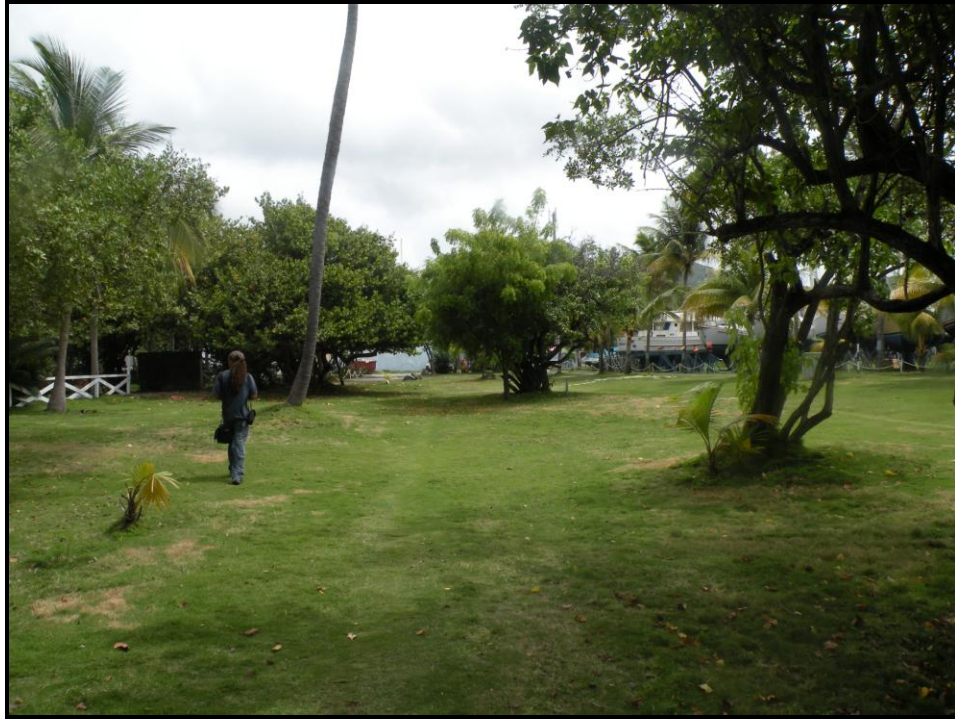
Figure 7. Grassland and open area community type.

This plant community is scattered throughout Nanny Cay, and includes lawns and low herbaceous patches (Figure 7).

The vegetation is dominated by grasses and herbaceous species such as: *Trianthema portulacastrum*, *Bidens alba*, *Cyanthillium cinereum*, *Tridax procumbens*, and *Sphagneticola trilobata*. Grasses include: *Axonopus compressus*, *Bothriochloa* cf. *pertusa*, *Cenchrus* sp., and *Chloris barbata*

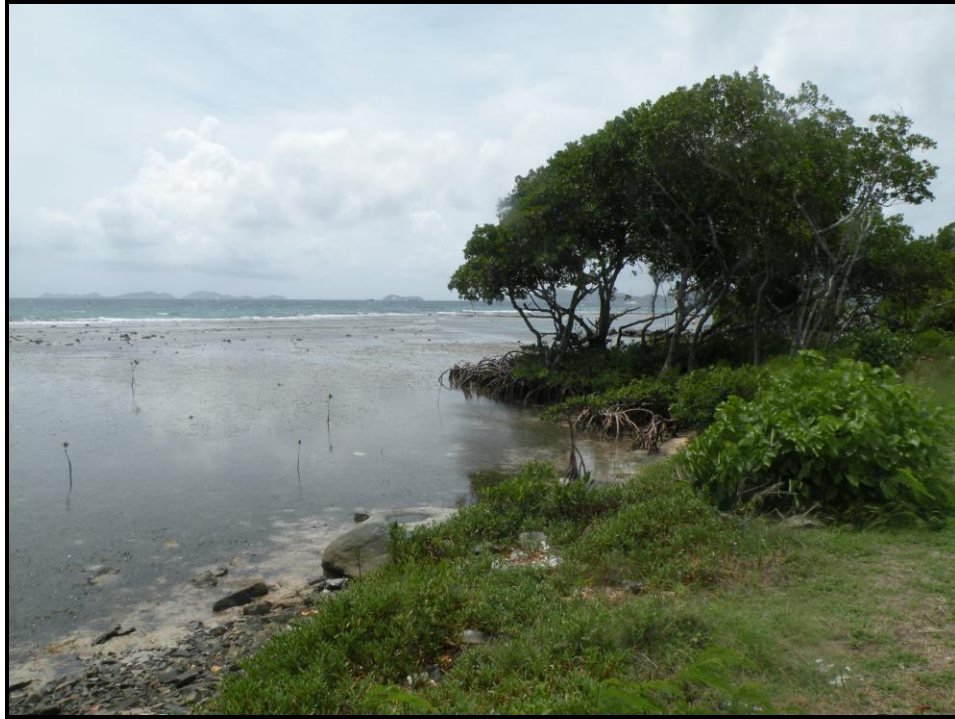
The first is fringing Red Mangrove (*R. mangle*) occurs along the northeastern coastline forming small patchy stands between the coastline and the sea (Figure 8). More extensive stands are found on the southwestern shoreline of the nearby mainland of Tortola at Hannah Bay, and along the northeastern shoreline of Seacow's Bay. The fringe is dominated primarily by Red Mangrove, but scattered here and there are Black Mangrove (*Avicennia germinans*), White Mangrove (*Laguncularia racemosa*), Buttonwood (*Conocarpus erectus*), and Seaside Mahoe or Haiti-haiti (*Thespesia populnea*).

Figure 8. Fringing Red Mangroves along the northeast coastline.

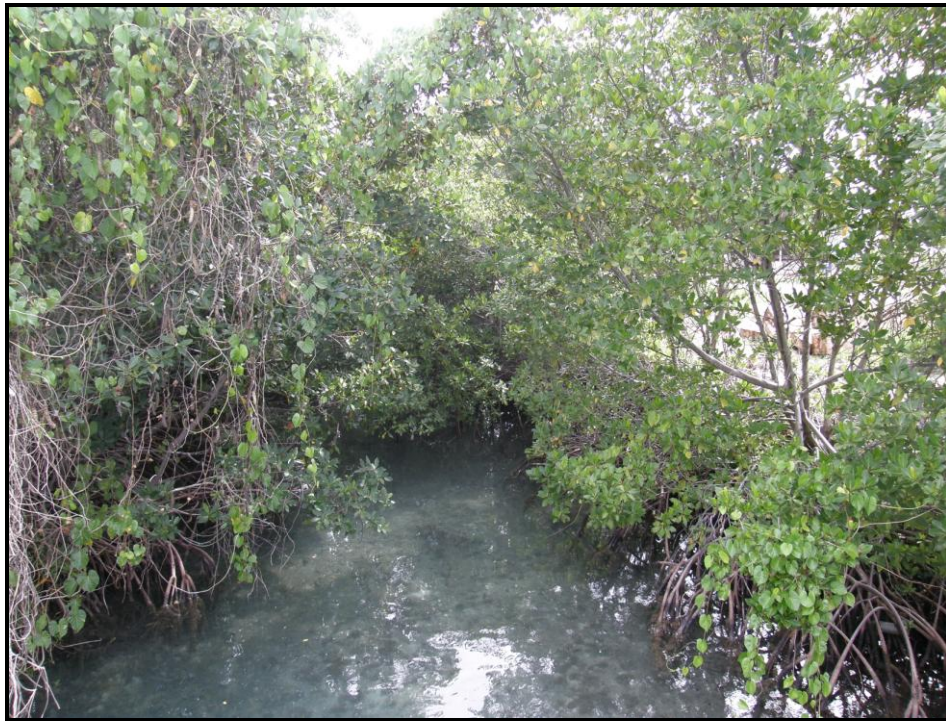
The second type occurs along artificial channels located on the northern and eastern areas of the Cay. These channels are lined with mangroves, including all four species and Seaside Mahoe (Figure 9).

Figure 9. Red mangroves lining the channel.

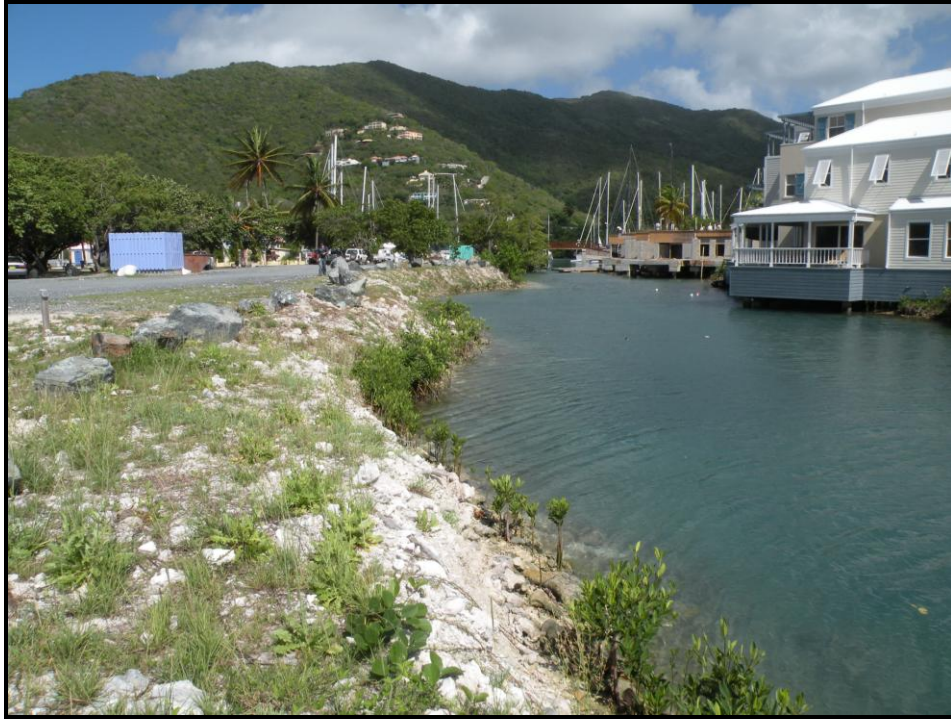
Mangrove habitats on Nanny Cay are relatively small and its distribution limited primarily along the channel, adjacent to the bridge, and to a smaller extent as small patches fringing along the coastline, especially on the northeastern side of the island. Recent residential development along the southwest bank of the channel has already reduced the mangrove coverage (Figure 12). Ground clearing activities to create more storage areas, and construction activities and the movement of heavy machinery have already caused some encroachment along the edges of the mangroves lining the channel.

Figure 12. Near the southwest channel entrance where channel has been widened to allow for new residential construction. Most mangroves were destroyed during this process. However, new red mangrove seedlings are sprouting along the edge.

Preserving some of these sites or alternatively, creating similar conditions elsewhere along the Cay's shallow-water coastline should be considered as a mitigation option.

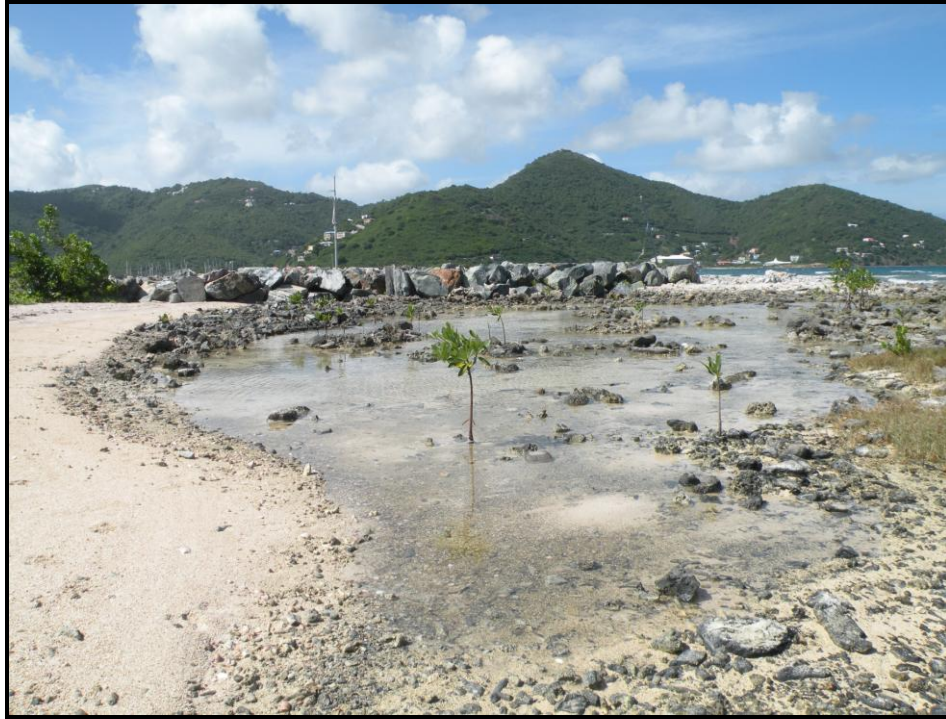
habitats not only provide good condition for the growth of mangrove seedlings, and benthic species, but also provide great foraging opportunity for shore birds and wading birds.

Figure13. Red Mangrove seedlings along the shallows.

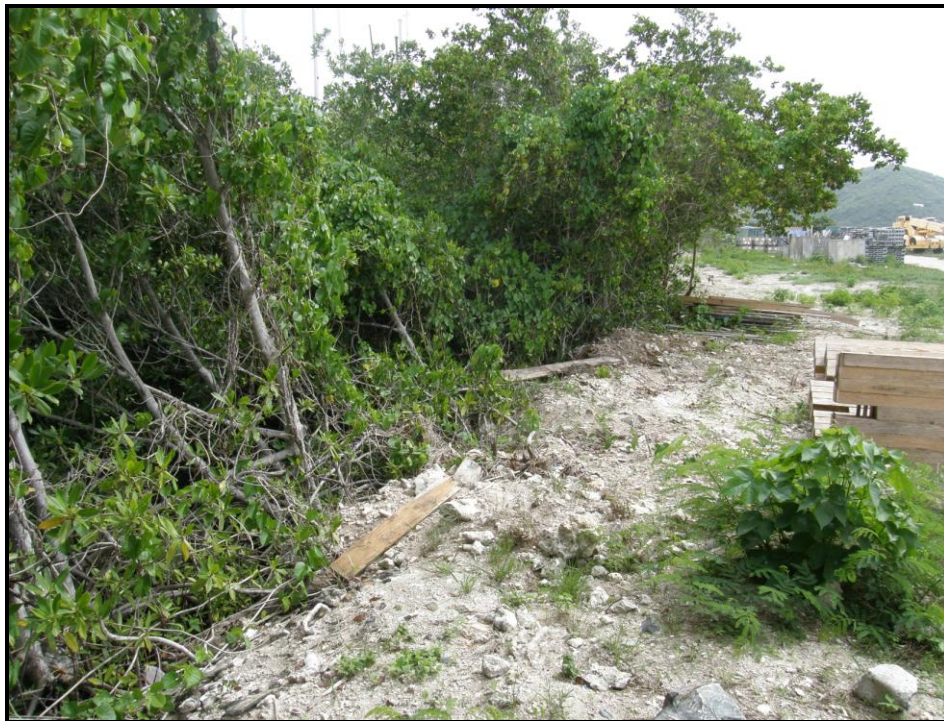
After heavy rains, we observe many instances of sediment runoff due to poor control and mitigation practices, including along the channel corridor where land was recently cleared and silt fences were not properly maintained thereby allowing fine sediments to enter into the channel (Figure 15). Many other areas of uncovered soil showed signs of erosion and sediment runoff.

Figure 15. Clearing activity along mangrove edge.

The implementation and monitoring of proper erosion control measure will be critical in the construction phase. We strongly recommend the adoption of guidelines and best management practices (BMP's) for erosion and sediment control for all of Nanny Cay during the construction phase, and also include some measures following the construction phases that would involve the homeowners. There should be some independent monitoring of these measures to ensure compliance and increase the level of transparency and confidence in the development process. A number of reference documents specific and
