## PILOT EXPERIMENTAL SEAGRASS TRANSPLANTATION PROJECT

SOUTH SHORE, ST. CROIX  
U.S. VIRGIN ISLANDS

August 1987

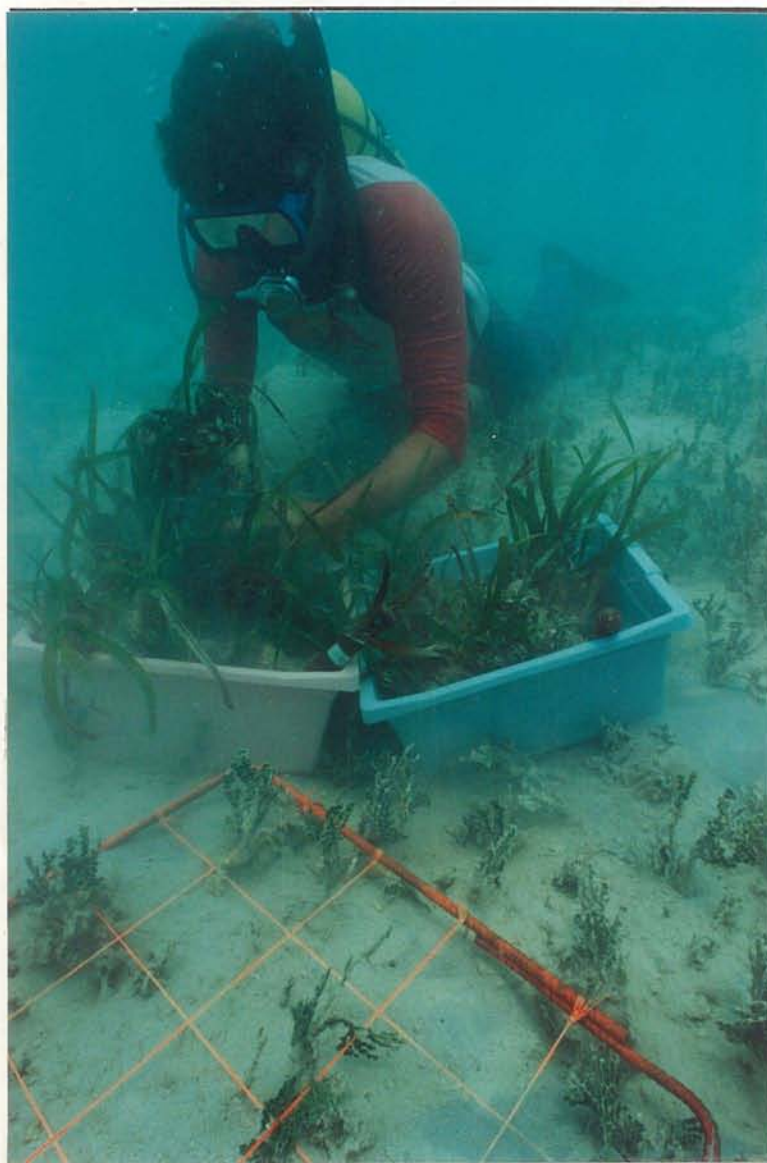
Photograph 1. Diver in Plot I removing 6-8 inch plugs from plastic containers to be planted.

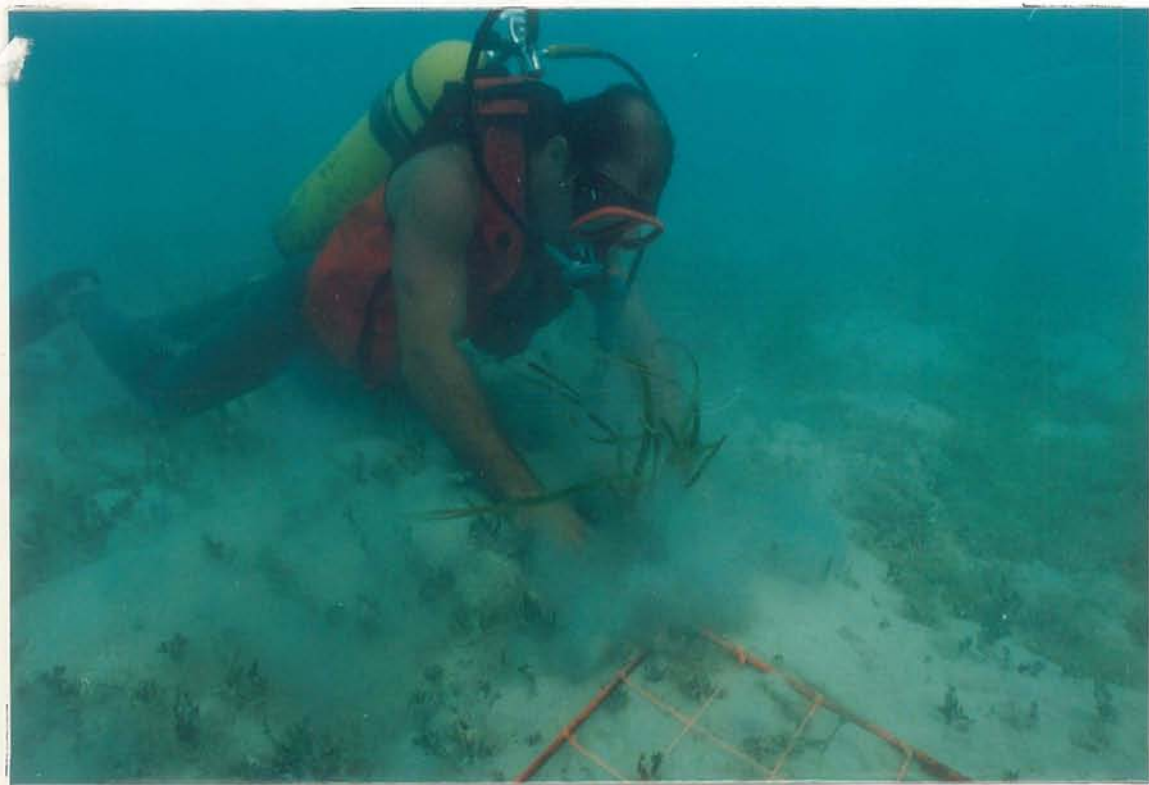
Photograph 2. Diver planting a plug in Plot I.

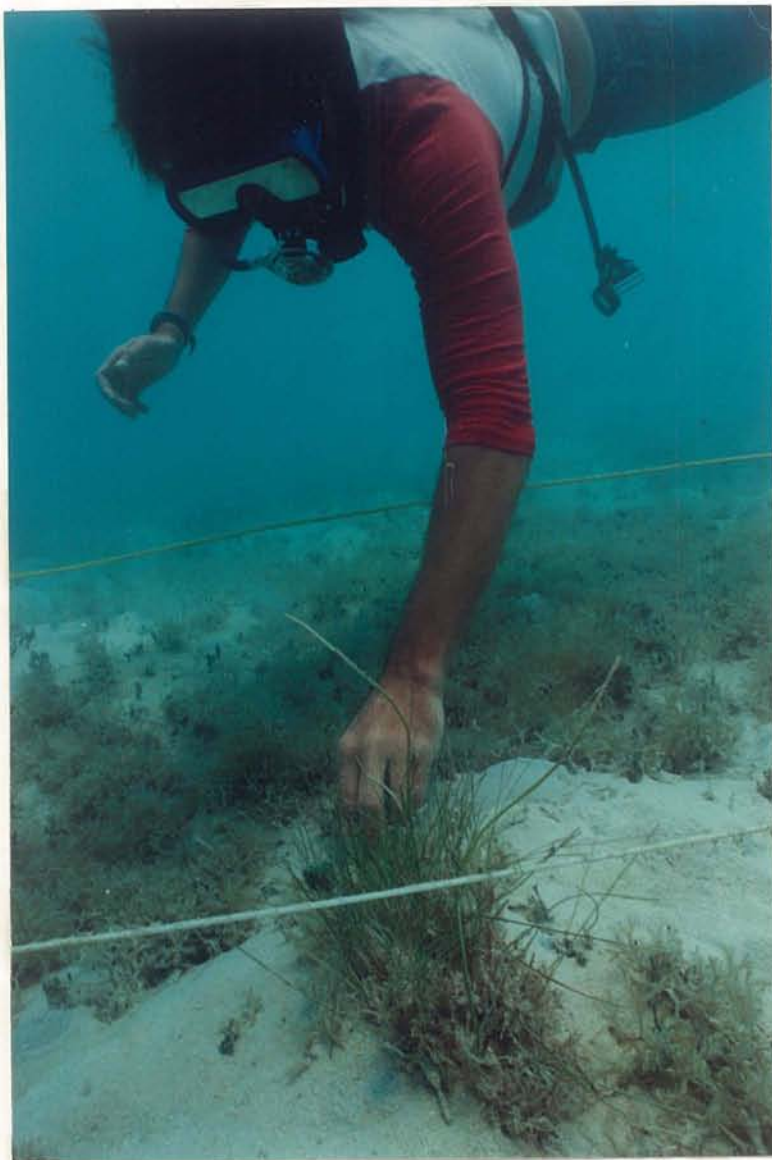
Photograph 3. Diver points to a plug of mixed Syringodium filiforme and Halodule wrightii planted in the sand in Plot I.

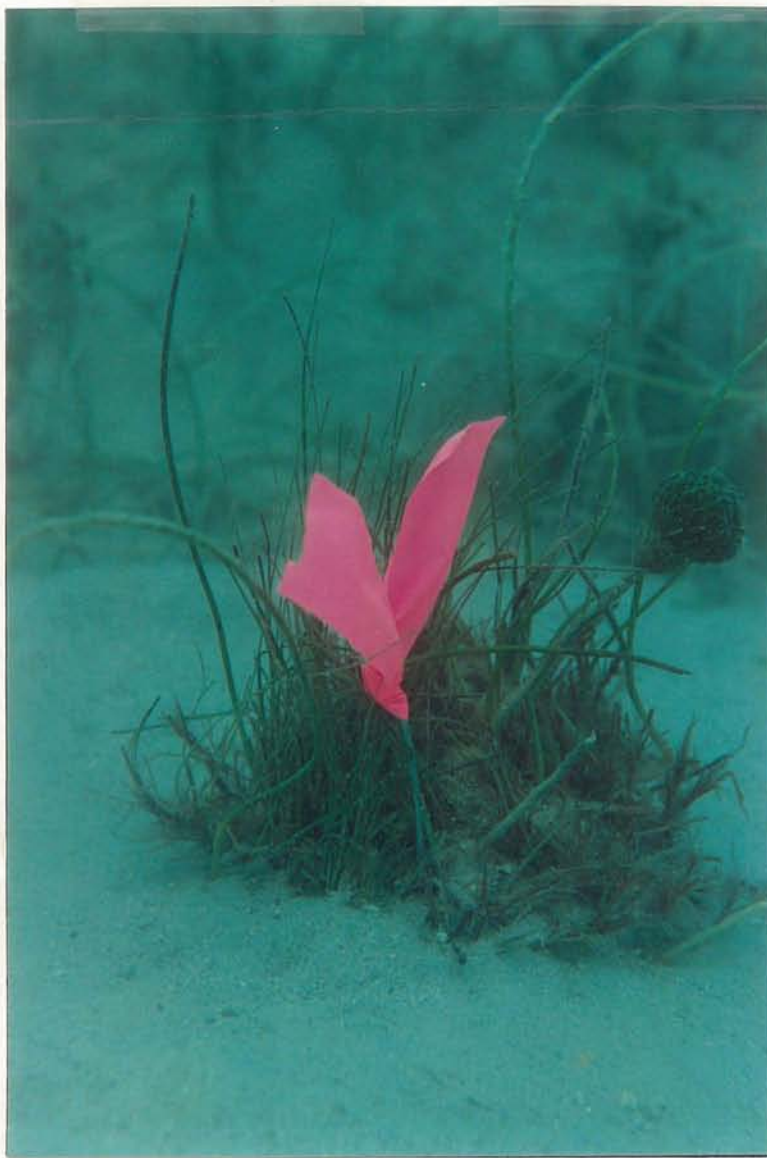
Photograph 6. A planted plug of mixed Syringodium filiforme and Halodule wrightii.

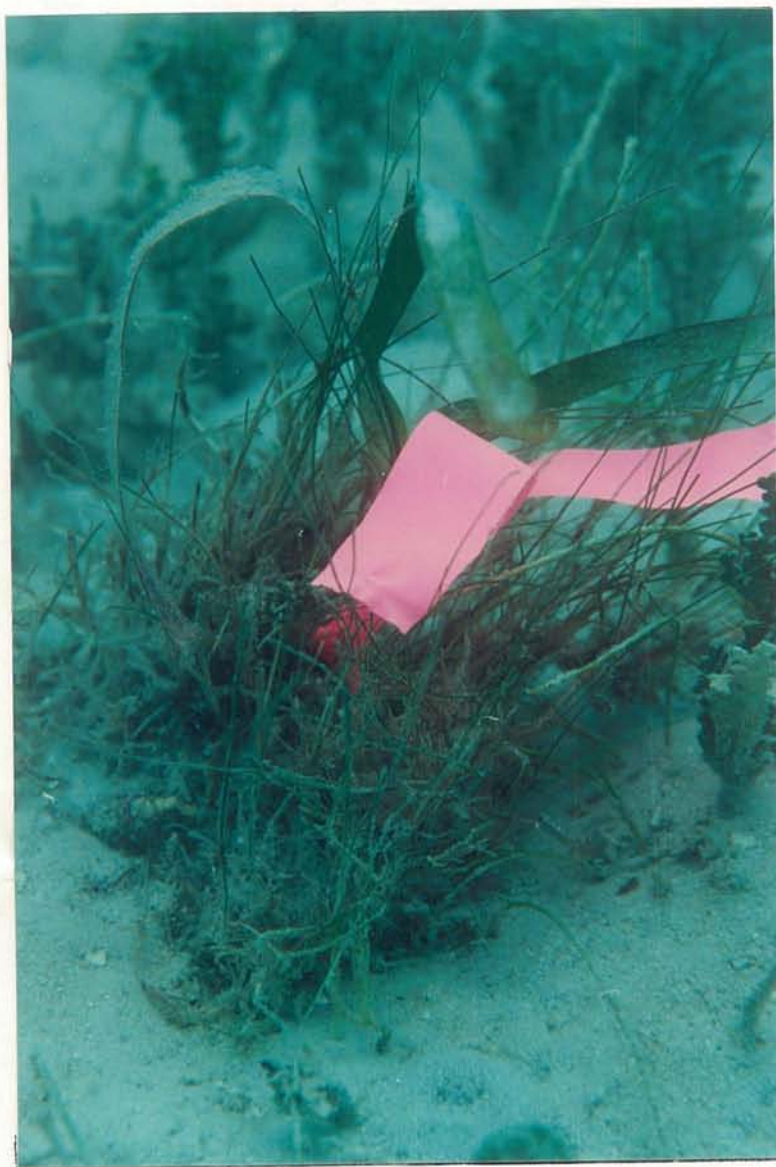
Photograph 7. A planted plug of mixed Thalassia testudinum and Syringodium filiforme.

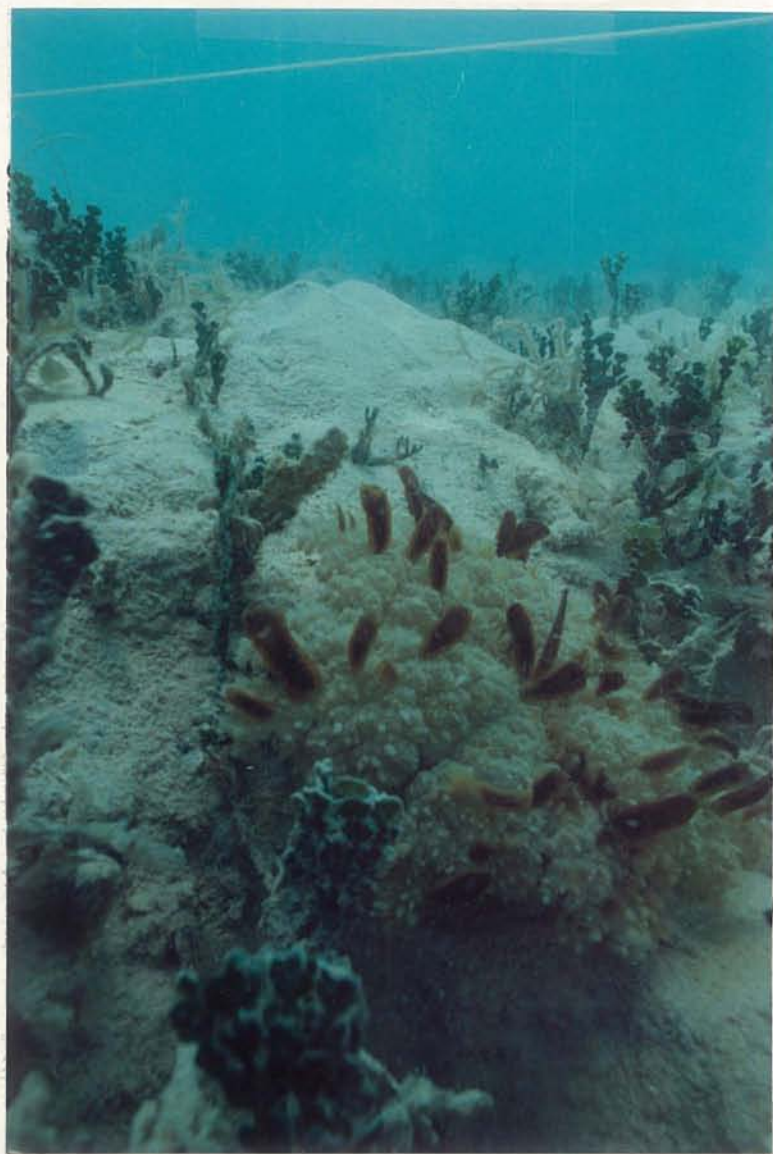
Figure 6. Recipient area for transplanting sea grasses. Callianassa mounds are seen in the background, the dominant algae, Halimeda sp. is conspicuous and the upside-down jellyfish Cassiopea frondosa, appears in the foreground.

The bottom characteristics found in the recipient areas can best be illustrated as shown in Figure 6. The area is sandy with the dominant algae being Halimeda sp. interspersed with moderate amounts of brown algae (Dictyota divaricata and Dictyota sp.) and red algae (Liagora farinosa), occasional Caulerpa cupressoides and several other species yet to be identified. Many mounds of the ghost shrimp (Callinassa sp.) also occupy the recipient area along with many queen conch and the upside-down jellyfish (Cassiopea frondosa). At the edge of planting area I, Syringodium is already growing. Since grass has already established itself in an adjoining area we know that conditions are favorable for further grass growth and there is a reasonable chance of the success of the transplant.

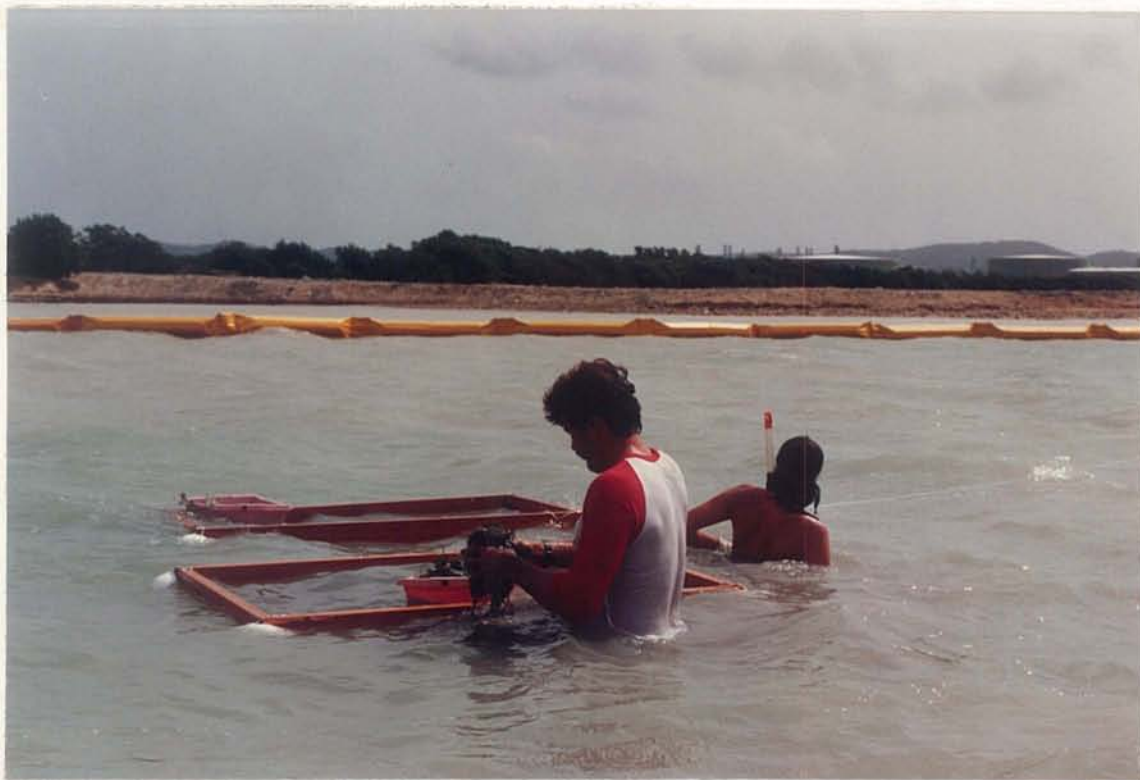
Figure 7. Fill area where donor seagrass is being removed and placed in floating trays.

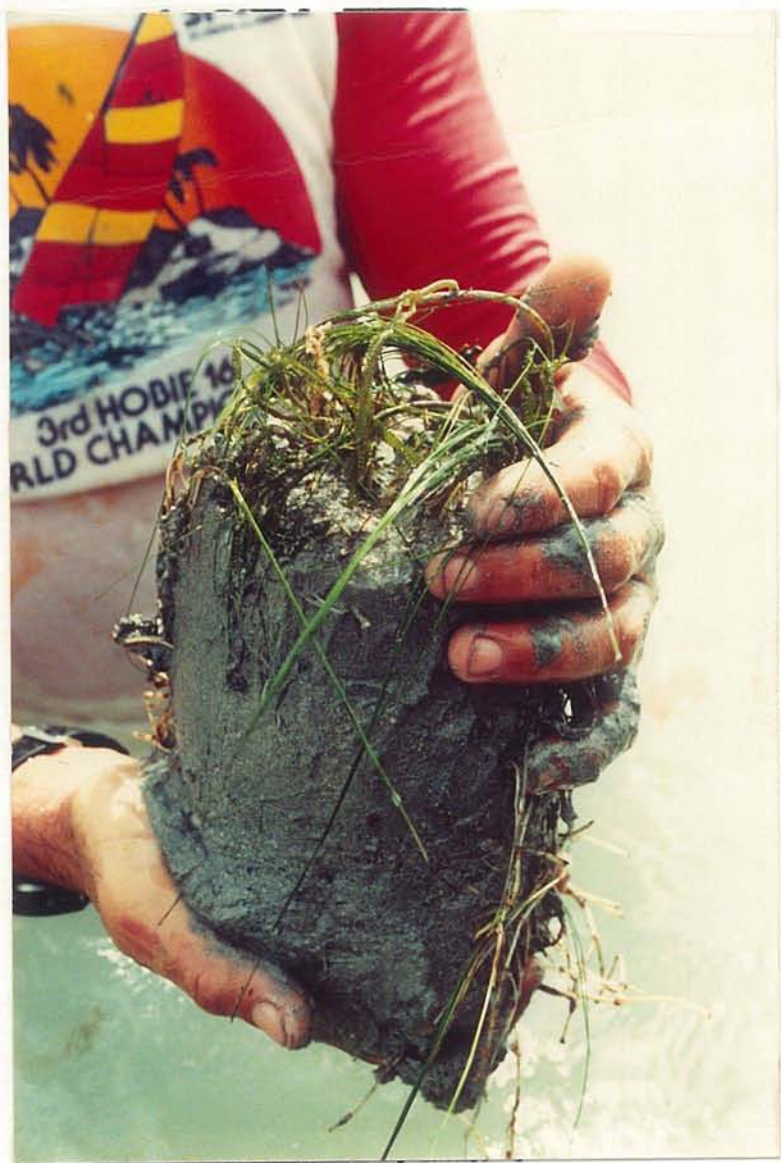
Figure 8. Sample plug 6in in diameter and 6 - 8in in depth. Plug contains a mixture of Syringodium filiforme and Halodule wrightii.

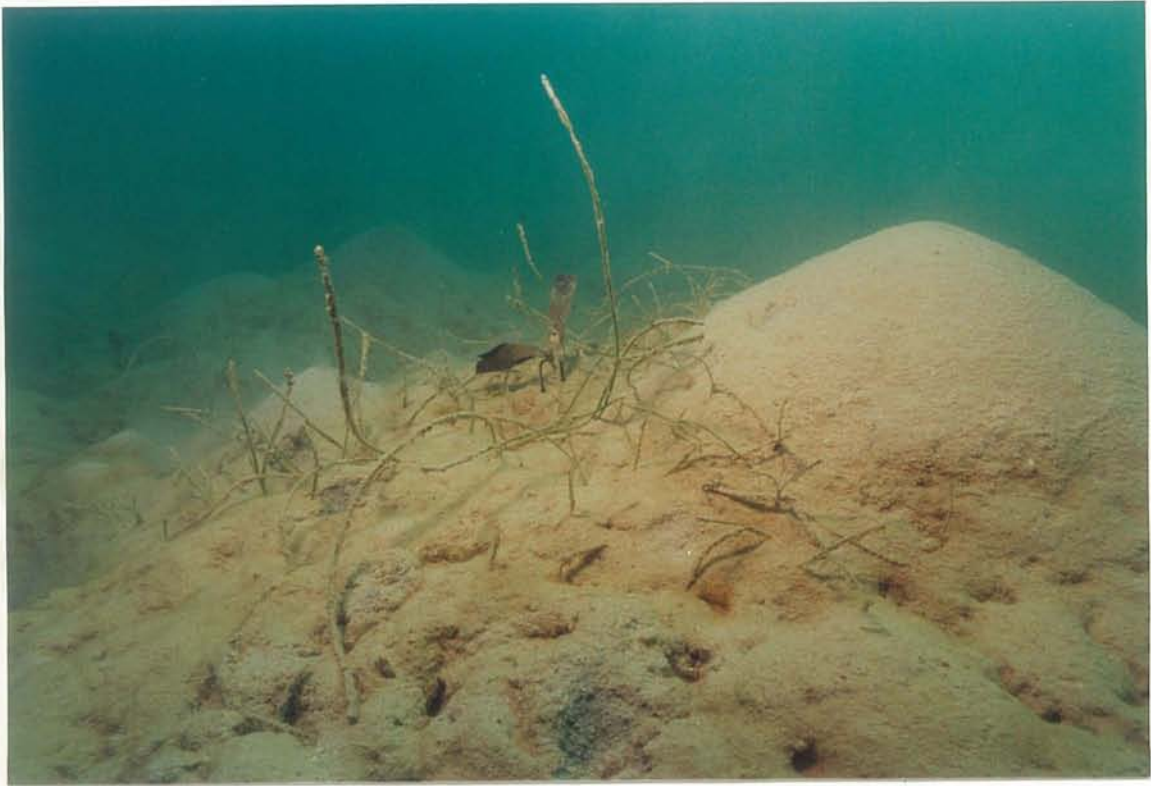
Figure 3. A successful sprig transplant growing in the almost totally unvegetated fine sandy bottom habitat (Type A). The area has many ghost shrimp (Callinassa sp.) mounds and large populations of the up-side-down jellyfish (Cassiopeia sp.) not shown in this photograph. The bottom has mats of brown diatoms which are a food source for the many conch (4 species of Strombus) attracted to the area.

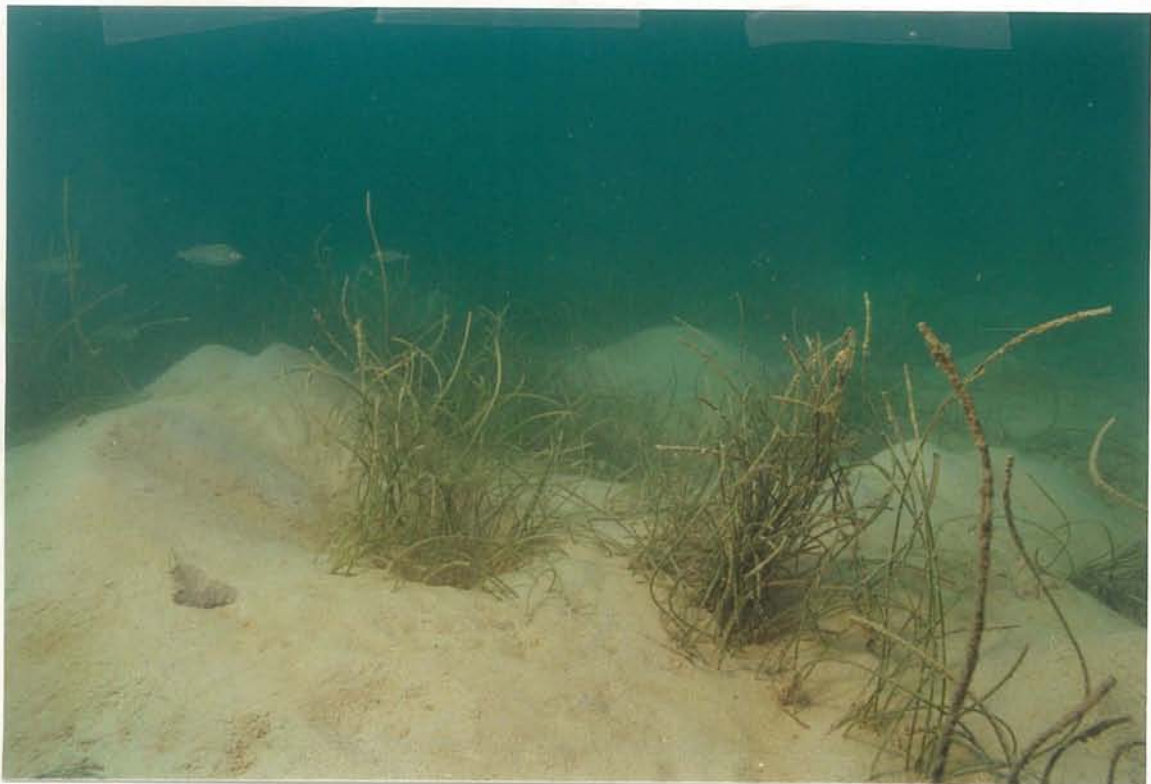
Figure 4. Healthy and spreading plugs of manatee grass (Syringodium filiforme) growing in the barren sandy habitat (Type A).

Figure 4 shows the growth of plugs in the same habitat. These plugs of Syringodium filiforme are healthy and spreading throughout the sandy, formerly unvegetated, area. Most of the successful plugs are of S. filiforme. Several plugs of Halodule wrightii were found. They were healthy, but did not show any signs of lateral growth.

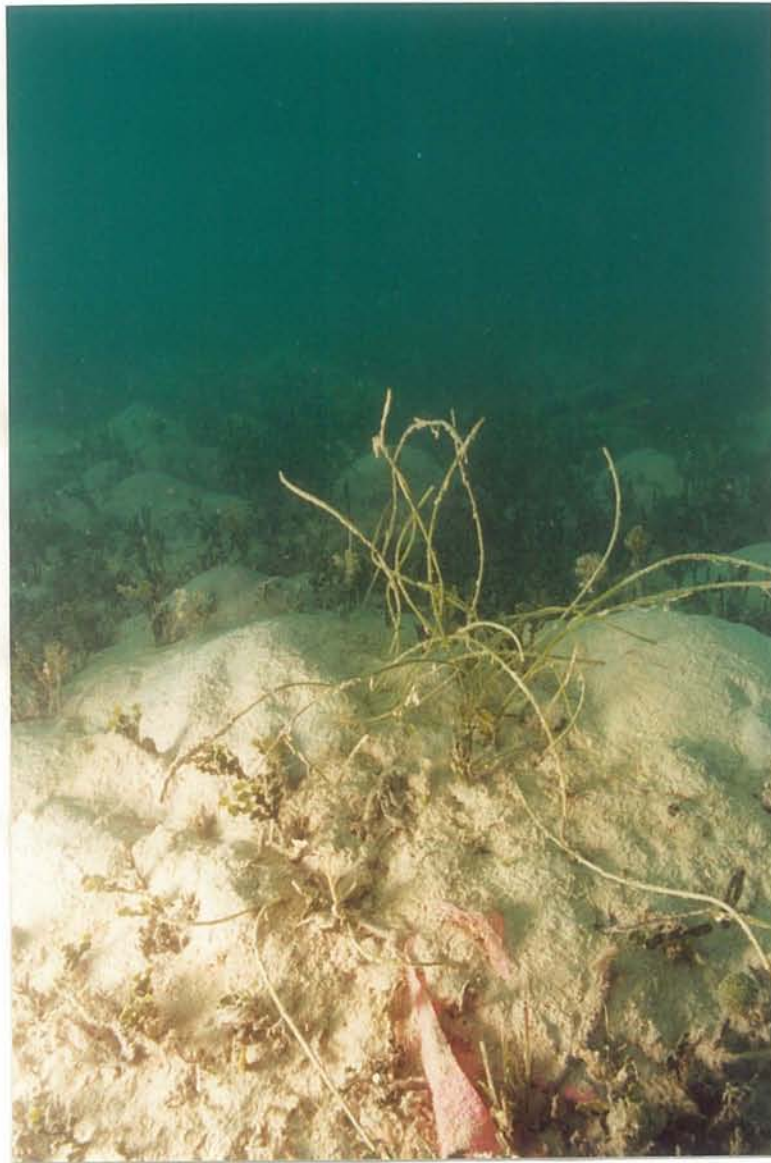
Figure 5. A successful sprig of *Syringodium filiforme* planted into habitat Type B. Note the large number of aerals which are used to rapidly spread throughout an area.

Figure 5 shows a successful sprig transplant into habitat Type B. In these new transplants a large number of aerals can be observed.

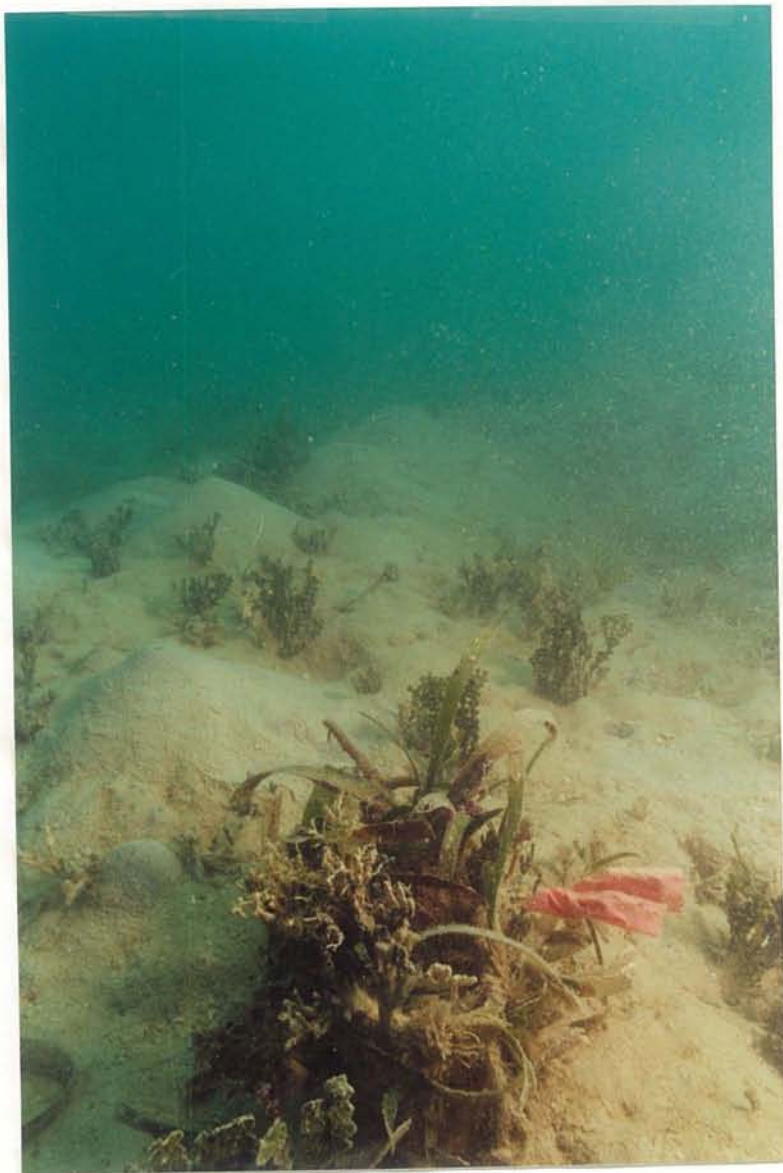
Figure 6. Turtle grass (Thalassia testudinum) plug located in habitat Type B. All turtle grass plugs were alive, but cropped and not spreading.

Figure 6 is one of the Thalassia testudinum plugs which were all planted in habitat Type B. All of the turtle grass plugs were alive, but they looked just like the one shown in the figure. They were cropped short with what appeared to be new, but short shoots. They had not spread at all.

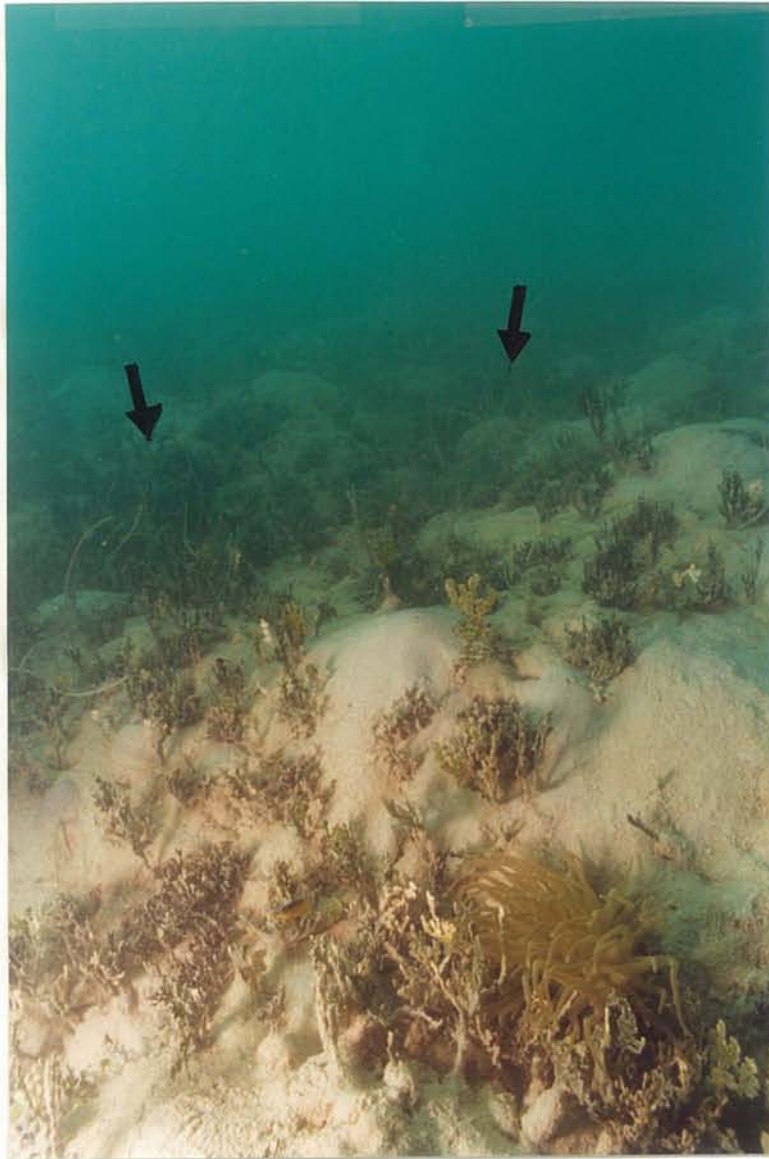
Figure 7. A typical habitat Type B bottom with one of the typical invertebrates, a pink tipped anemone (Condylactis gigantea) in the foreground. The arrows point to two successfully established manatee grass plugs.

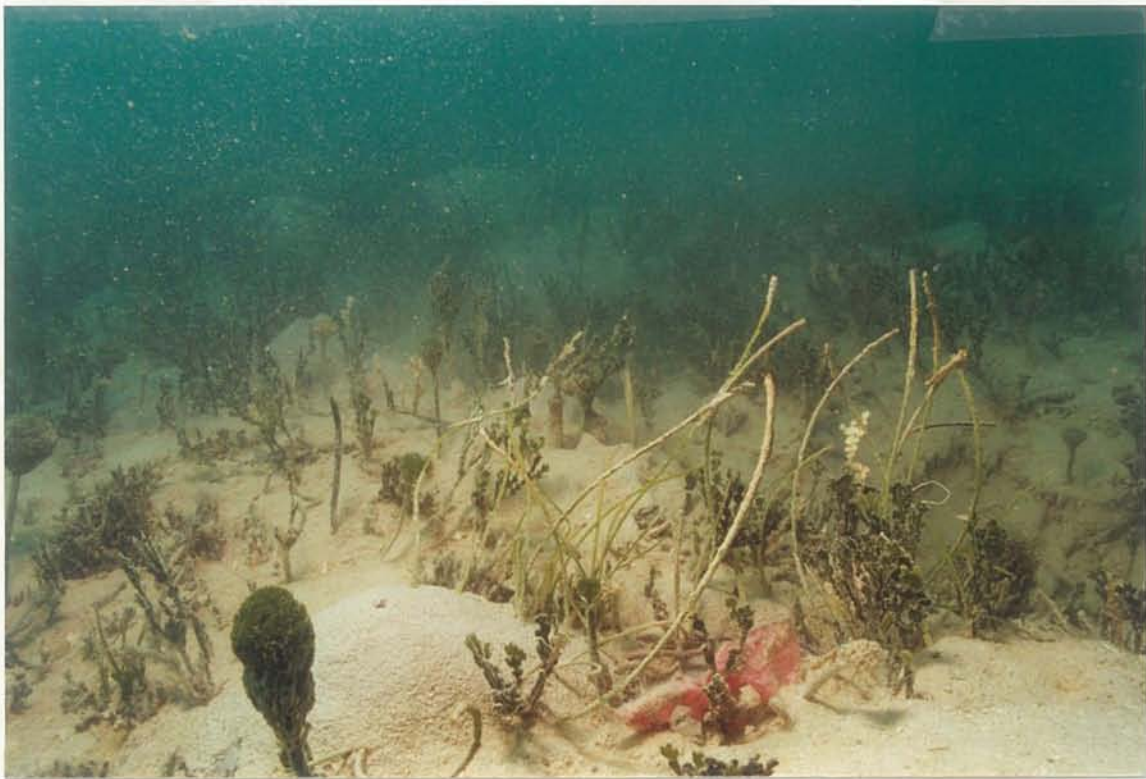
Figure 9. A healthy and spreading plug of manatee grass, (Syringodium filiforme), growing in habitat Type B.

Figures 8 and 9 show examples of growing and spreading plugs of Syringodium filiforme. Figure 10 shows one example of the abundance of juvenile fish found among the debris on the bottom within the study area.

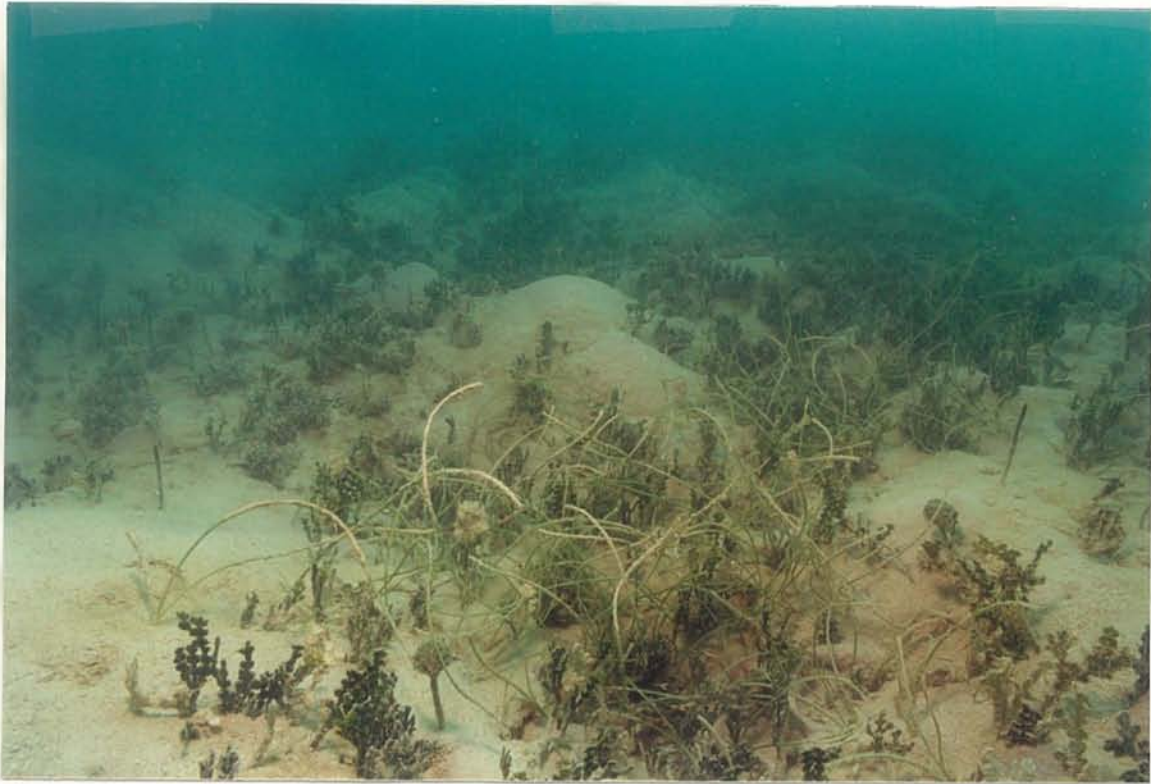
Figure 4. An extensive patch of Syringodium filiforme. The photograph was taken during the November, 1987 monitoring and exhibited a much more extensive lateral growth during the February monitoring. The patch in the photograph corresponds to the area marked #2 in Figure 3. The area is in plot I and is the characteristic habitat type "B" described in the text.

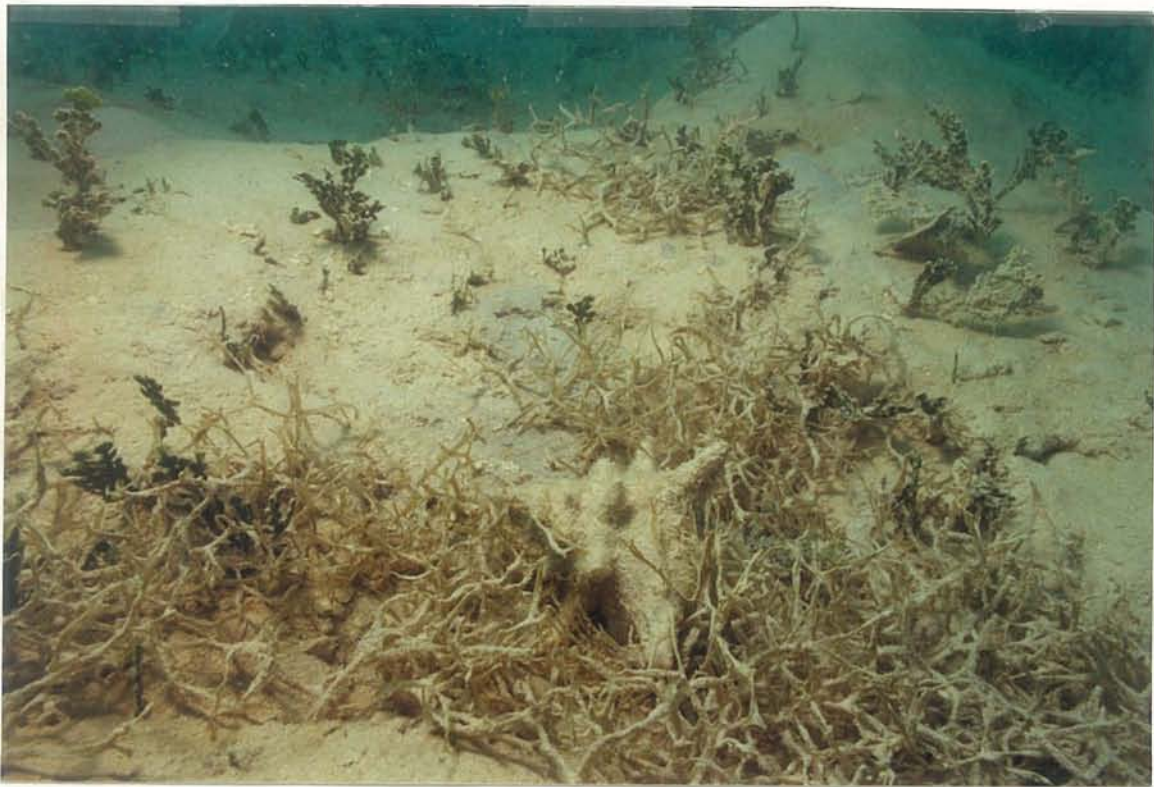
Figure 5. In the foreground are clumps of the brown algae, Dictyota. A single juvenile conch is shown grazing the area. This photograph was taken in November and shows the sparse distribution of the algae. During the February visit, this algae literally covered and buried the entire area where no grass was growing. However, the seagrass patches had almost none of this algae present.

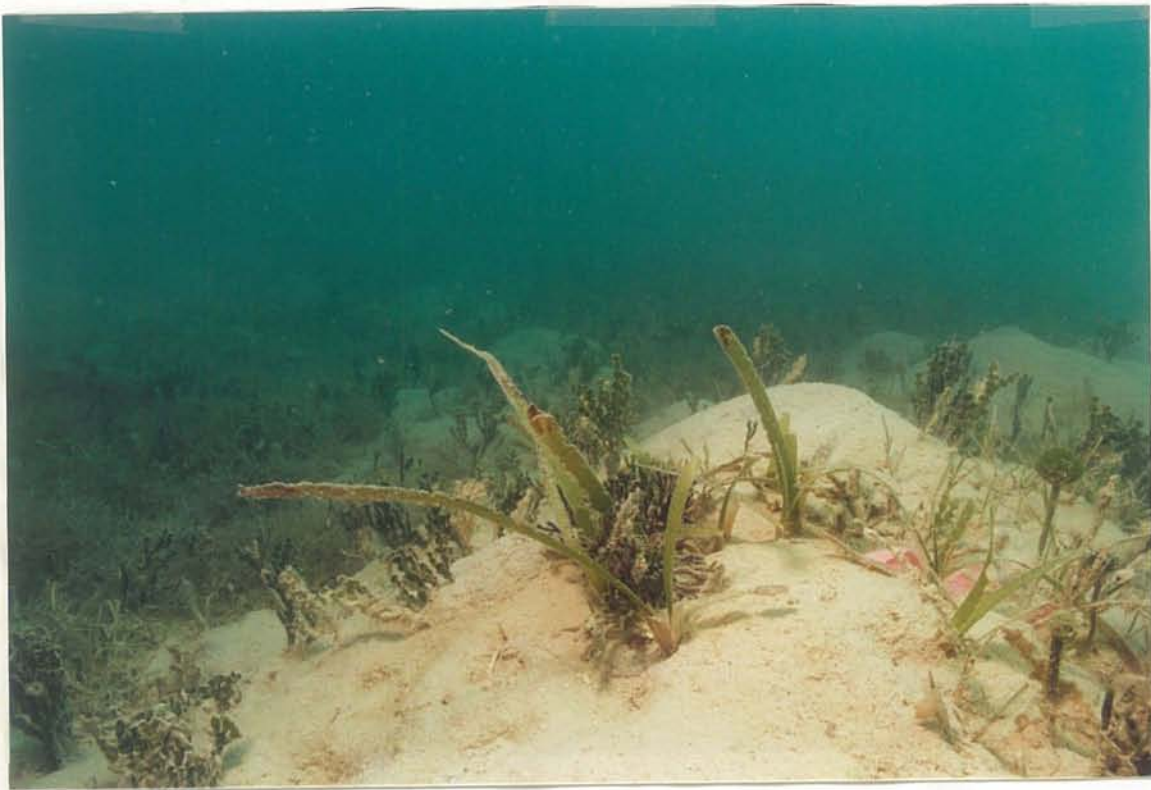
Figure 6. Off to the left of the photograph is shown an extensive patch of the brown algae, Dictyota. A surviving seagrass plug of Thalassia testudinum is shown in the foreground. Pink flags indicate where plugs were placed. A pink flag was placed in the center of all transplanted plugs and one can be seen in the photograph along with surviving seagrasses.

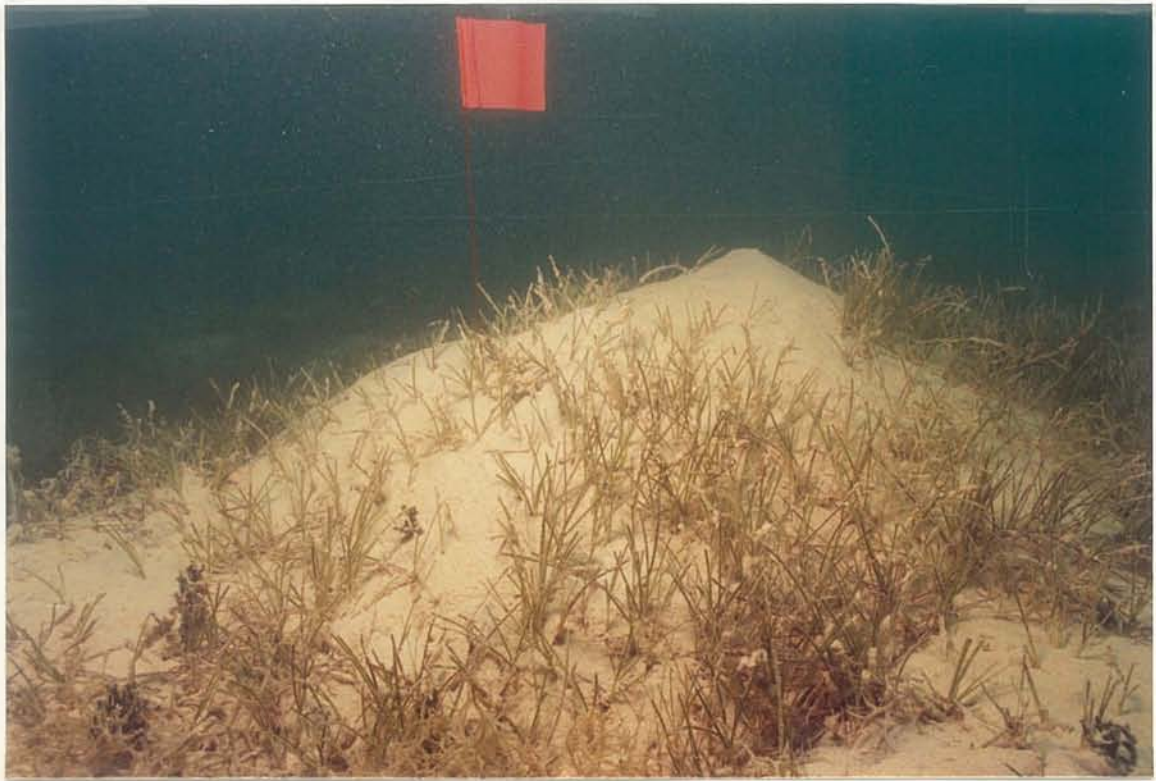
Figure 4. One of the typical extensive patches of shoalgrass, (Halodule wrightii), grown from transplanted plugs and/or sprigs now found in the successful transplant area as defined in Figure 3.

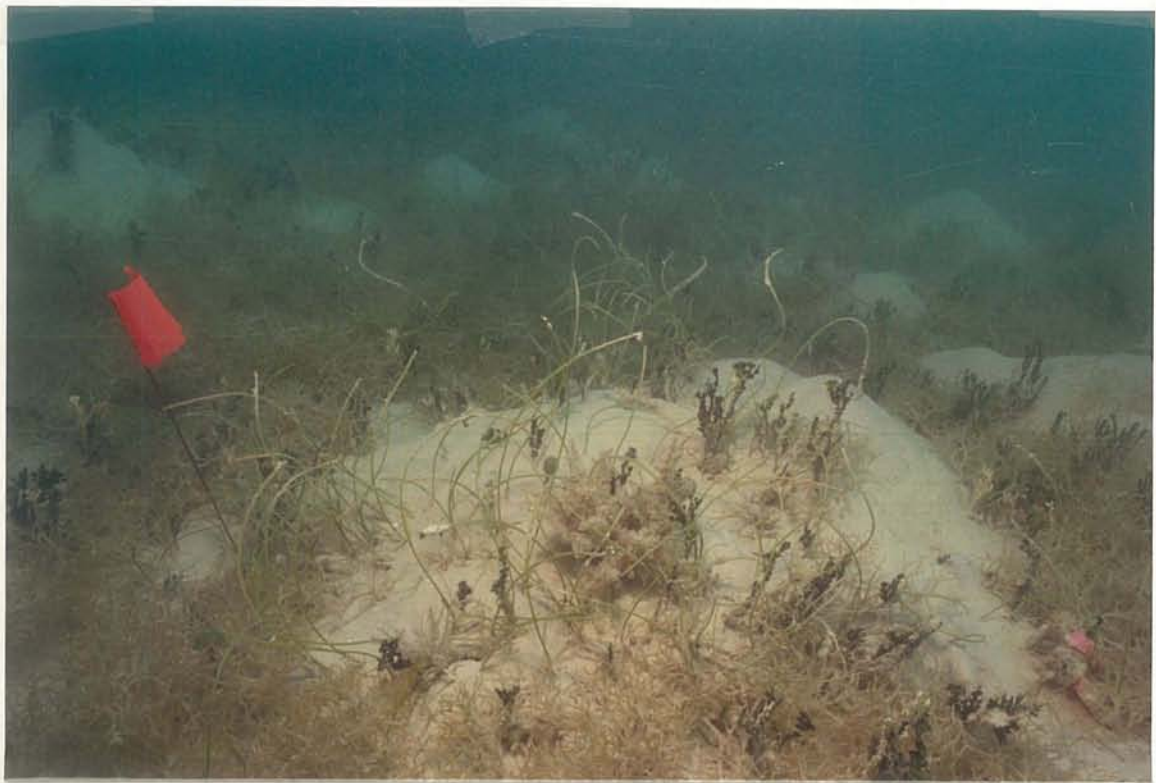
Figure 5. A representative patch of manatee grass, (Syringodium filiforme), typically found throughout the successful recipient area as defined in Figure 3. Note the pink marker flag in the right hand corner of the photo, indicating the location of a transplanted plug.

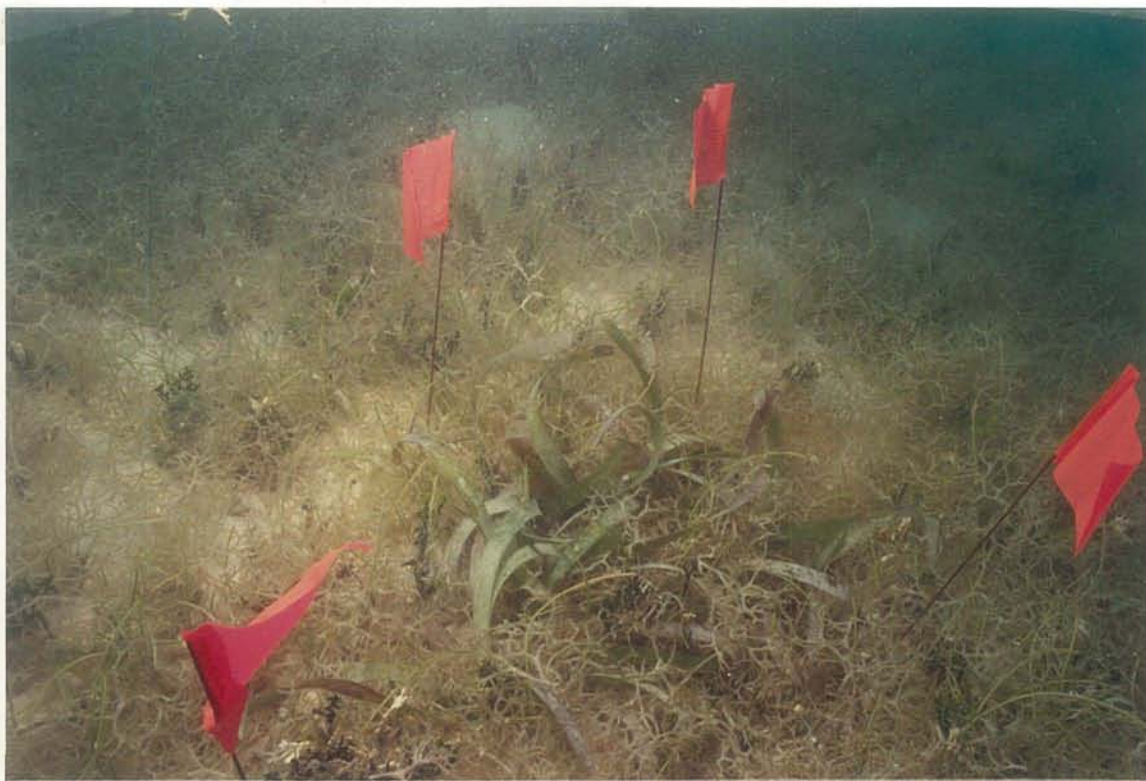
Figure 6. A transplanted plug of turtle grass, (Thalassia testudinum), which has grown laterally. The blades are whole, healthy and show few bite marks from grazers.

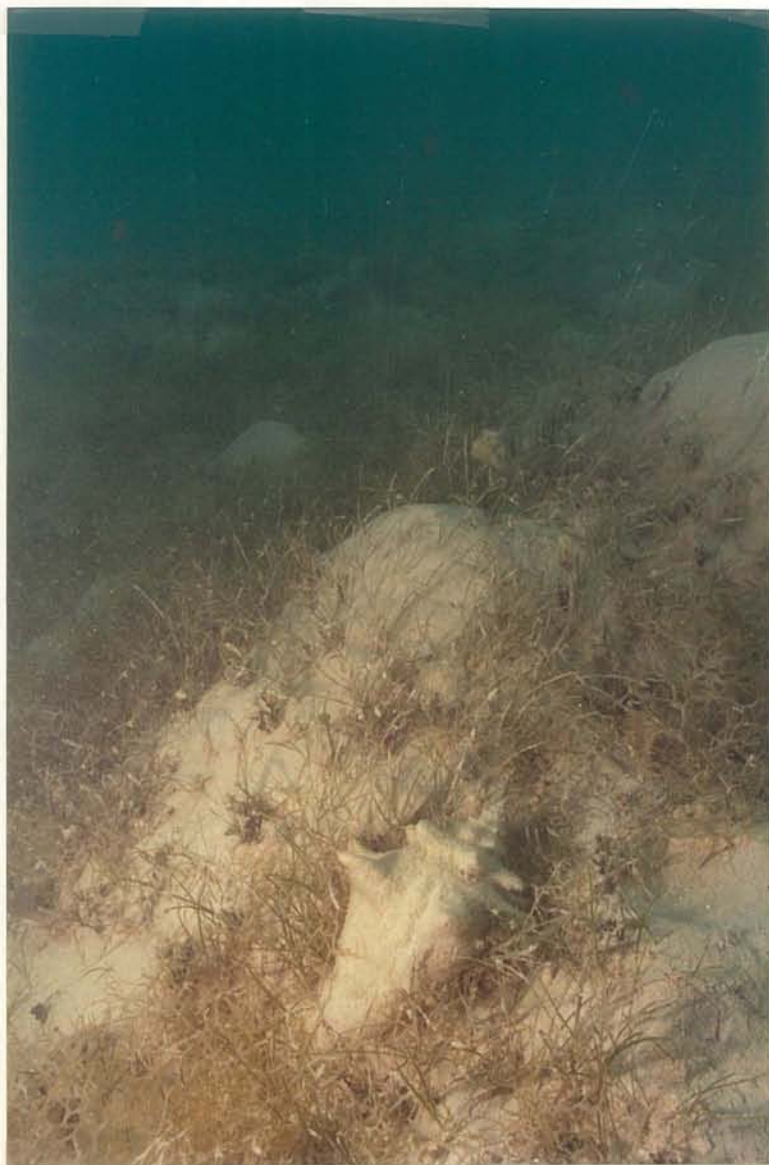
Figure 8. A representative view of habitat type "B". This habitat type is the only one supporting the growth of all three transplanted species of seagrasses. The many mounds created by ghost shrimp can be seen throughout the area. In the foreground is one of the many juvenile queen conch also found in this area. The seagrass, Halodule wrightii, is prominent as are clumps of tan drift algae.

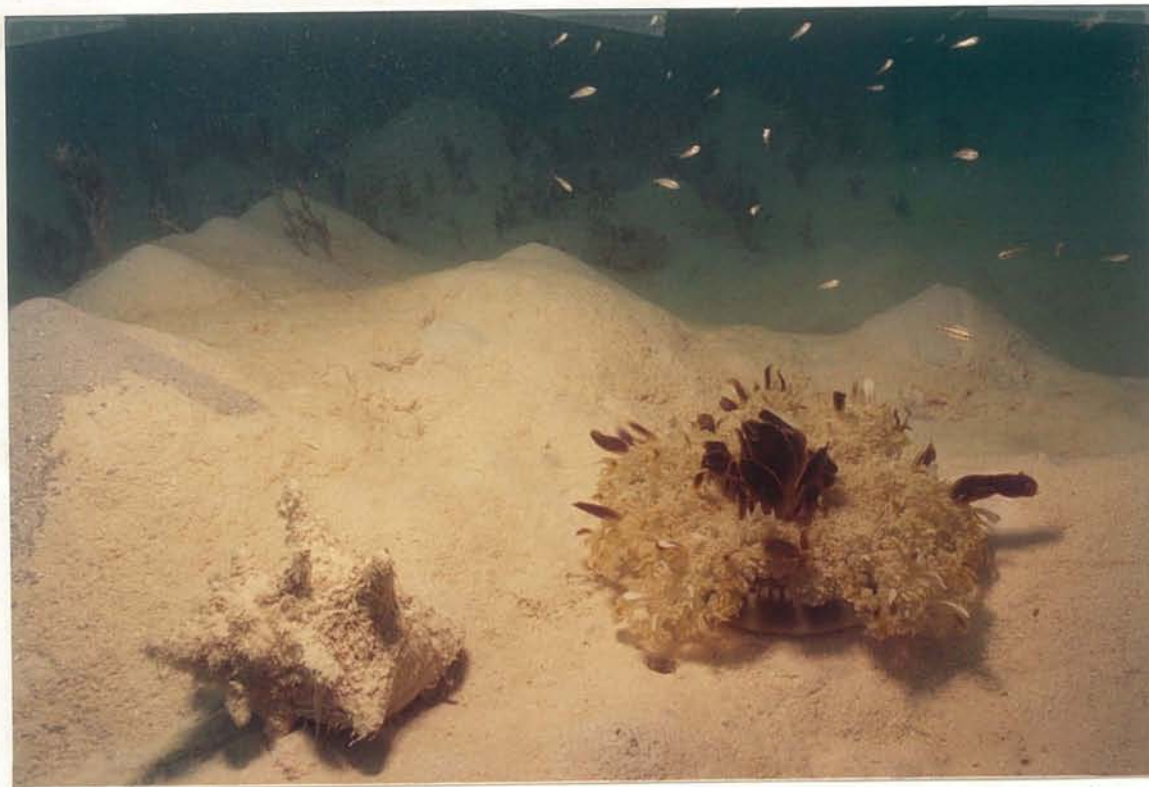
Figure 10. The habitat, type "A", found at the edge of lateral growth of the transplanted seagrasses. This habitat has the many ghost shrimp mounds characteristic of habitat type "B", but lacks any seagrass growth and the diversity of algae species found in the area of successful seagrass transplantation. Characteristic of this area is the abundance of up-side-down jellyfish, brown diatom scum covering the sand, and grazing conch.

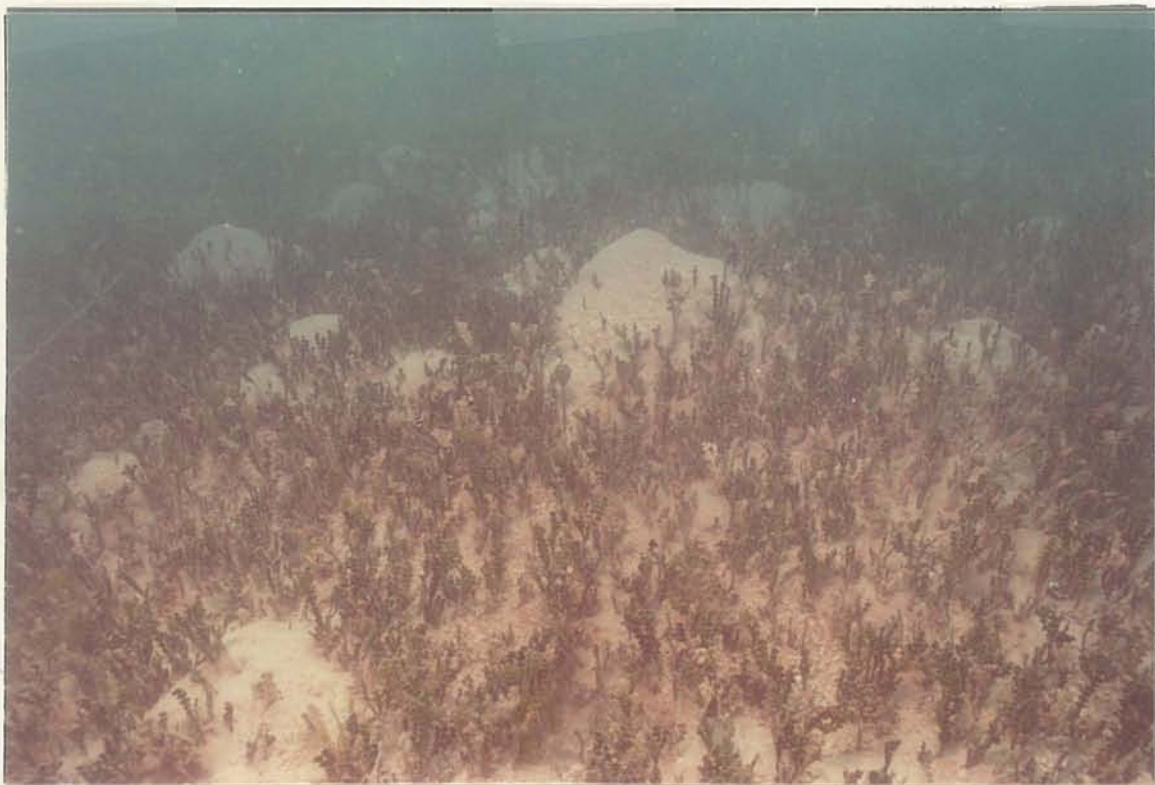
Figure 5. Dense patch of the algae, Halimeda incrassata, found at the edge of seagrass expansion (see Figure 4, area "D").
