## PILOT EXPERIMENTAL SEAGRASS TRANSPLANTATION PROJECT

SOUTH SHORE, ST. CROIX  
U.S. VIRGIN ISLANDS

August 1987

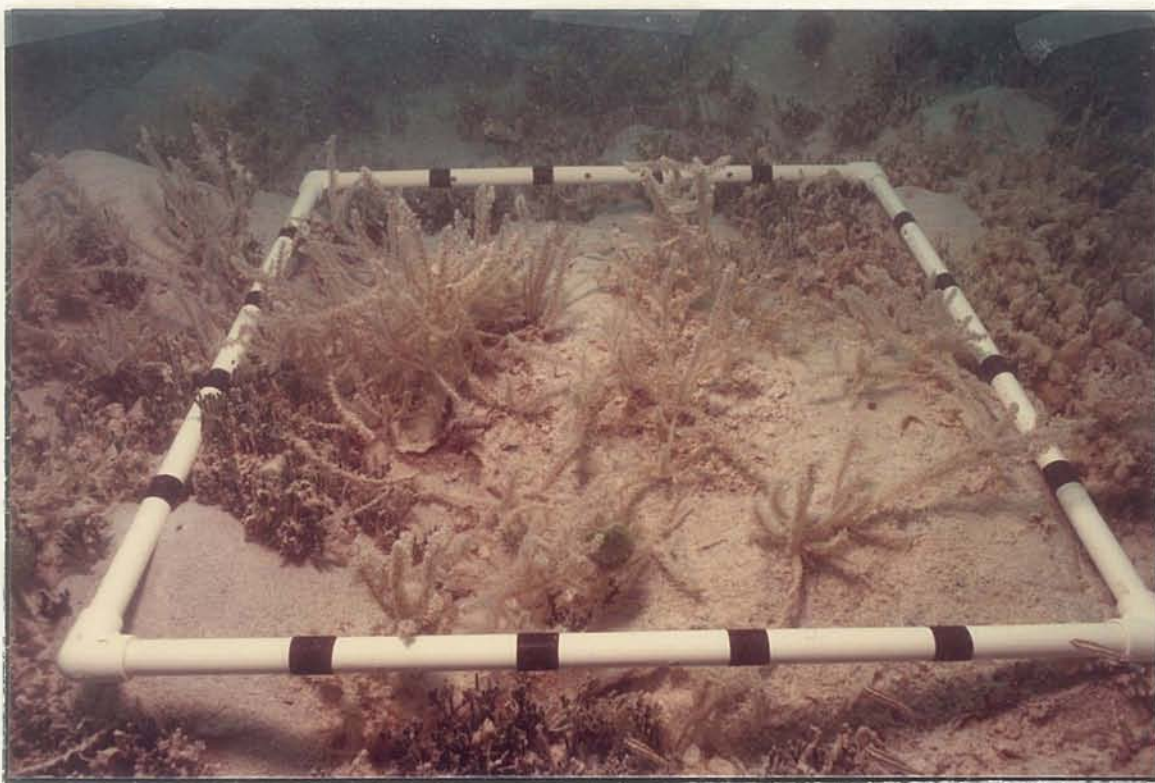
Figure 6. Another community found at the edge of seagrass expansion (see Figure 4, area "E") with the dominant algae, Acanthophora spicifera.

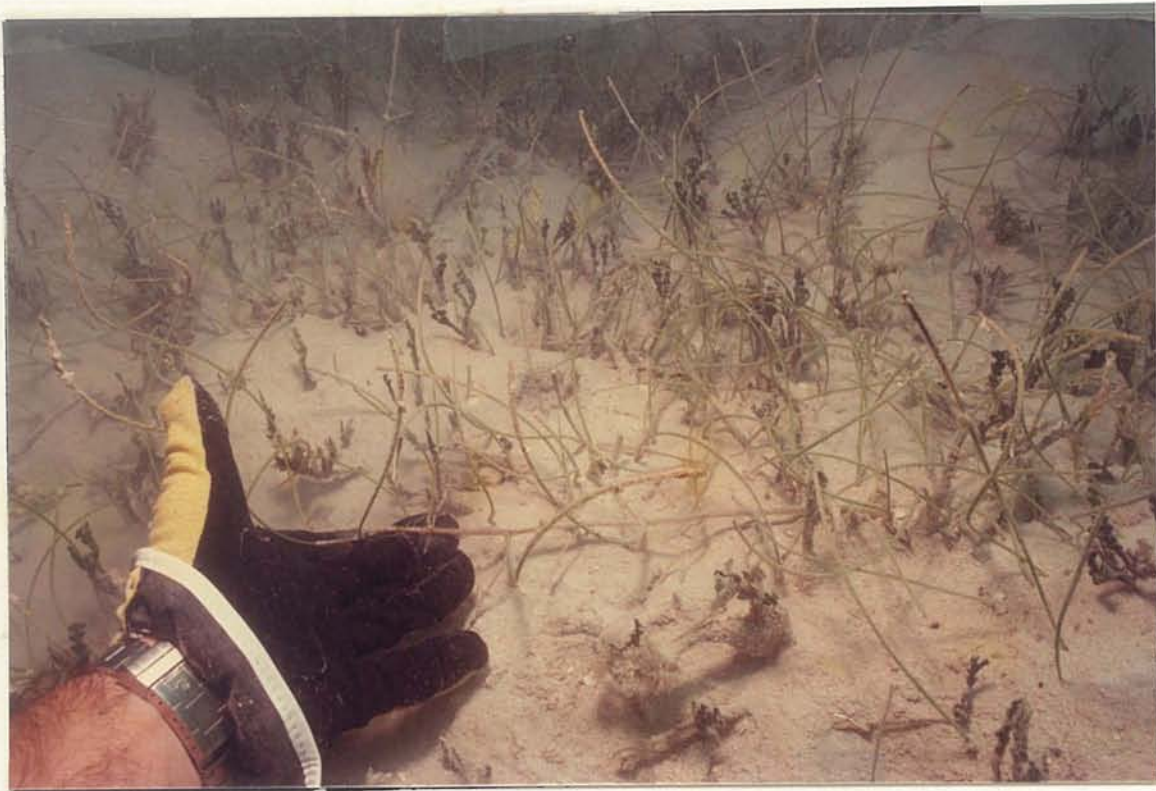
Figure 7. Syringodium filiforme showing the presences of a long runner, indicating the potential for rapid colonization and expansion.

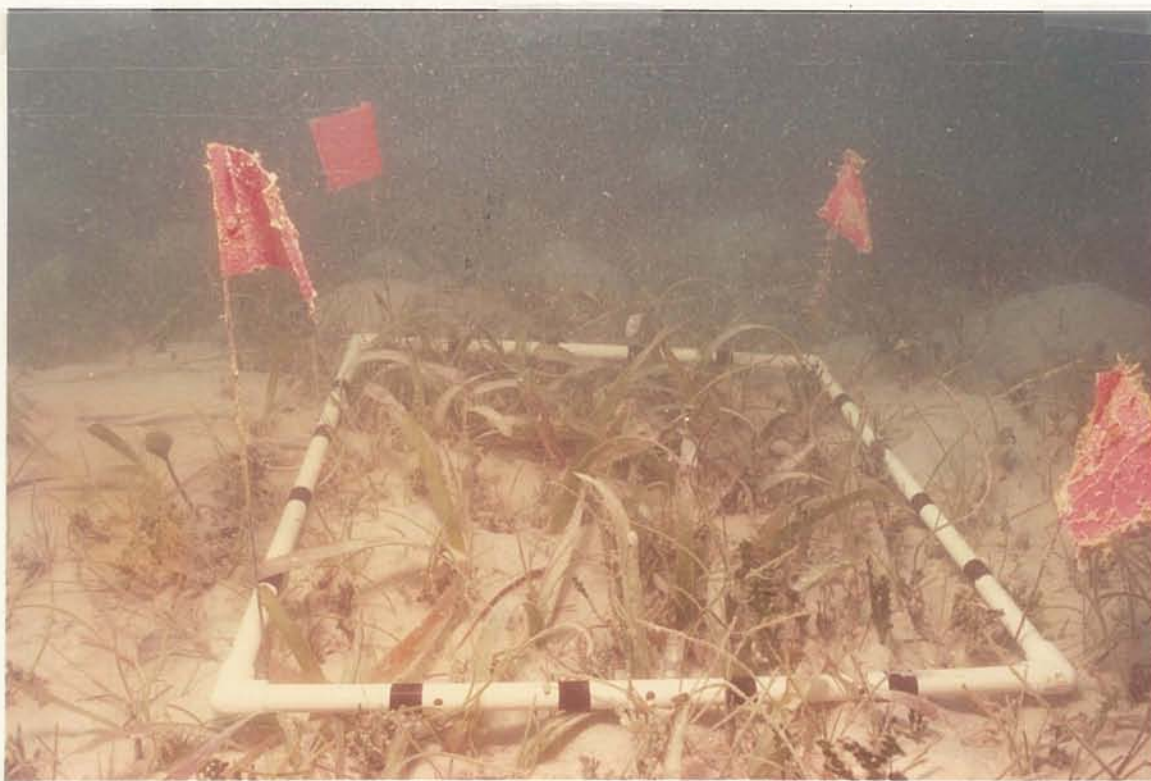
Figure 9. Manatee grass (Syringodium filiforme) is interdispersed among turtle grass (Thalassia testudinum), both originating from seagrass that was transplanted

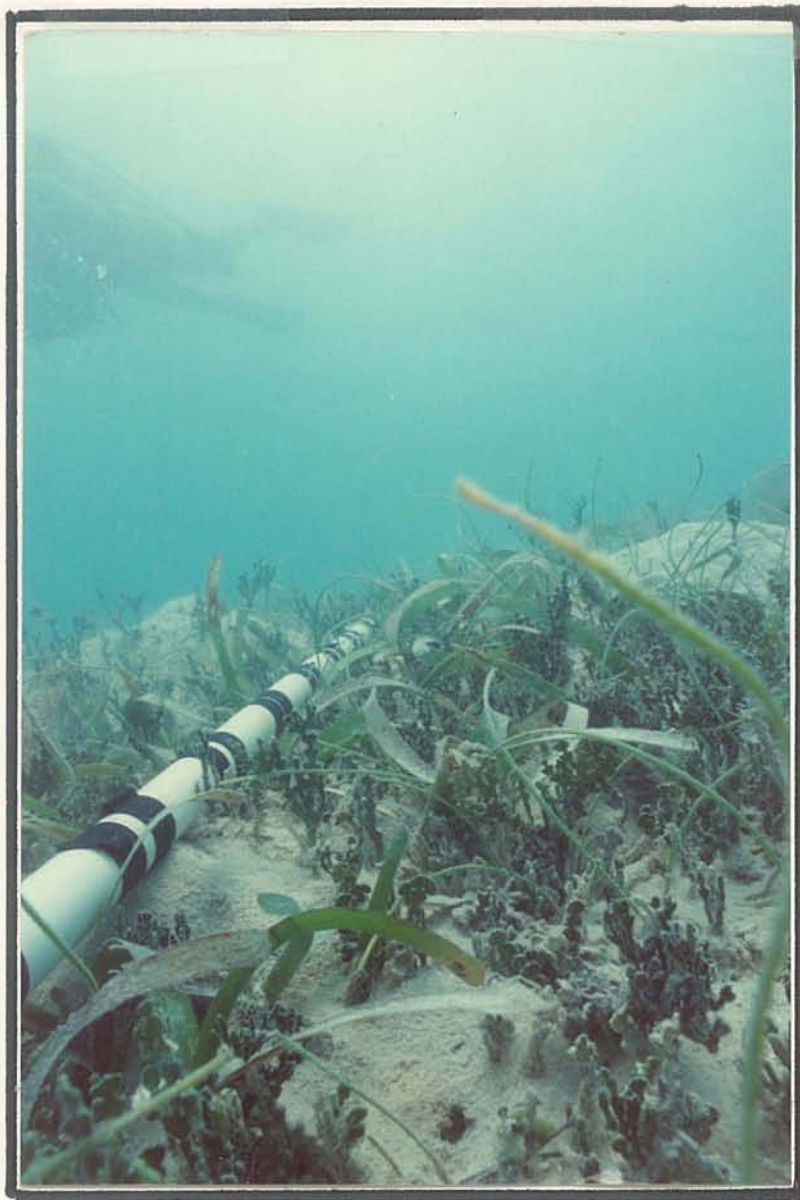
Figure 5. A meter length of PVC pipe, marked off in 10 cm segments, was placed perpendicular to a guideline (not shown) marked off in meters. Divers then used this meter and the meter marked off on the guideline to define a meter square in order to estimate percent cover and count grass blades within each plot.

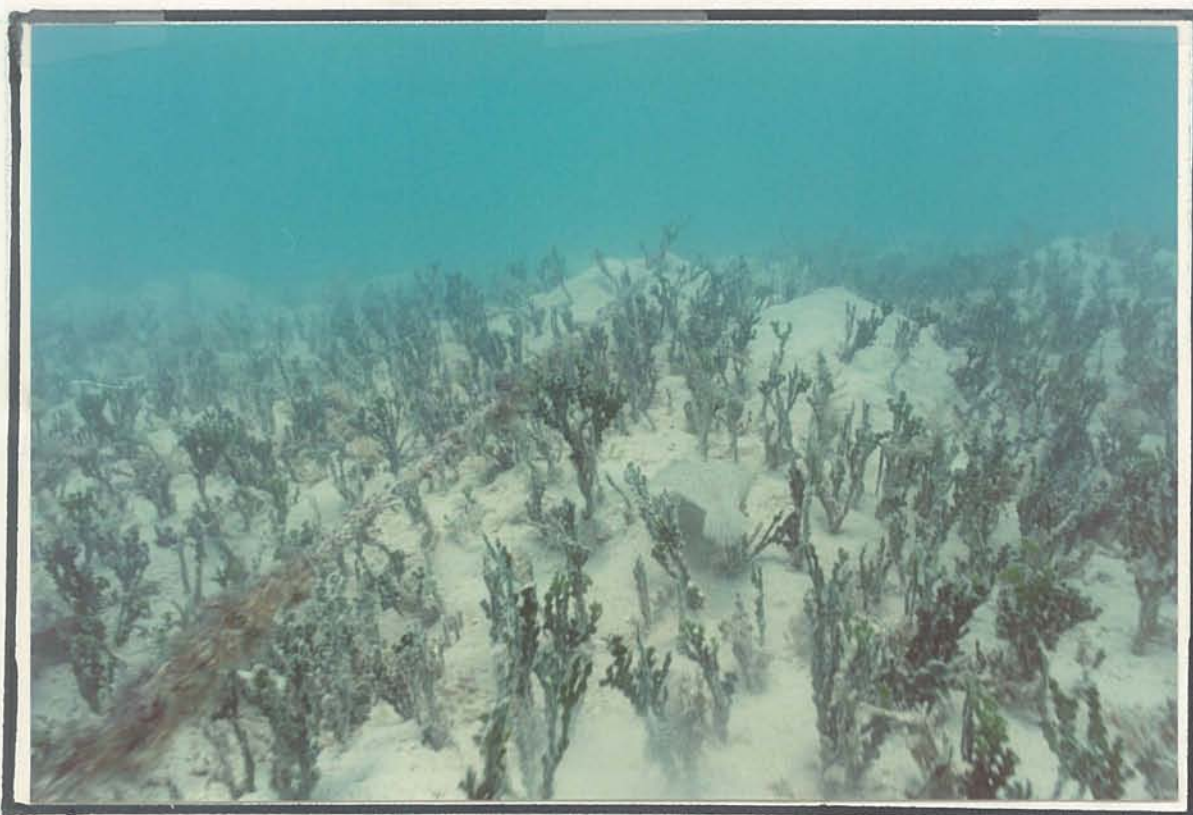
Figure 8. One of the original lines defining the plot; north side of plot I.

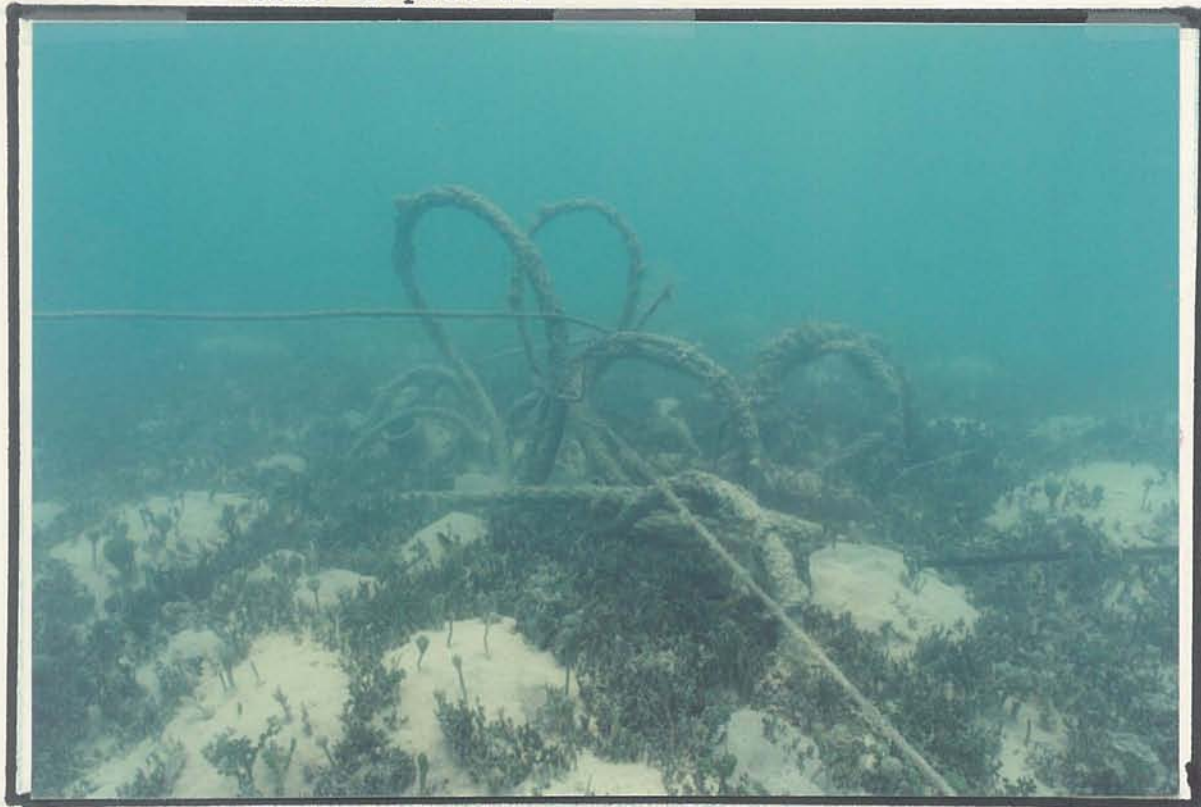
Figure 9. Original lines defining plot I; the northwest corner.
