THE CABRITS

AN INVENTORY OF EXISTING CONDITIONS,
AN EMERGENCY STABILIZATION PLAN
AND DEVELOPMENT RECOMMENDATIONS
FOR THE STABILIZATION AND RESTORATION
OF THE CABRITS

Douglas White, A.I.A.
Historical Architect
Island Resources Foundation
St. Thomas, USVI

1982

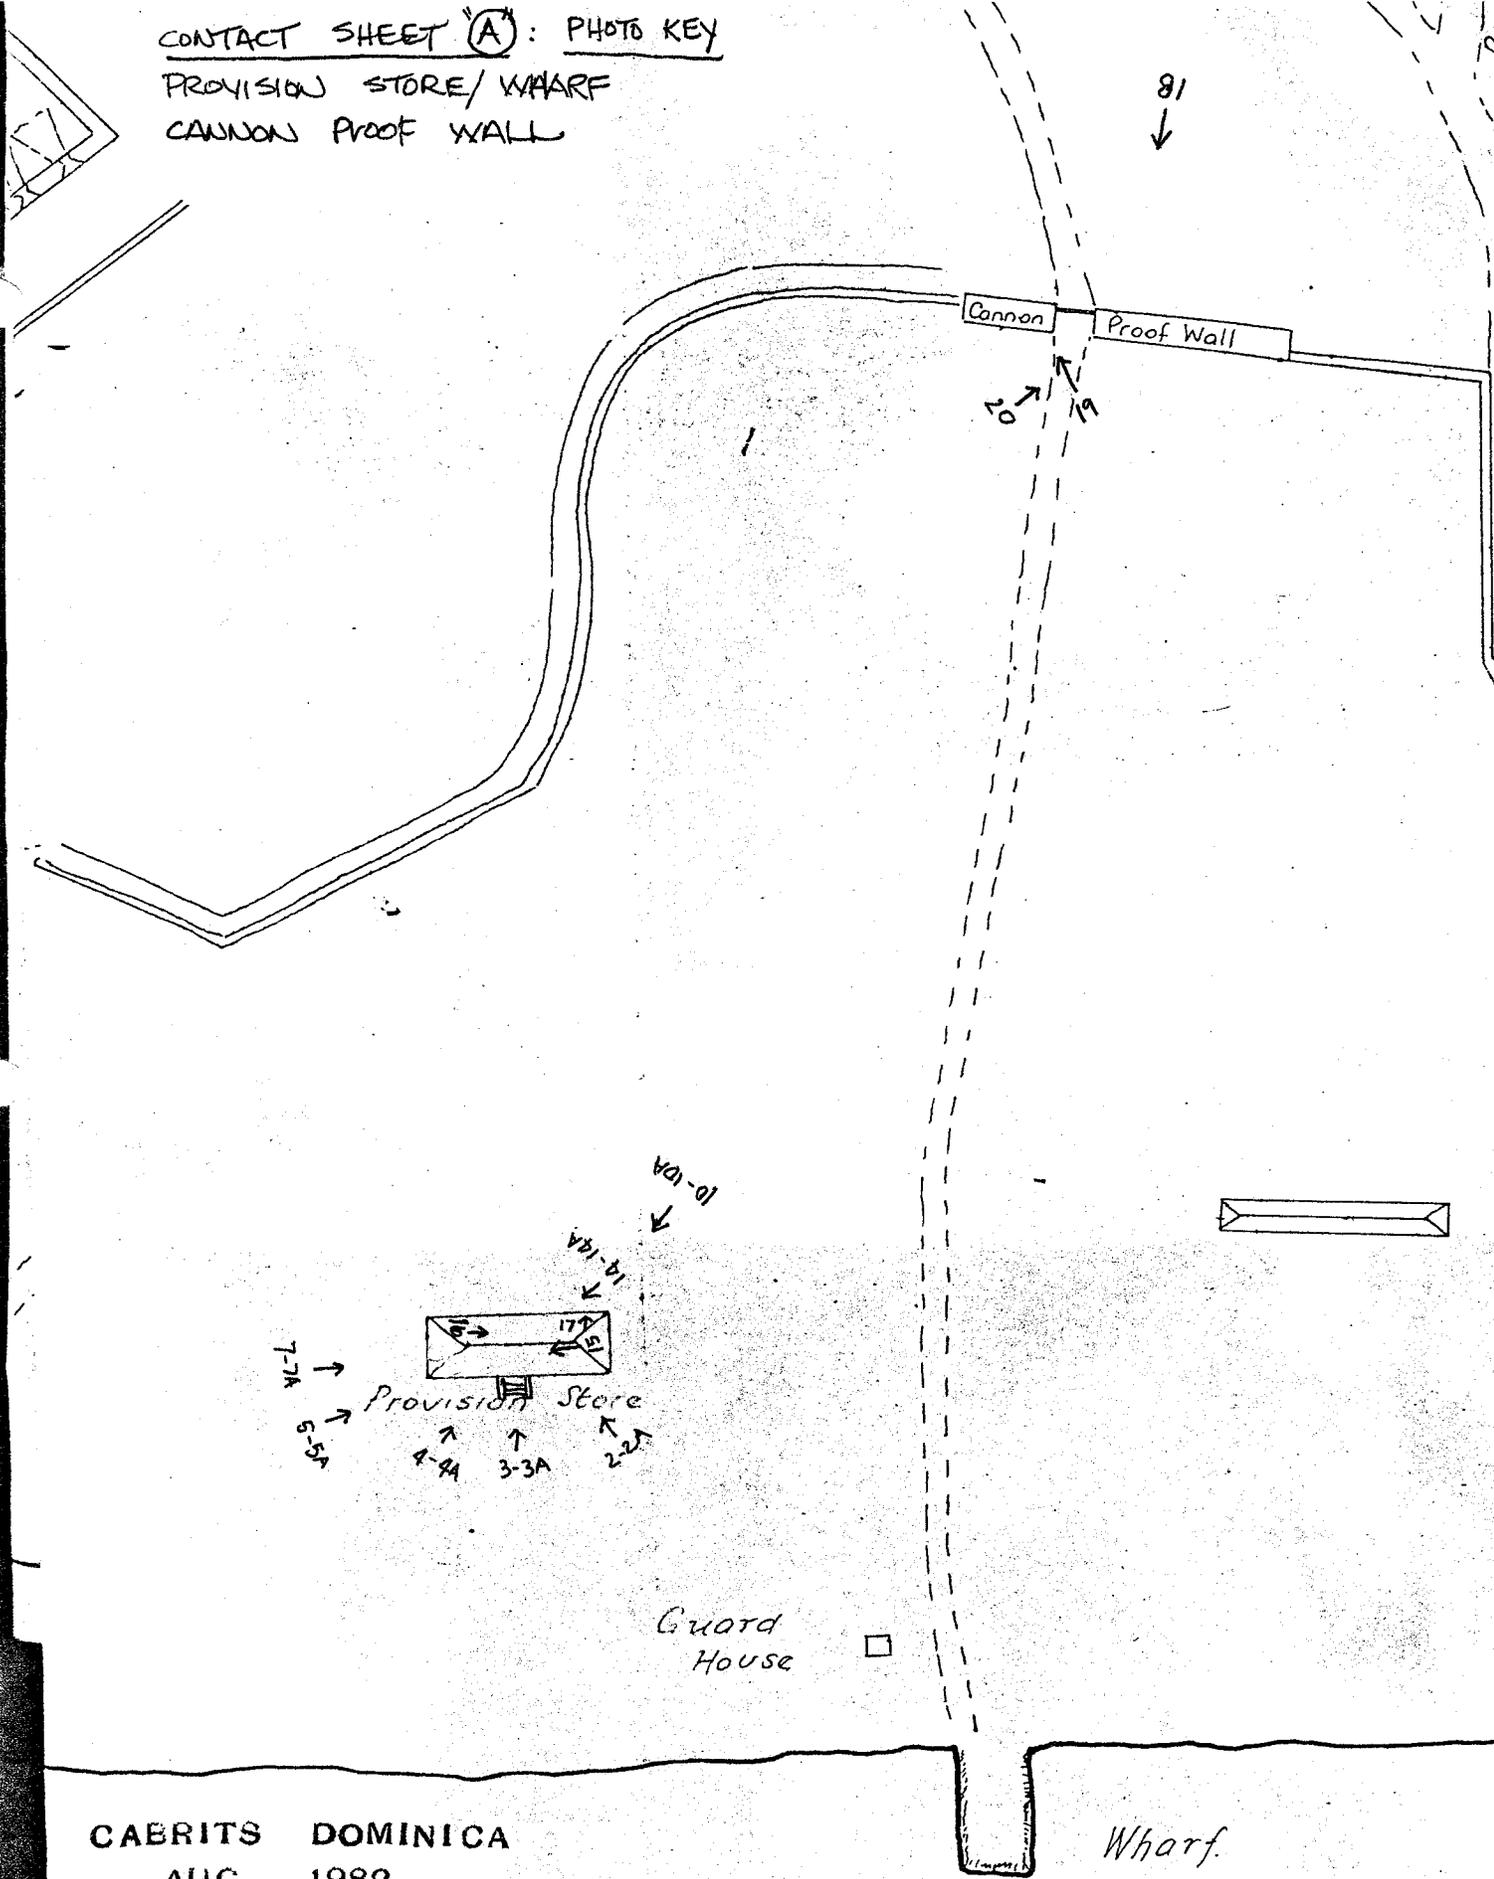
PROVISION STORE/WHARF

CANNON PROOF WALL

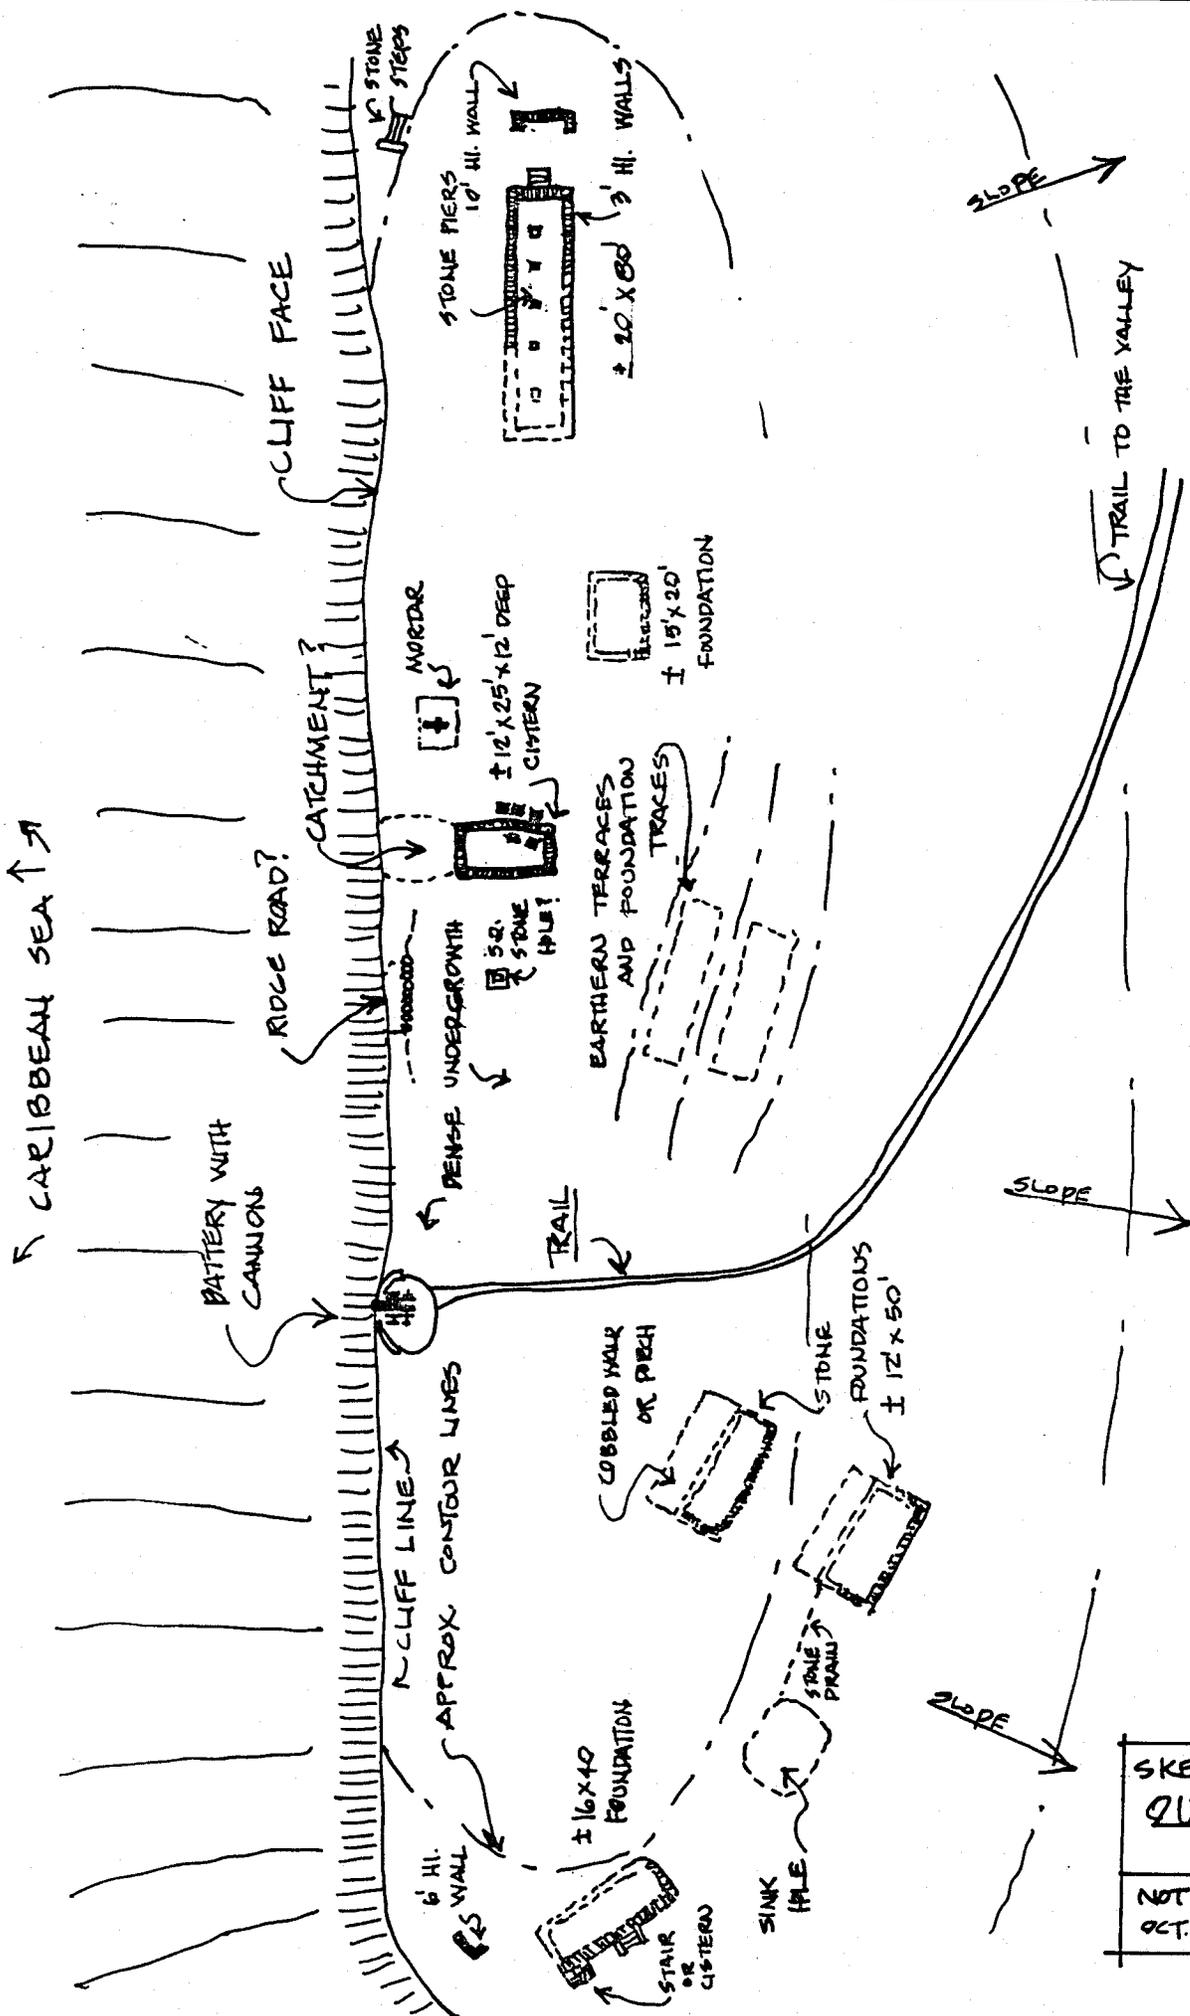
NORTH ↑
 SKETCH MAP OF THE
 OUTER CABRIT
 DOMINICA
 NOT TO SCALE
 OCT. 1983 D. WHITE

Condition of the Fabric. Of the approximately nine building foundations located on the Outer Cabrit, there are only two wall sections standing to a height of 6 feet or above. The condition of the foundations ranges from fair in the Hospital to poor in the Officers Quarters to almost non-existent in the Troop Barracks. The terreplein of the lone cannon is fair with a few stones missing while the semi-circular breastwork has completely disintergrated.

General Recommendations. The discovery of the heretofore unknown (in modern times) hospital foundation, cistern and mortar at the northern end of the Outer Cabrit further increases the vastness of the scale of the Cabrits. The area should be made accessible by cutting a trail in through the bush but is, in general, of low priority.

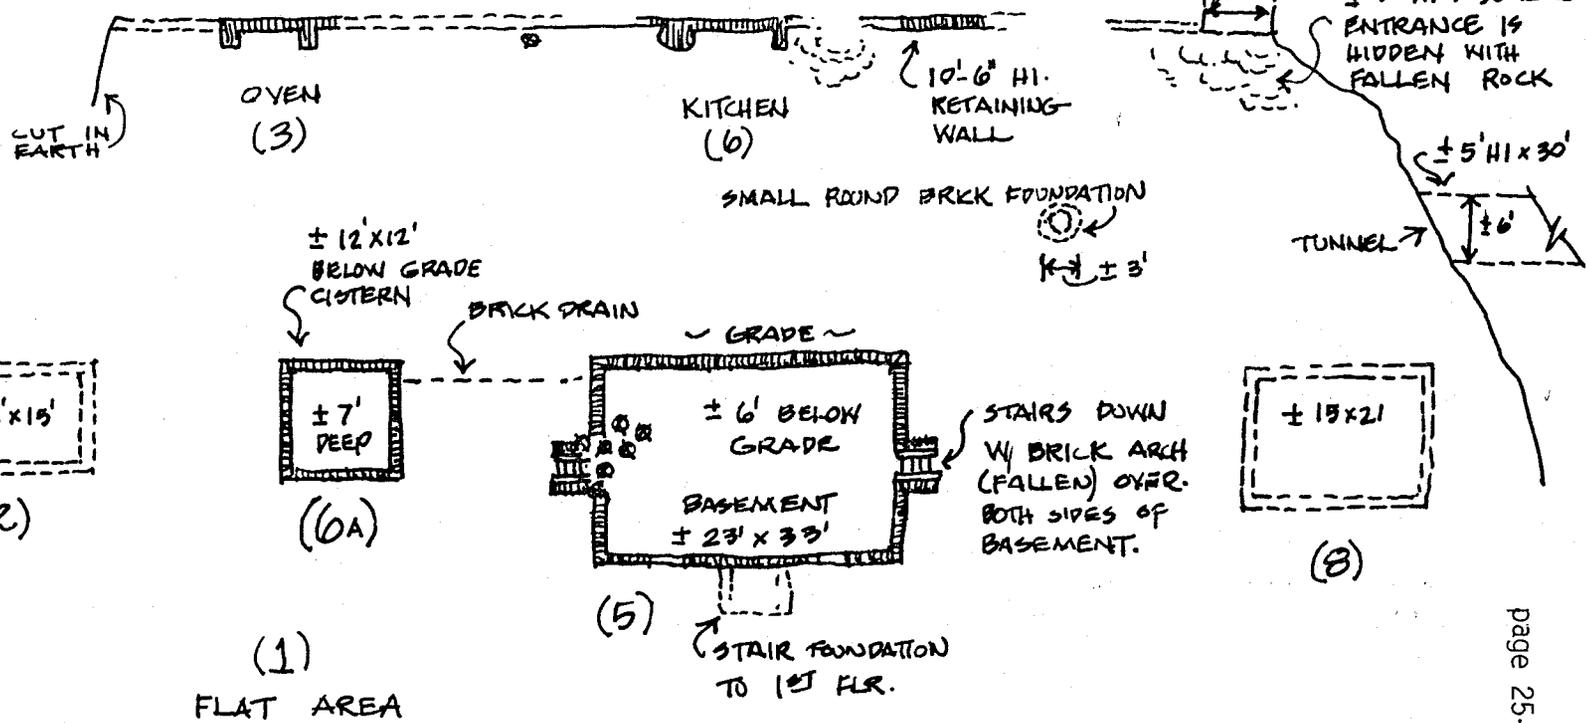
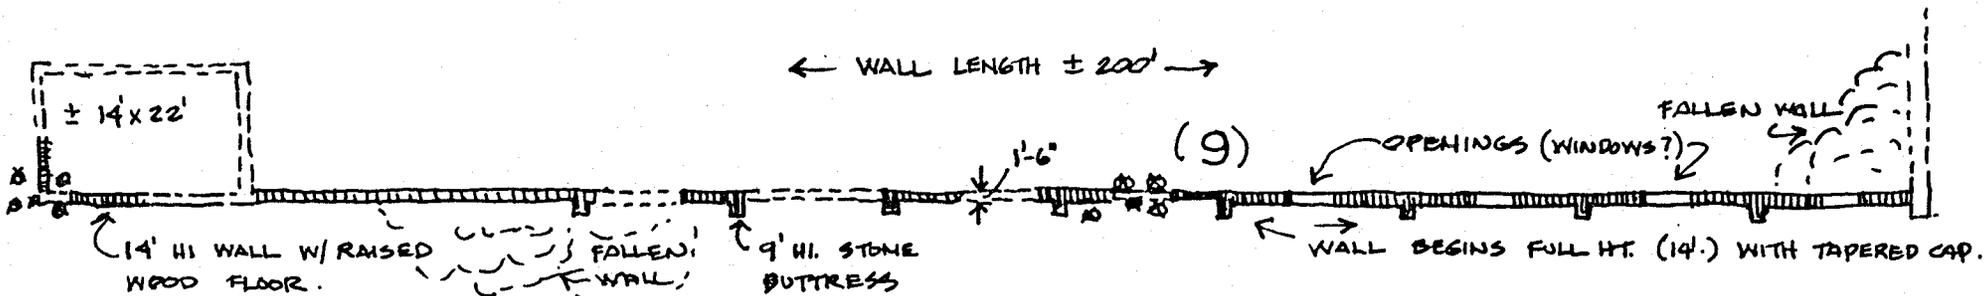
COMPLETELY OVERGROWN
 WITH VEGETATION

SKETCH MAP: RUINS IN THE
 WEST VALLEY OF THE CABRITS
 DOMINICA

APPROXIMATE SCALE 1" = 20'-0"
 OCT. 1983 D. WHITE

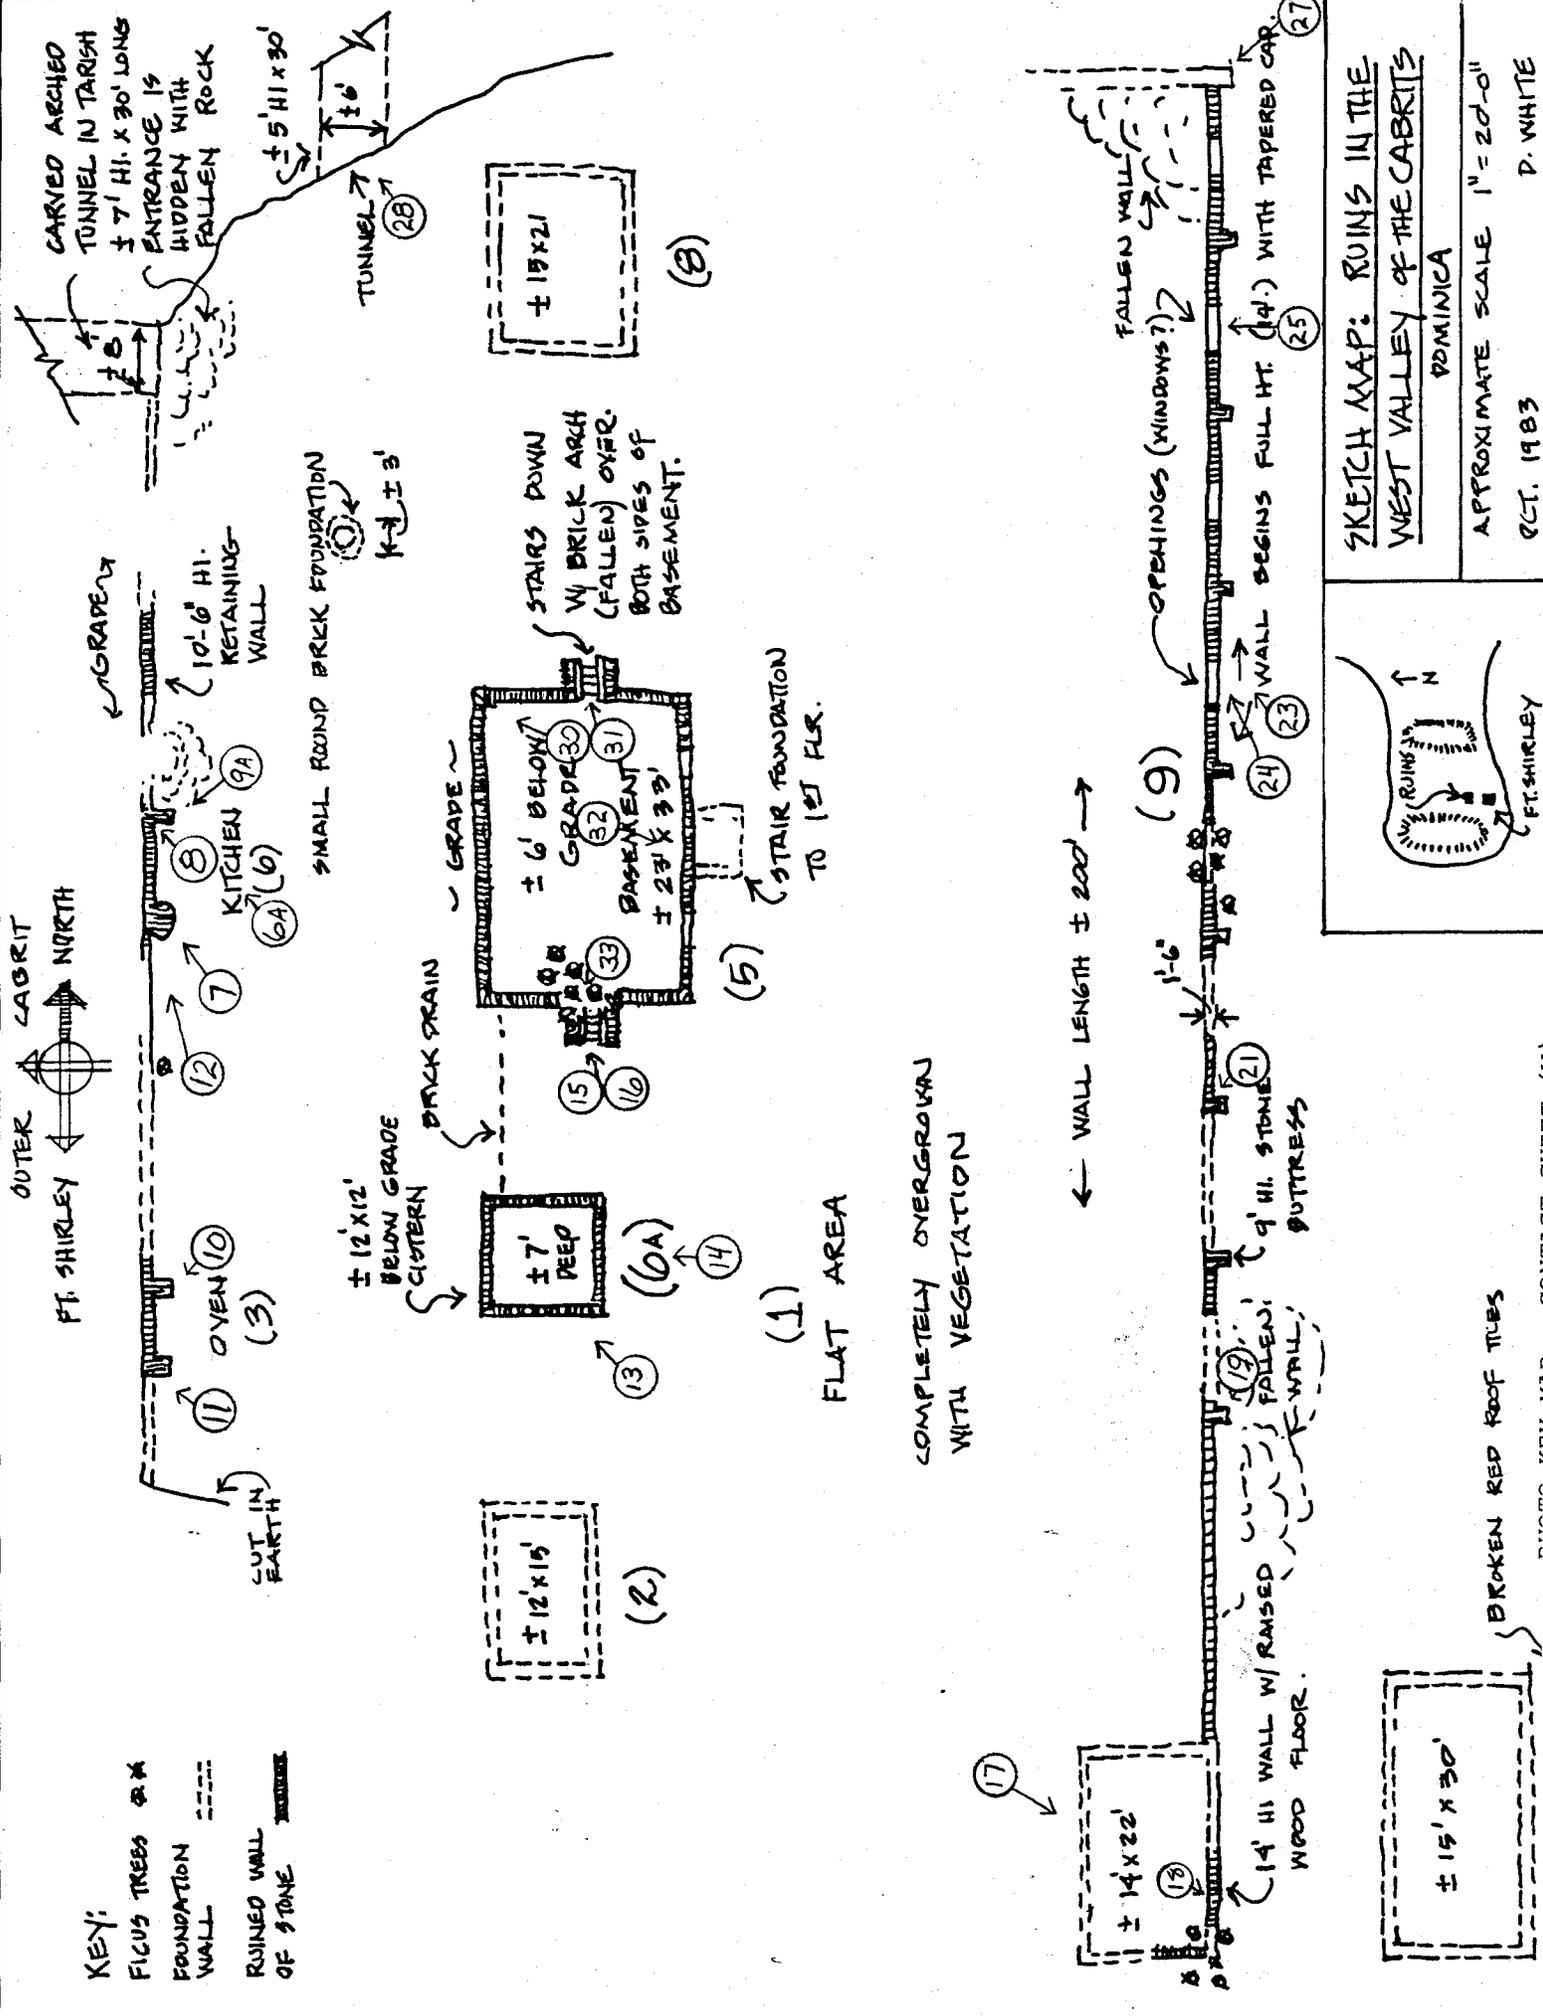
SKETCH MAP: RUINS IN THE WEST VALLEY OF THE CABRITS
 DOMINICA
 APPROXIMATE SCALE 1" = 20'-0"
 OCT. 1983
 P. WHITE

KEY:
 FIGUS TREES
 FOUNDATION WALL
 RUINED WALL OF STONE

To the north of this complex, and also identified on the 1832 map, are two additional structures. A split-level structure (approx.) 20 feet by 30 feet, identified as a forge, has most of its walls intact but no roof. The second structure is a long, narrow, rectangular, below-grade cistern with no roof, similar in size to the cistern found on the Outer Cabrit.
